## Marine Safety Forum – Safety Flash 08-27

**Issued: 28 July 2008**

**Subject: Incorrect Lifting Equipment**

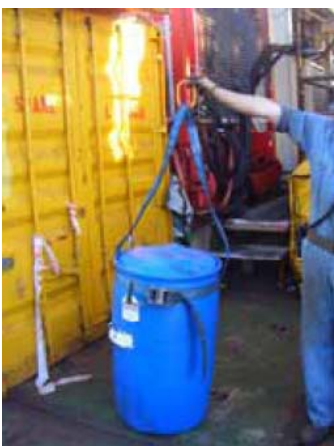
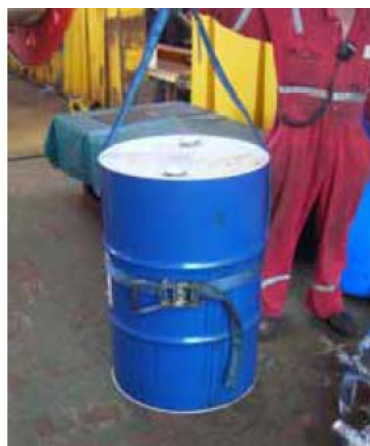
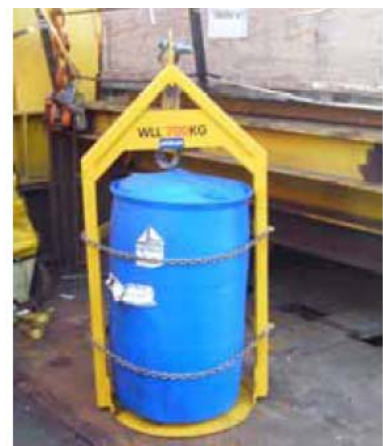
Deck crews were lifting a full 200l (40 gallon) drum of Oceanic HW 443 (ethylene glycol) with the crane using a cargo strap drum lifter. As the drum was being lifted over some deck equipment it slipped out of the span set type drum lifter and dropped approx 6m to the deck. No one was in the area under the drum when it slipped out. The top of the plastic drum split and 40-45l of the fluid within spilled on to the deck. Shipboard oil pollution emergency plan (SOPEP) equipment was deployed and the spill contained to the immediate vicinity. No fluid was lost overboard.

- Poor choice of drum lifting device – a barrel span set lifting strop designed for lifting metal drums was used to lift a plastic one with sides that curved in slightly towards the lid which allowed the drum to slip out of the strop;
- There was a change in the lift plan without a reassessment of hazards;
- Lack of knowledge of the correct applications for this type of drum lifting gear.
