## Marine Safety Forum – Safety Flash 09/09

**Issued: 23<sup>rd</sup> April 2009**

**Subject: Hose Snagging Incident**

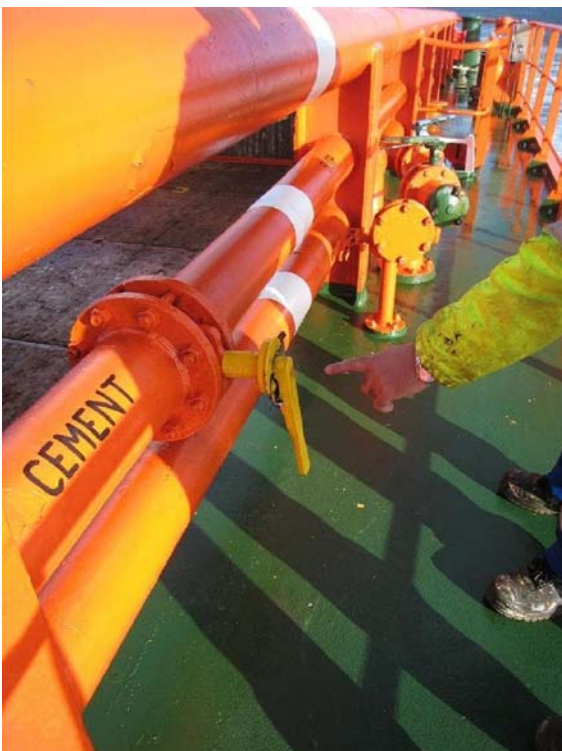
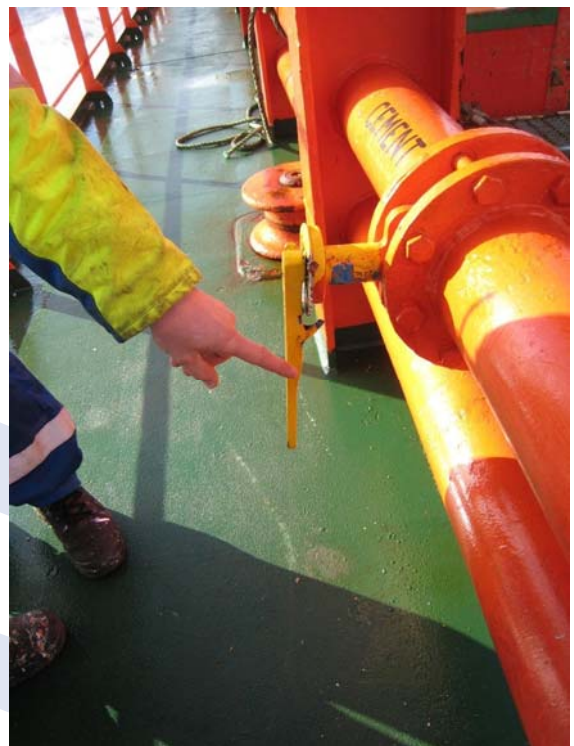
Weather conditions were; Sea State 3.6 mtrs, wind speed and direction 20knots @ 020dgrs. The water hose was connected to the crane pennant ready for release from the vessel manifold, whether the banksman / operator miss-timed the lift we will never know. When the lift took place the hose was trapped under the cement valve and through good luck as the hose is made of soft walled material the hose burst and ripped away from the valve handle. If the hose had been diesel or cement and their hose criteria being hard walled then there was a possibility of the hose ripping the handle or pipe work off the cement line causing all kinds of problems.

What we are concerned about is the fact that the vessel crew may have been injured / or environmental issues occurred through this operation and wish to raise the importance of reassuring that the vessel crew and hose(s) are well clear of any equipment that can foul up the hose or injure a crew member when in the process of removing a hose from a vessel.

The MSF recommend the soft sling arrangement should be used whenever possible. This would limit spare hose on board and hold the hose in place until it is disconnected, and placed in a location where it is clear of all snagging hazards and can be safely connected to the crane wire/pennant.
