Marine Safety Forum – Safety Flash 08-10

Subject: **Bollard Incident**

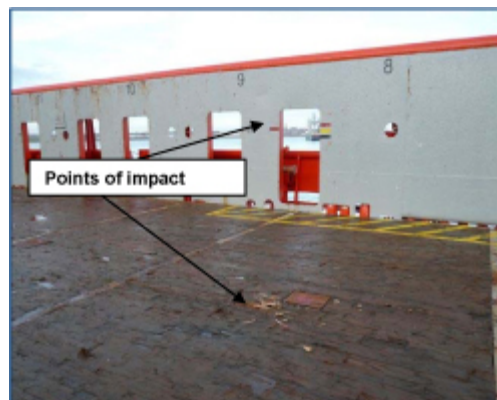
While alongside Peterhead South base, a vessel deployed an extra line due to concerns over swell. The breast line was rigged in the form of a 2-fold purchase going from ship to quay twice. This gave the rope a resultant breaking strain of 4 to 1.

The shortness of the line allowed no elasticity and as a shock load came onto the line due to the vessel rolling, the bollard casting split in half catapulting the horn section over the barrier onto the main deck. The impact on the deck broke two deck timbers. It then bounced and hit the offside safe haven bulkhead and finally came to rest a further 10-15 metres down the deck. During this time, there was a member of the vessel's crew standing on the deck.

- Risk assess the weak link in systems (by doubling up the line, the bollard became the weak link)
- Carefully assess mooring systems, in particular the deployment of breast lines on short nips
- Vessel crew to ensure that the vessel is moored safely and continuous checks carried out
