Marine Safety Forum – Safety Flash 08-11

Issued: 17th February 2008

Subject: Vessel Contact with Quayside

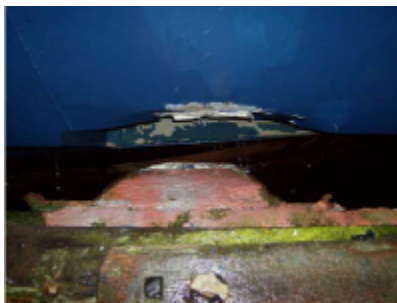
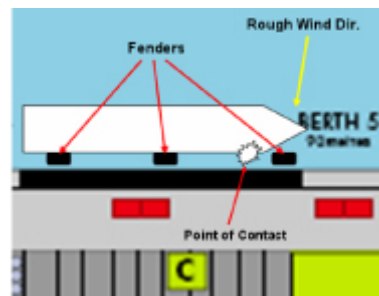
While moored at Peterhead South base, a vessel came into contact with one of the ribs on the quayside causing slight damage to the vessel hull. During mooring, the vessel had been positioned further astern than normal and resulted in the forward Yokohama fender being positioned under the flare of the bow which reduced its effectiveness.

As part of ongoing improvements, Peterhead base is currently upgrading berths to four Yokohama-type fenders per berth. It should be noted that the potential for this type of incident still exists regardless of the quantity and position of fenders. If the stern lines are allowed to go slack and the vessel's bow is blown in towards the quayside, contact could still occur.

- Risk of significant damage to vessel and quayside
- Difficulty of positioning certain types of vessel on three fenders

- Mooring procedures to cover positioning of vessel on fenders (base and vessel)
- Good communication between berthing operative and vessel crew throughout mooring operation
- Vessel crew to ensure that the vessel is moored safely and continuous checks carried out through duration of stay
