## Marine Safety Forum – Safety Flash 08-13

Issued: 4<sup>th</sup> March 2008

Subject: Safe FRW Engine Testing

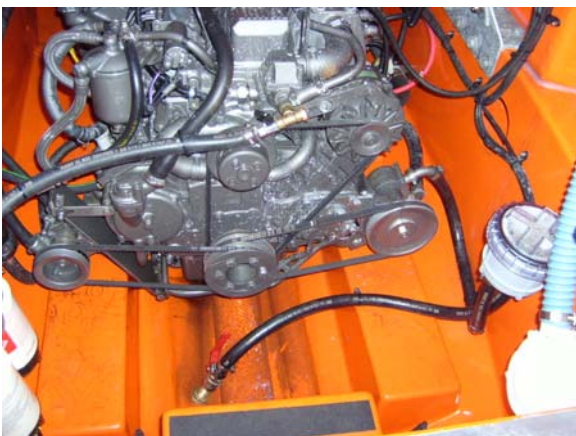
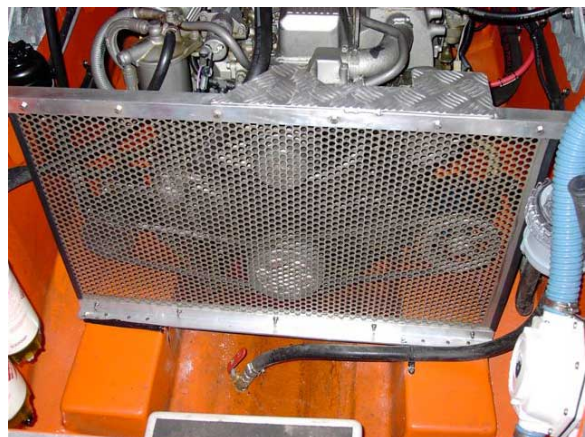
After maintenance of a Fast Rescue boat with Waterjet (FRW) cooling system, the FRW was launched for sea-trials. During sailing, the temperature of the engine was getting too high and the hatch to the FRW engine room was opened for inspection of the cooling system. While the engine was idling and the FRW was drifting in open sea (Hs 1 mtr), the AB lost his balance and tried to avoid falling into the engine room. However, his right hand hit the belt drive to the generator, his glove was caught by the belt and took a turn around the pulley. He was left bleeding heavily from the middle finger of his right hand, the bone was visible and he had severe pain in his other fingers. The FRW was recovered and first aid treatment started.

- As you can see from the pictures below (before and after), a safety guard has been erected around the rotating belt drive.
- A hose connection has also been made to the cooling system so that, in future, the system can be tested while the FRW is in the cradle on the mother vessel, involving less movement.
