Marine Safety Forum – Safety Flash 08-17

Issued: 15th April 2008

Subject: Fatal Accident to a Crew Member During Mooring Operations

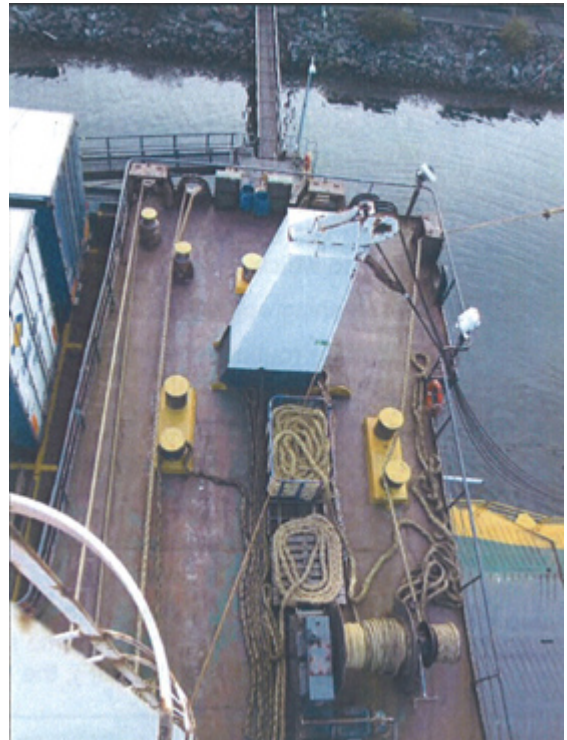
The stern line was made up of a polypropylene length from the ship which connected to a High Modulus Polyethylene (HMPE) line permanently secured ashore. The difference in elasticity of the two lines meant that the shorter, more elastic, polypropylene length was subject to material fatigue effects from the constant cycle of stretching and release. It was further degraded by exposure to ultraviolet (UV) radiation from sunlight. Subsequent tests revealed its breaking load to have reduced from 60 to some 35 tonnes.

The electric mooring winch used for the stern line had a stated nominal load of 12.7 tonnes and it was not immediately clear how this could have parted the rope, even in its degraded state. However, tests showed that the winch was capable of pulling up to 37 tonnes for a short period on first starting. There were no indications, either on the winch markings or in the manufacturer's manual, that the starting load was so much greater than the running load, nor was there any reference to the Minimum Breaking Load (MBL) of the rope to be used on the winch.

- Man-made fibre mooring ropes deteriorate in service and can have serious consequences if they part. Operators should develop a *Rope Management System* to provide a formal inspection routine of all mooring lines and include as a minimum:

- Assess mooring arrangements as a system; consider the suitability of each element and the compatibility of individual components, particularly ship and shore supplied lines.

- Ensure that the full capabilities of mooring winches are known and understood by all those involved in conducting and managing mooring operations, including the Minimum Breaking Load of ropes to be used.
