Marine Safety Forum – Safety Flash 08-18

Issued: 15th April 2008

Subject: Fast Rescue Craft Capsizes

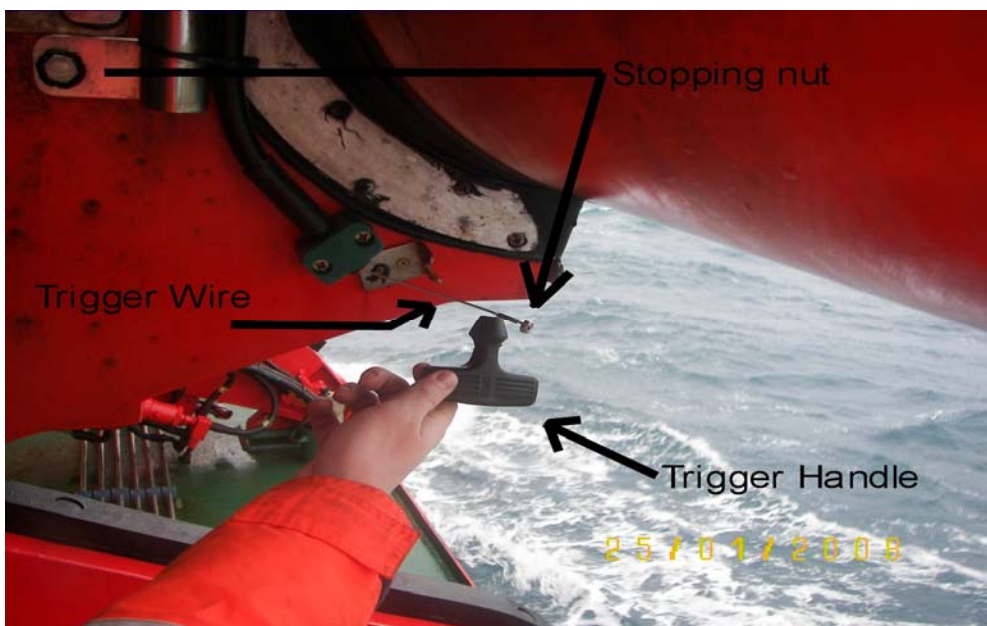
The three crew members of the FRC, who were all wearing immersion suits, cleared the upturned craft immediately as per their training, and noting that the engines were stopped the coxswain proceeded to the self-righting activation handle located at the stern of the boat. When he pulled the handle it came away from the cable without activating the balloon.

- Highlighting to all involved with FRC operations that constant care and vigilance must be maintained even during routine operations, it also should be noted that the crew of the FRC should be alert to the weather conditions as well as the Coxswain
- Regular inspection of the pull cord and all clamps as part of the boat maintenance routine to ensure that there is not a repeat occurrence.
- Regular inspection of self righting mechanisms should include the pull handle; inside the handle there should be a steel washer to prevent the wire from pulling through. This had been removed by the manufacturer as unnecessary; after consultation with them, all new handles will once again have the washer installed.

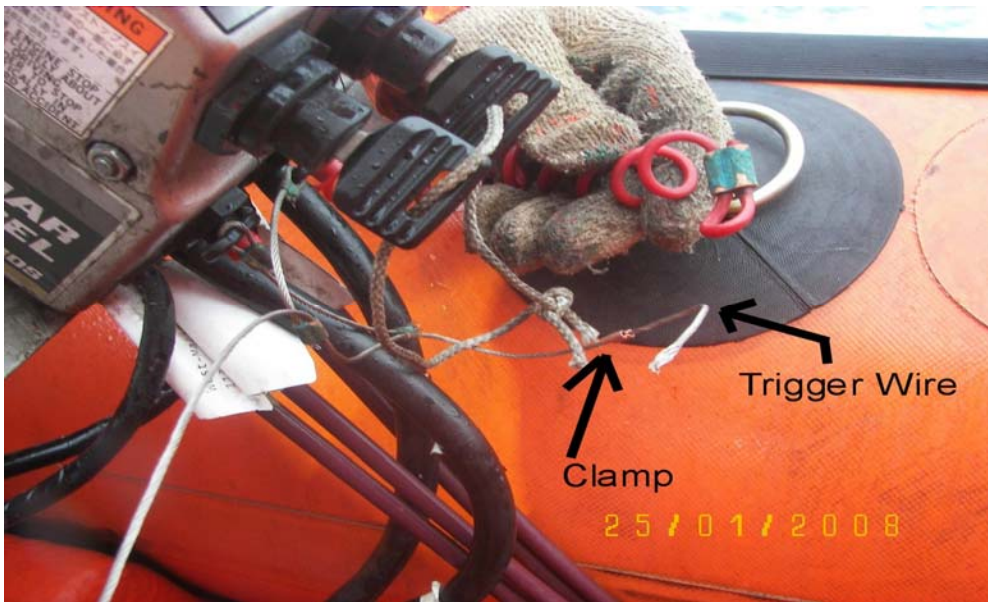
After righting the boat by use of a pair of pliers, the 3 crew members re-boarded the craft and made contact with the mother vessel, it was then noticed that the engine emergency stop pull cord was still in place and that the engines had stopped due to water ingress.
