# Marine Safety Forum – Safety Flash 08-19

**Issued: 15<sup>th</sup> April 2008**

**Subject: Fatal Accident on ROV Vessel**

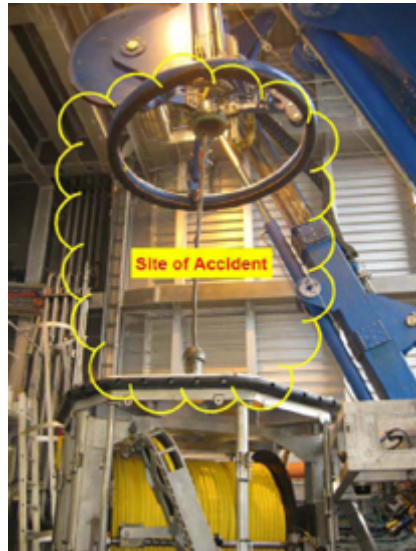
Around 1030 hrs a total power blackout occurred on board the vessel due to a lack of cooling water supply to the auxiliary engines. The fatality happened at the time of the blackout when the TMS unit made a sudden and significant vertical movement (approximately 2.5m) until it was stopped by the Docking Head overhead. The ROV Senior Supervisor was standing on top of the TMS with the aim of assisting with the pull-out of the umbilical. He was trapped and subjected to a massive force of 13.7 tonnes between the TMS and the Docking Head.

The accident was sudden and the witnesses of the tragedy estimated the uncontrolled and rapid spooling of the winch in the order of 2–3 seconds.

- The accident occurred at the same time as the power blackout. The ROV winch spooled in the umbilical instantly and uncontrolled, lifting the TMS module vertically up towards the Docking Head and causing the fatality.
