Marine Safety Forum – Safety Flash 08-25

Issued: 16 July 2008

Subject: Loss of Thrusters

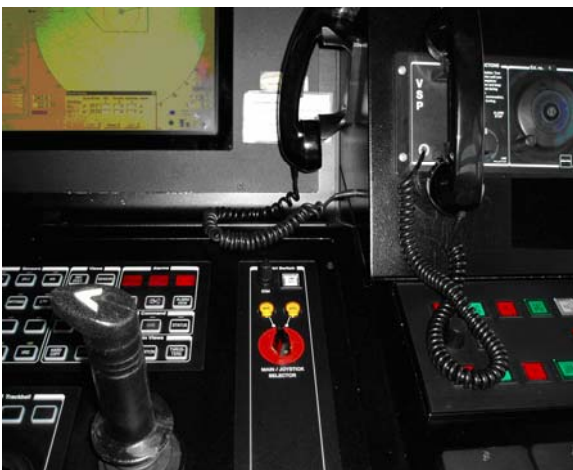
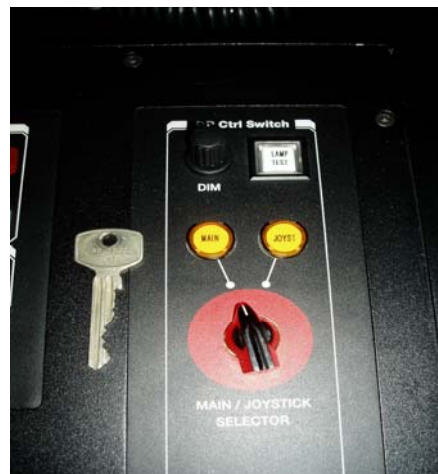
The Master was called up to the bridge and an investigation was started to find out what the reason was for the loss of thruster control on DP. It was found that the inter-switch between MAIN DP controller and JOYSTICK controller had been moved from position MAIN to position JOYSTICK. (See Picture attached.) This was probably caused by the cable connected to the VHF handset.

Make sure that all switches and other similar equipment are covered and that safeguards are in place to prevent any incidents as described above. E.g. a Plexiglas cover should be fitted over the inter-switch to prevent this from happening again.
