Marine Safety Forum – Safety Flash 08-28

Issued: 21 August 2008

Subject: Self Sealing Quick Release Coupling

Self Sealing Quick Release Coupling Failure

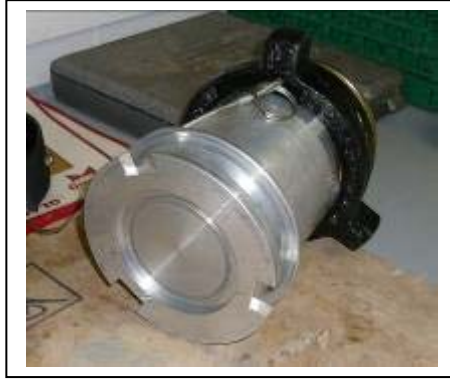
Photo 1. to right

On completion of discharging OBM the hose was disconnected and returned to rig. The AB's noticed that the internal workings of the vessels self sealing quick release coupling were missing. After inspection, all but 1 piece was found and the coupling was changed out with a new one. This piece is a ½" diameter stainless steel disc and it is presumed that the fragments may have been taken into the rigs tanks or vessels tanks.

The type of coupling is of a single cast aluminium manufacture (Manufactured by: Mann-Tek 112G Ø164 4"NPT) and it cannot be internally checked in the monthly planned maintenance scheme as is currently rigged. The connection is normally checked for correct operation only.

Shows the solid cast type of connection which failed.

Connection was immediately changed out with a spare one onboard, crew checked and changed out other couplings as required. Vessel amended onboard procedures to ensure filters are put in place within the line. Also added:

1. Coupling onboard to be removed and checked internally, rigged again with Weco type connection as shown below.
2. To be discuss with Tech Supt, systematic replacement with more robust type if available.
3. Inform Rig that fragments of the shattered inner disc may have entered their tanks.
4. Vessel with this make of coupling made aware of the potential failure.
5. Marine Superintendent to circulate to industry via Marine Safety Forum

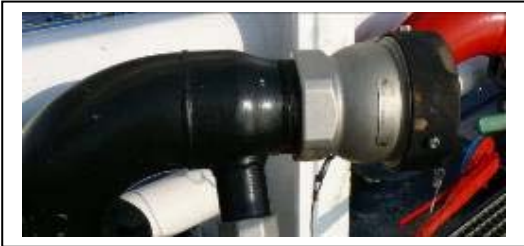
Photo 2 to the left

This photograph show how the coupling was rigged onboard.

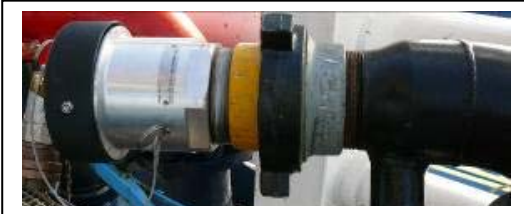
Photo 3 to the left.

This shows how the coupling will be rigged in future so as to aid inspection.

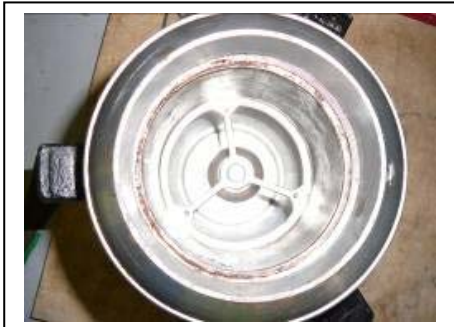
Photo 4 to left.

Inside Coupling prior to failure.

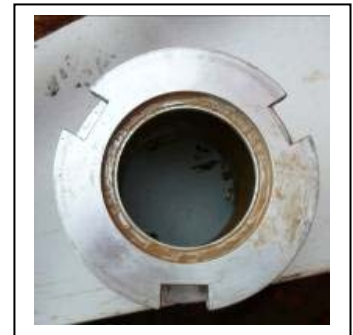
Photo 5 to the right.

Inside coupling following failure.
