Marine Safety Forum – Safety Flash 09/21

Issued: 14th June 2009

Subject: Back Loading High Potential Near Miss

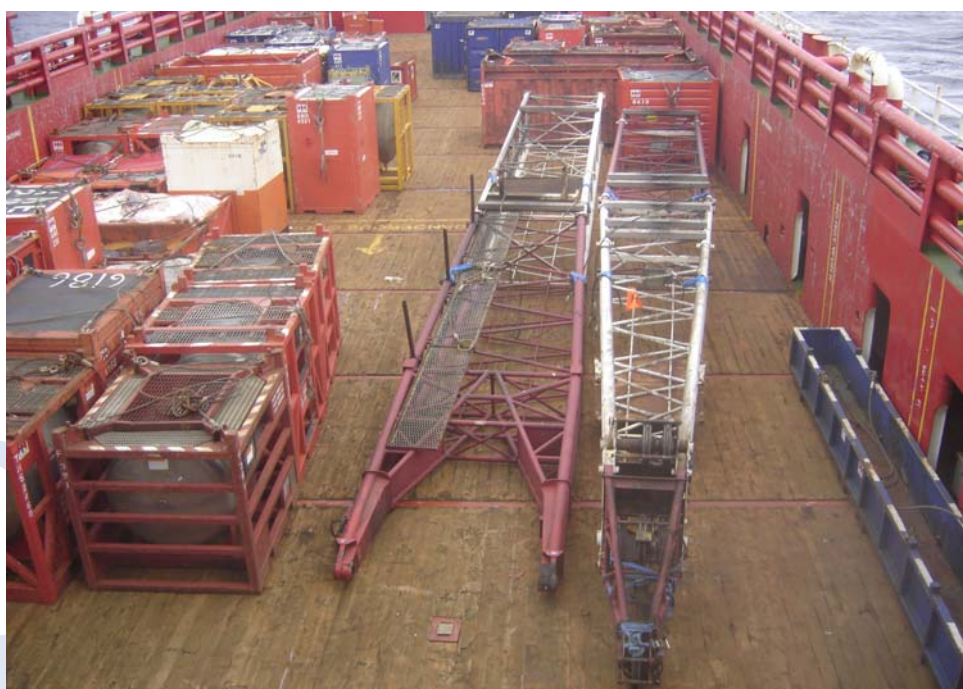
This back loaded crane boom section was first landed on deck with no clearance from adjacent tote tanks. However, the ABs had to pass between these tote tanks and the back loaded crane boom section to access the crane hook for unlatching. Therefore, the crane operator was asked to move the back loaded crane boom section towards the port side of the main deck to create a gap to allow the ABs clear access.

The crane operator then started to heave and raised the back loaded crane boom section by about 1 meter to approximately waist height with the ABs positioned between this back loaded crane boom section and the tote tanks. This resulted in a potential for the ABs to be crushed between the back loaded crane boom section and the tote tanks.

- communicate their actions to the vessel before proceeding with lifting operations
- ensure that all communications are fully understood and verified by all relevant installation and vessel personnel before proceeding with any lifting operation
- avoid making assumptions and to verify with the vessel that the deck area is clear of all personnel before proceeding with lifting operations.
