Safety Alert

Number: 16-27

Subject: Fuel Spill During in Port Bunkering

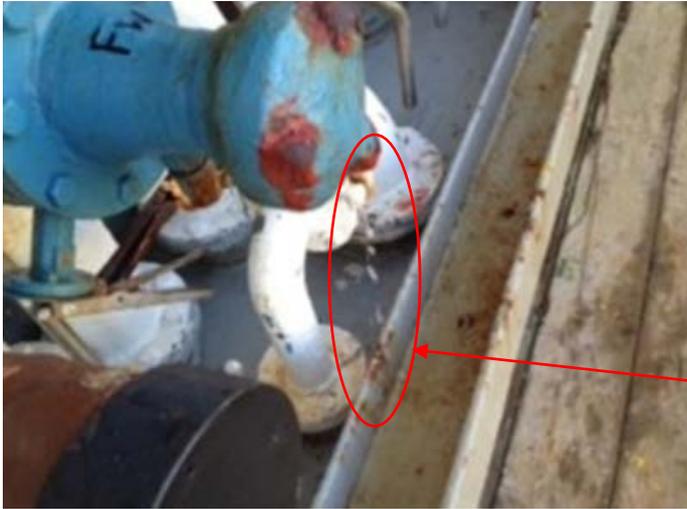
As is common with this type of operation while the water pump is running all water manifolds in the system are under pressure and this included the port midships water manifold. Unfortunately, the port midships manifold had a leaking valve which was allowing fresh water to pass through and out into the port midships drip tray which in turn was filling up the port side drip tray and safe-haven with fresh water.

1. The leaking fresh water manifold valve. The leak from this manifold allowed the drip tray and safe-haven save all's to fill up with water which in turn meant the fuel escaping from the sample / drain cock lay on top of the water and hence spilled overboard.
2. Failure to fully ensure the requirements of the 'pre bunkering' check list were met. Despite the completion of a 'pre bunkering' check list the requirements of the check list were not fully met and complied with, this included failing to ensure the scuppers were properly plugged, (I.e. the fuel loading check list required 'Drip trays around bunkering connections to be empty and oil tight'.) It was found that the drip tray had water in it, the drip tray plug was missing.
3. Although a watchman was in place there was a failing to maintain a proper watch on all areas where fuel could possibly leak from.

Port midships fresh water manifold showing water leaking from the cap.

- The port midships fresh water manifold valve was immediately repaired and made water tight.
- The fuel manifold drain cock was repaired thus ensuring fuel could not escape from it again.

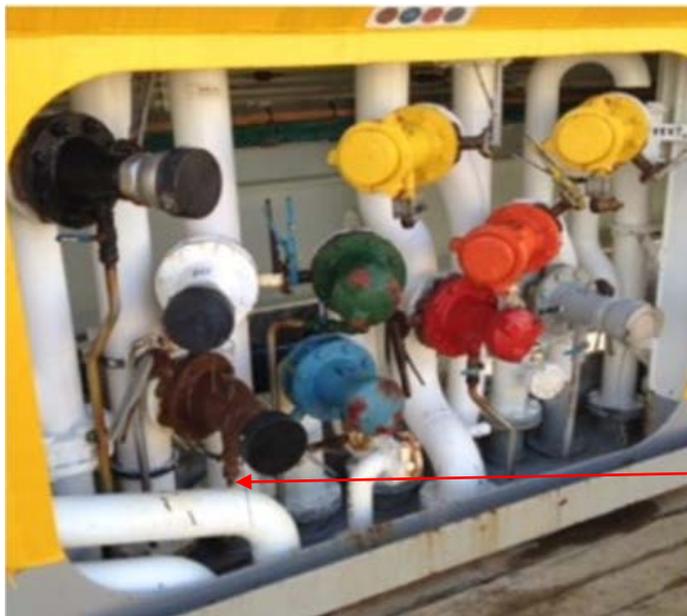
The investigation revealed that during the bunkering process fuel had been leaking from the fuel sample / drain cock (which is attached to the fuel manifold for the purpose of allowing fuel samples to be taken during fuel discharges) into the drip tray and draining overboard along with the fresh water originating from the water manifold.

Port midships hose bay & fuel sample / drain cock location.
