Safety Alert

Number: 18-19

Subject: Snagged Lift

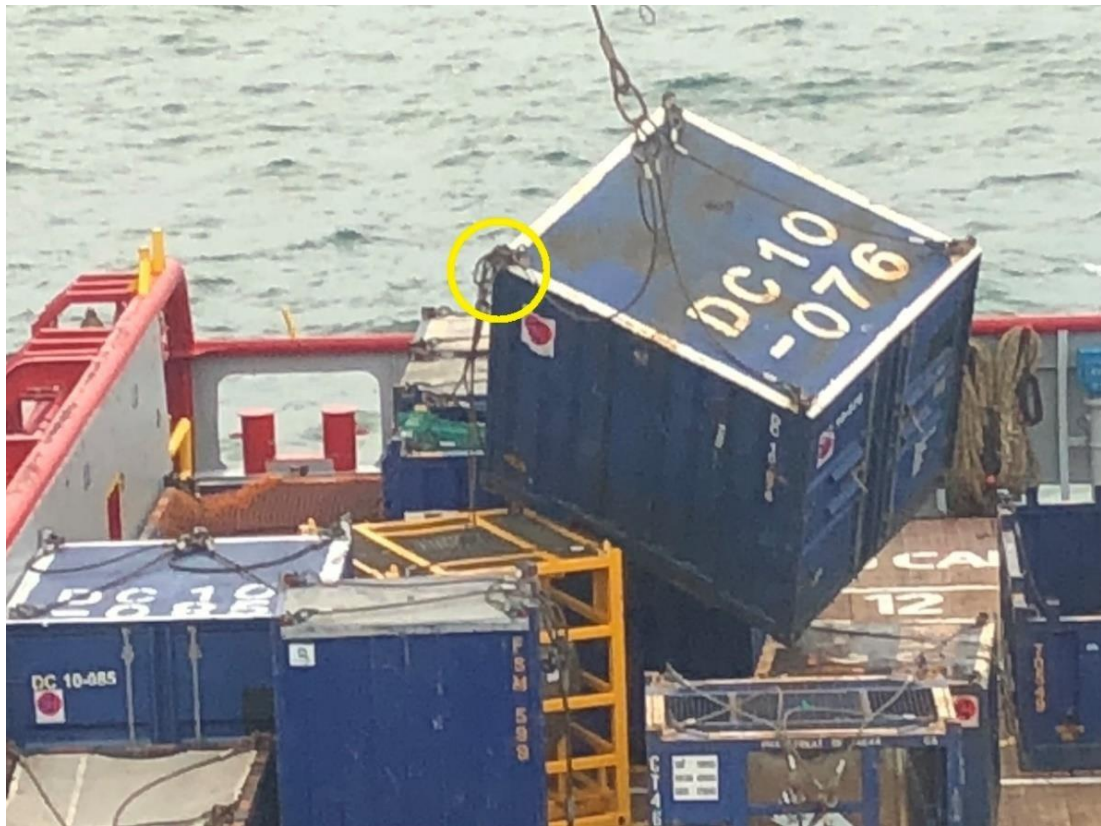
During deck cargo operations at an offshore location, a hoisted 10ft container became snagged on the bridle of a backloaded tote tank. A 'Stop Stop Stop' was given over the Radio and the Crane Operator immediately stopped hoisting and both containers remained suspended 3m off the deck. The Crane Op tried unsuccessfully to manoeuvre both containers free but due to restricted space on the deck he was forced to land the containers on top of a nearby tubular stack.

- The usable deck space was fully utilised with limited space to manoeuvre and stow cargo.
- The number of lifts declared for offload and backload altered significantly while the vessel was on location, including additional tubulars to be backloaded.
- The snagged bridle could not be seen from deck level by the crew or from above by the Bridge Team and Crane Op.
- Each corner of the 10ft container was fitted with a guiding pin which stopped the snagged bridle slipping free as the weight came on.
- The snagged bridle was not 'tucked away' or secured when the tank was backloaded.

When safe to do so, the vessels deck crew approached the lift and removed the bridle using a long boat hook. The containers were safely discharged and deck items securely re-stowed with minor cosmetic damage to the tote tank.

- The bridle of the tote tank could have been tucked away into the grillage after disconnecting the hook. These actions would not have prevented this incident but may help prevent future similar incidents before they occur.
