Marine Safety Forum – Safety Flash 15-10

Issued: 12th February 2015

Subject: Fire in Engine Room

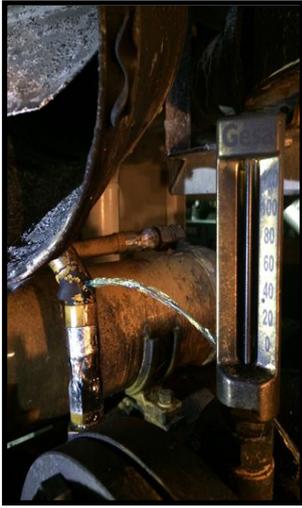
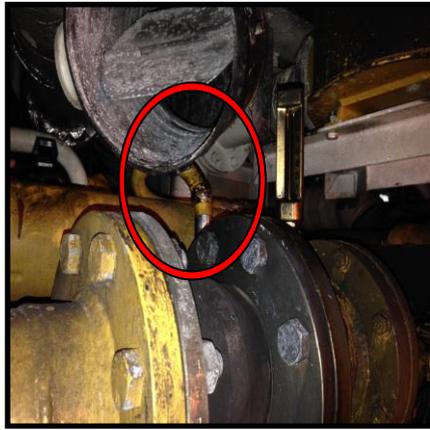
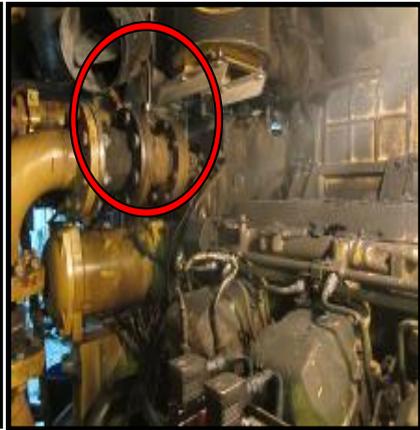
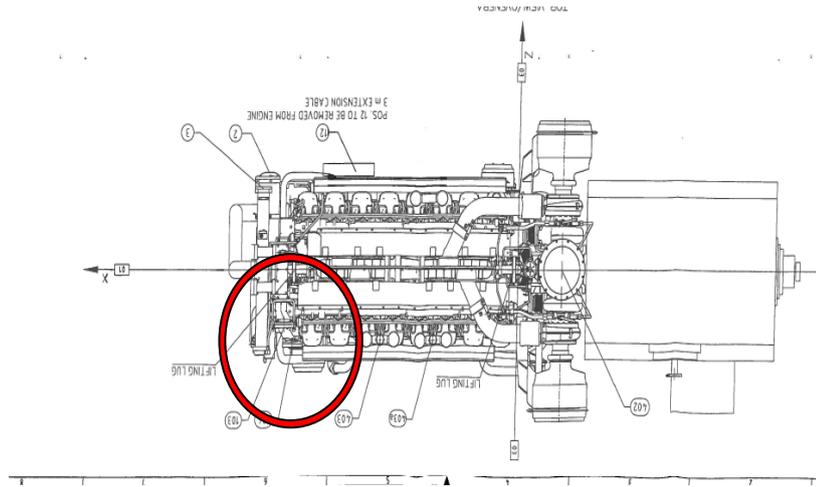
The root cause for the incident was a burst low-pressure flexible fuel hose located on top of and at the forward end of the diesel generator (see pictures). This is the auxiliary fuel filter hose and is pressurised (<6bar) when not in use. The system is to be used when the main engine fuel filter needs to be changed during operations whereby the generator cannot not be stopped. The fuel sprayed over the generator flowed underneath the manifold shield and settled on the manifold where due to heat, fuel vapour was created and then ignited. Additionally, the spread of the fire was increased due to various items stowed on the deck grating directly above the engine (see picture).

During the pre-delivery sea trials of the vessel, rigid air ducting was installed directly above the fuel filter hose. When the hose was pressurised the ducting caused an excessive bend and rubbing which created a weak point. This potential hazard was not detected by many interested parties over a considerable period of time, i.e. standard watch-keeping duties, on-hire inspections, port state control, manufacturer's service visits and class inspection / approval visits etc.

- Fleet experience transfer issued immediately following incident to check ALL hoses for condition and replace accordingly.
- Fleet experience transfer issued regarding the stowing of items above machinery.
- PMS to include guidance from IMO, P&I, SOLAS with regard to engine room fire prevention measures.
- Incident to be rolled out across the fleet as part of the monthly safety campaigns.
- Review the robustness of the inspection / examination process during planned maintenance.
- Liaise with manufacturers on engine design, manifold protection and "hot spot" arrangements.

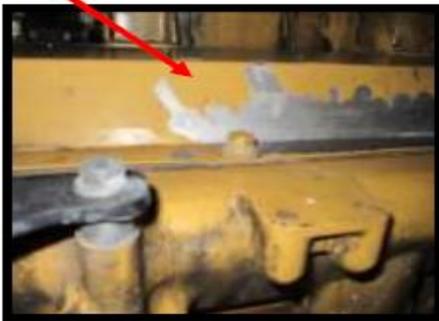
Exhaust manifold shield

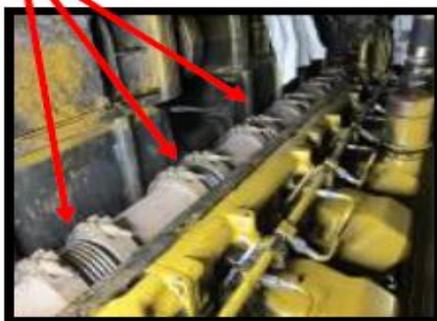
Probable path of fuel underneath shield

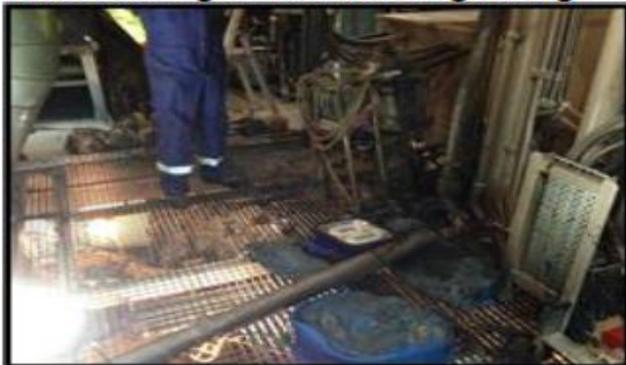
Fire damaged items on grating
