# Marine Safety Forum – Safety Flash 15-15

**Issued: 4<sup>th</sup> May 2015**

**Subject: Failure of Floodlight Capacitor**

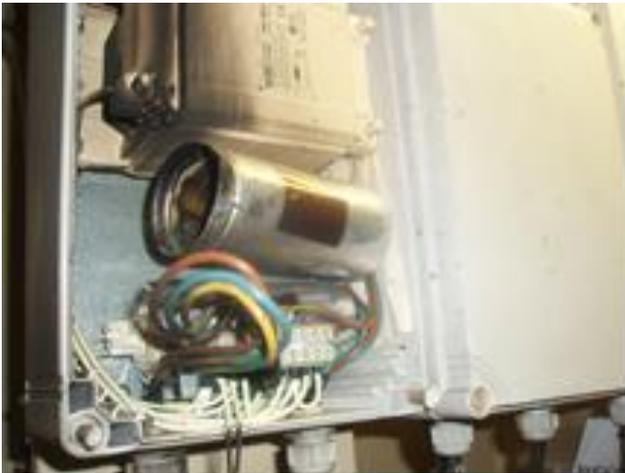
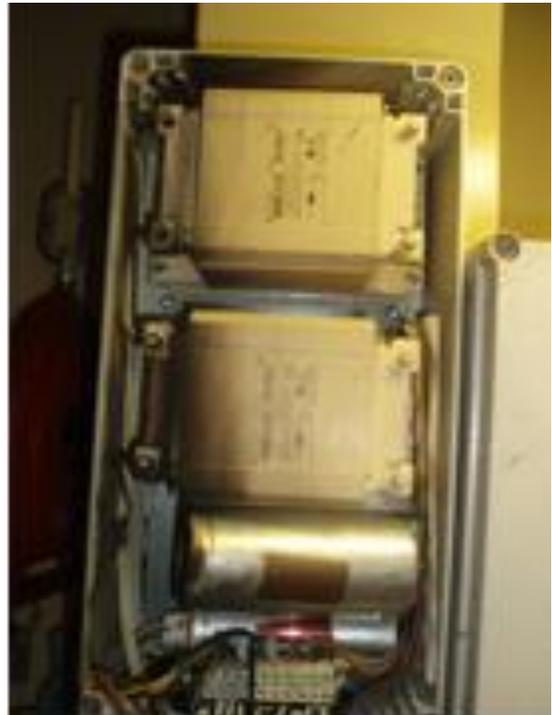
The vessel was anchored completing demobilisation activities when at 21:45 LT the Fire Detection System activated indicating there was smoke in the main crane pedestal. The vessel's crew responded as required by the SMS Contingency Plan and the cause of the smoke was found to be from a 1200W low pressure sodium floodlight ballast unit for the lighting on the main crane. This system was electrically isolated and the area was vented of residual smoke. (See Photos).

It was noted that there was some heat damaged material on the deck below the box and an item of Tank/Working at Height Rescue Equipment, which is stowed beneath the box, had been slightly damaged by the hot material that fell. The area was clean and tidy and there was no secondary fire.

The ballast unit comprises of 2 x ballast coils with 2 x power factor correcting capacitors. One of the capacitors failed, the ensuing explosion causing the front of the plastic enclosure to blow off. The internals of the capacitor ended up on the floor and sprayed onto the equipment stored in the crane pedestal.

The reason for the capacitor failure is believed to be due to its age. A capacitor's working life is dictated by numerous factors; age and temperature being two of the main ones and the nature of their use results in them running hot.

- An additional Planned Maintenance task will be raised to monitor the internal condition of these ballast units
- Consideration should be given to changing the capacitors on a regular basis; e.g. every 5 years
- There are many of these ballast units fitted on this vessel and within the fleet, some mounted in areas where this type of damage may result in a more serious incident if flammable material is stored in the immediate vicinity
- Consideration should be given to reviewing the location of such units which may not be protected by fire detection systems

- All vessels should check the location of this type of equipment and record same on board
- Vessels should check the internal condition of the units especially the capacitors and verify that there is no evidence of heat build-up within the unit
- An inspection of the areas in the vicinity of these units to ensure there is no flammable material stored in close proximity
