Marine Safety Forum – Safety Flash 15-16

Issued: 4th May 2015

Subject: Fatal incident during change-out of chain wheel (gypsy) on AHTS vessel

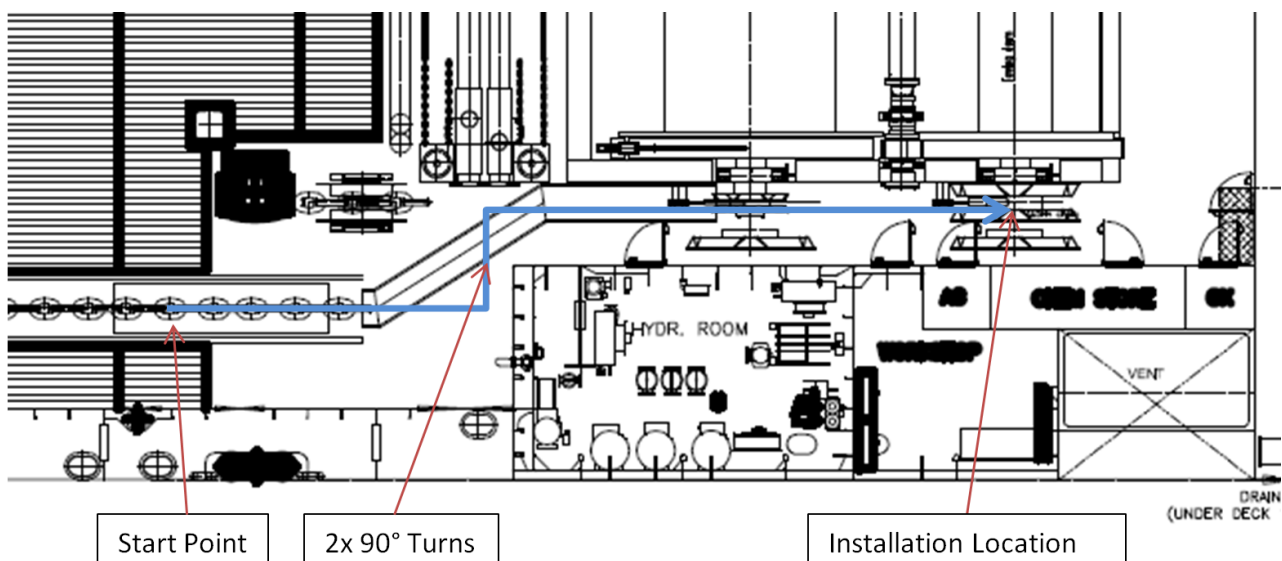
Plan view drawing of the intended route for the installation of the gypsy

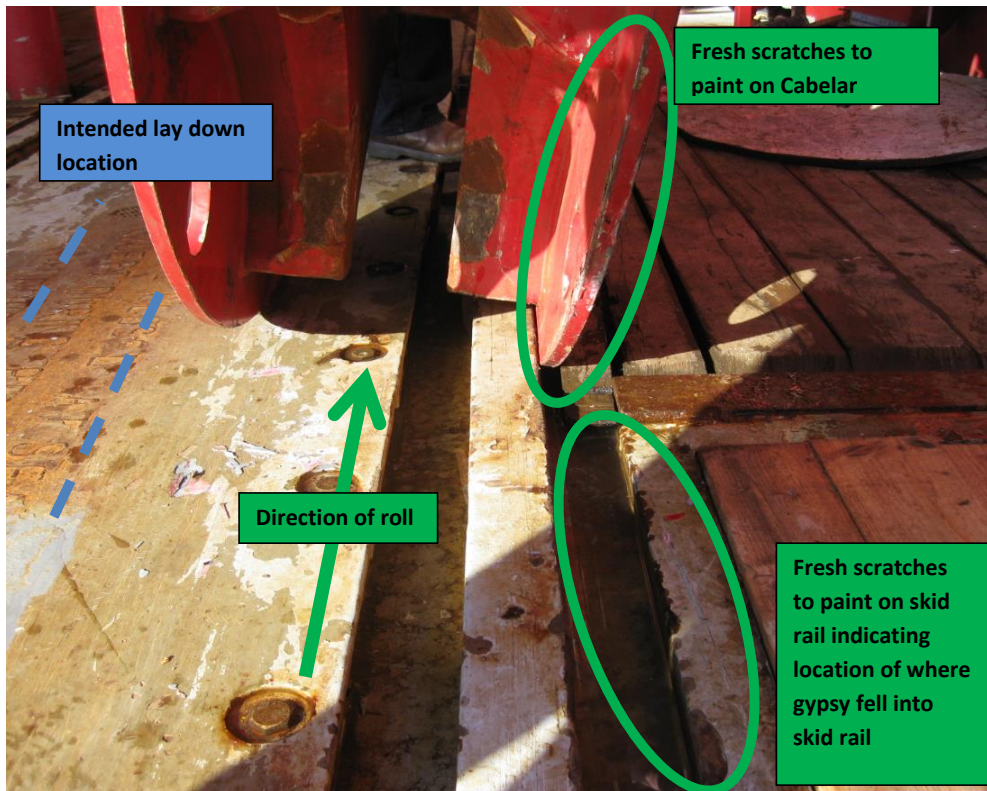
The crew disconnected the gypsy from the crane without checking its final landing position. Therefore, they did not see that the rims of the gypsy wheel were on each side of the skid rail for the chain lifter. Immediately after disconnecting from the crane, the crew started to roll the gypsy. This resulted in the starboard rim dropping into the gap in the rail causing the wheel to tip beyond balancing point. It fell over and pinned two crew members against the bulkhead. This resulted in one fatality and one first aid case.

Showing the cause of the gypsy wheel tipping over (the term “cabelar” is used as well as “gypsy”)

- ◆ The immediate causes were:
 - Gypsy rolled into skid rail causing it to tip over;
 - Lack of risk management;
 1. Failure to identify hazards and risk.
 2. Failure to comply with safe working practices.
- ◆ Contributing factors:
 - Inadequate design review for this particular mode of operation conducted by vessel;
 - Gypsy was not handled in the intended method as established when vessel was designed;
 - Insufficient lifting or handling appliances for handling and changing the gypsies.
- ◆ Root Causes:
 - Inadequate monitoring and verification of organisational performance;
 - Weaknesses identified in the design review processes;
 - Lack of effective implementation of risk management.

- ◆ Gypsies should not be manually handled or rolled;
- ◆ Monitoring and verification of worksite performance was found to be inadequate.

- ◆ Company-wide instruction forbidding free-rolling of these heavy items;
- ◆ Technical task force to evaluate a safe method for the installation of gypsies in the short and long term and review change- out methods across the fleet;
- ◆ All vessels to review and re-risk assess current methods for handling gypsies and submit risk assessment for approval.
