Marine Safety Forum – Safety Flash 15-17

Issued: 4th May 2015

Subject: Tag Line Incident

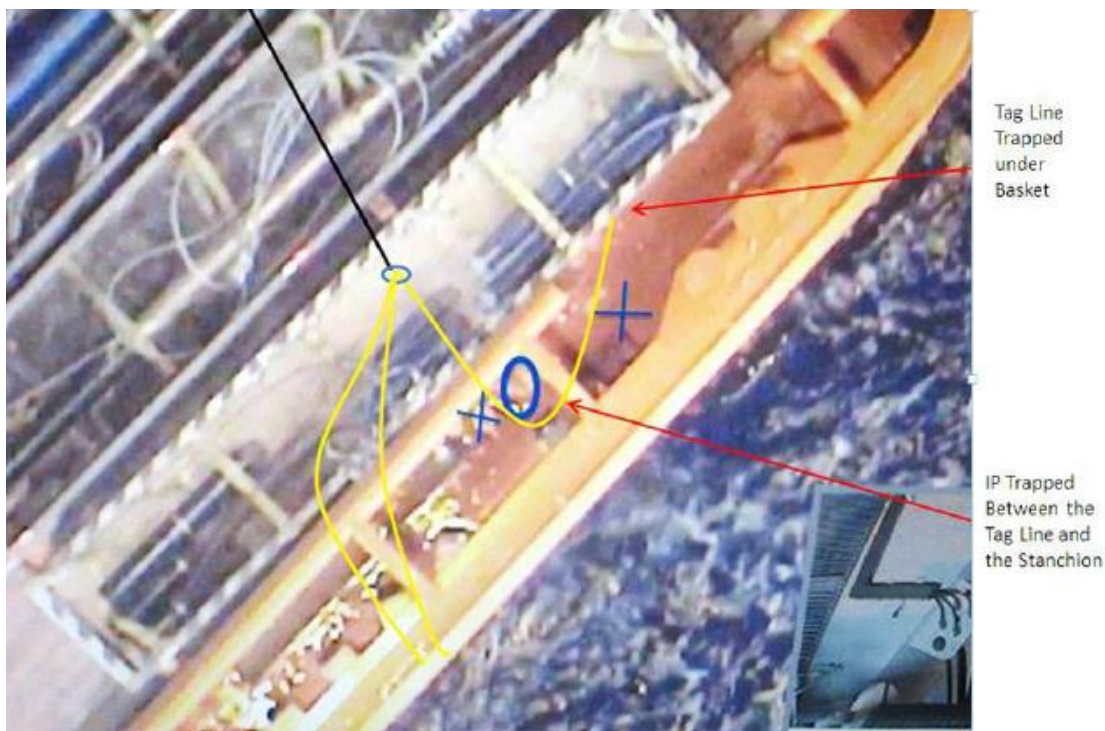
Photograph 1 – Location of Trapped Tag Line

Photograph 1 below shows the tag line (yellow line) routed around the stanchion and the banksman attached to the crane hook (blue circle).

The banksman signaled by radio for the crane operator to hoist up the hook and tag lines. As the crane hoisted the hook, the trapped tag line became tight pinning the banksman against the stanchion with the tag line.

- Inadequate supervision and oversight by vessel banksman; did not follow job duties and stay well clear of “any” lift (includes all personnel)
- Inexperience of sling men on vessel (relatively new personnel)
- Failure to recognize the hazard

- Review procedures with customer and vessel operator to address appropriate use of tag lines including use of risk assessment for when to use or not to use tag lines. (review of WRA between vessel and rig before loading/unloading operations commence)
- Vessel operator to address this incident with their staff for proper banksman duties
- Rig personnel to review this incident (in particular crane operators) and communicate with vessel supervision when vessel crews are not following correct procedure
- Use of ‘Time Out for Safety’ as appropriate
