Marine Safety Forum – Safety Flash 15-22

Issued: 09.07.2015

Subject: Vent Pipe Clogged

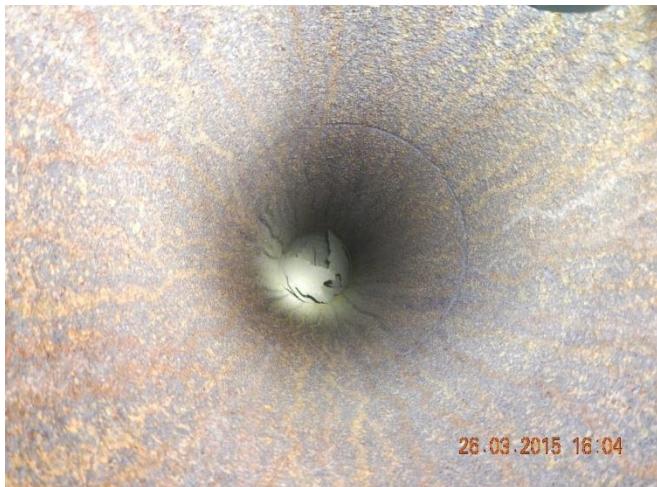
To further investigate, the complete vent head was removed and a blockage was observed in the vent pipe at the first elbow, approximately 1.5 meters below the deck level. It consisted of large rust scales and hardened dust. (Please see photographs below). Due to this discovery, FO tank #2 was inspected and found to be in a similar, although to a lesser extent, condition.

The capacity of FO transfer pump is 2 x 50 m³/hr, which is significant considering the size of the tank. However with the amount of vacuum it created, it is obvious that the vent pipe was blocked and there was no air relief at all.

This incident could easily lead to serious damages to the FO tank / hull construction if it had not been discovered.

- The collected rust and scale was removed.
- The vent pipe has had an internal inspection job created and included in her Planned Maintenance System.

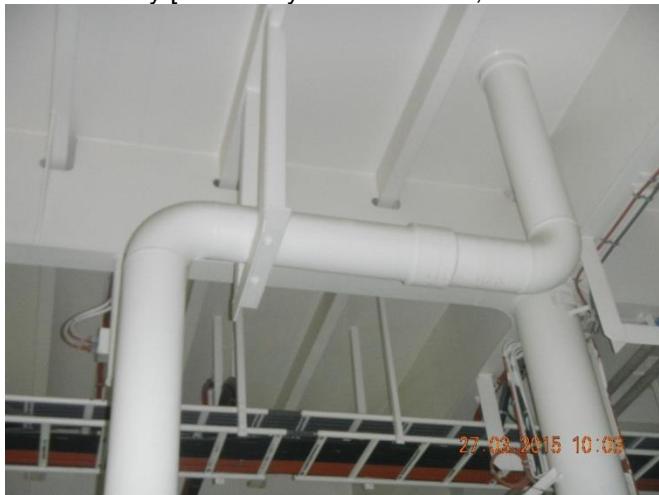
The design of the vent had sections that were vertical, horizontal, and then another near vertical. See photo.

- It had not been recognised that, although the exterior of the pipe was in good condition, there would also be a necessity to open and inspect the inside of the pipe. That was not done.
- Over several years, rust and scale had accumulated in the vertical section, the rust and scale had then collected at the foot of the upper vertical section, as it did not have any slope to help take it away [admittedly into a FO tank, but where it would likely sit at the bottom of the tank].
