# Marine Safety Forum – Safety Flash 15-23

Issued: 28<sup>th</sup> July 2015

Subject: Protector Plate drops from crane

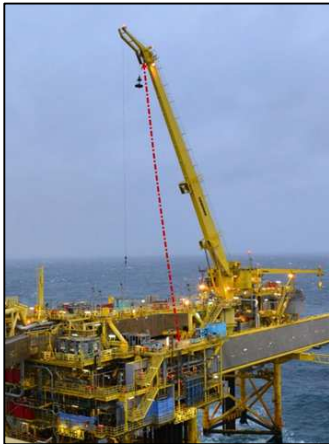
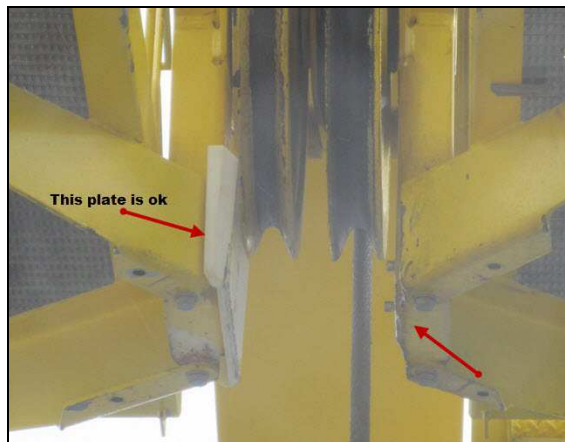
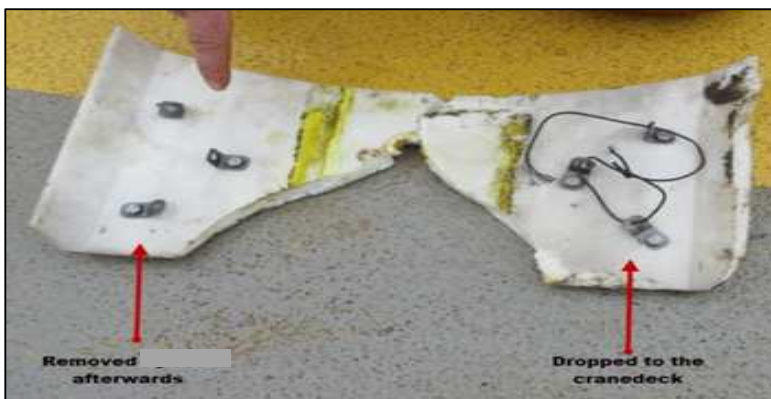
During crane operation, the crane operator noticed an object falling from the crane. The object turned out to be a piece of nylon protector plate from the crane boom. Weight 0.95 kg, drop 40 m. No one was working in the area so there was no damage to people or platform

Mitigating actions from previous occasion have proved insufficient to avoid repeat incident (arresting wires fitted after this incident failed)

Indications are that the crane wire has become snagged on a corner of the plate thus applying excessive force to the plate

- Investigate in other business units if cranes are installed with similar arrangements
- Protector plate design must be reviewed
- Investigate if the crane is being operated correctly
