# Safety Alert

**Number: 19-06**

**Published: 03/05/2019**

**Subject: Lashings not removed before offload**

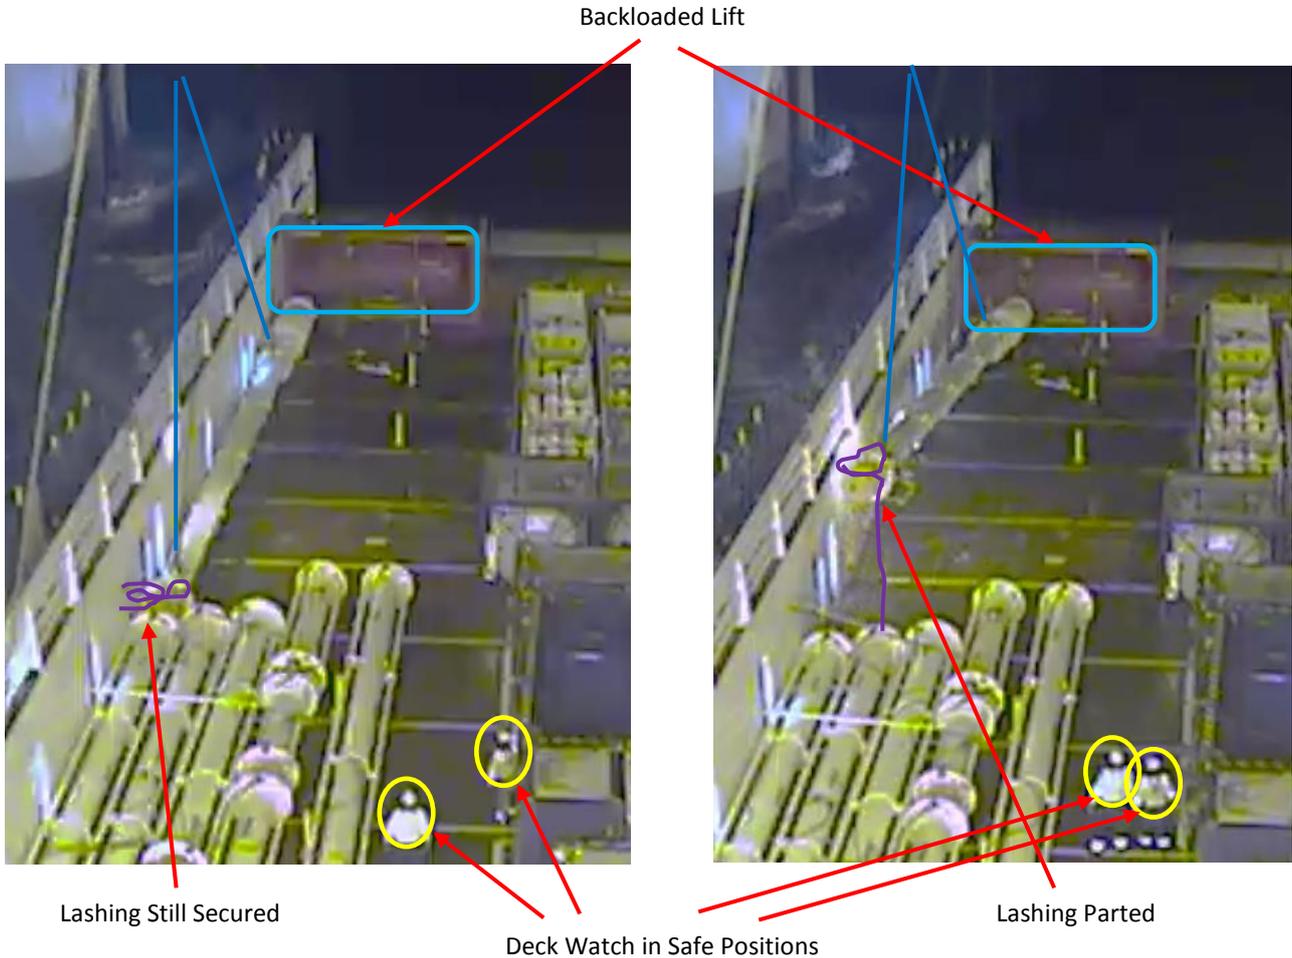
Whilst offloading a slip joint from the vessels starboard side aft, the forward lashing was not removed. As the crane was taking up the weight on the wire, the securing lashing parted (remaining attached wrapped around the slip joint). This consequently created a rocking movement to the slip joint, which then came in contact with a previously back loaded lift; causing damage to its construction.

The last lashing was on the forward end of the riser which was hard up against risers forward of it. The lashing was underneath, thus it was very hard to see, it was dark, and all deck spotlights were on, it was not noticed until the lift was a few meters above the deck.

1. Before the weight came onto the Crane

2. As the Lashing Parted and Slip Joint hits backload

- Ensure that this incident is raised at the next safety meeting.
- This "Lesson Learned "should be posted in a prominent position, back to back crews should be notified.
- Vessels should check that their deck lighting is working correctly.
- Information regarding Cargo Securing should be re-read by all concerned.
