Safety Alert

Number: 19-14

Subject: Basket Snagged on Ships Structure

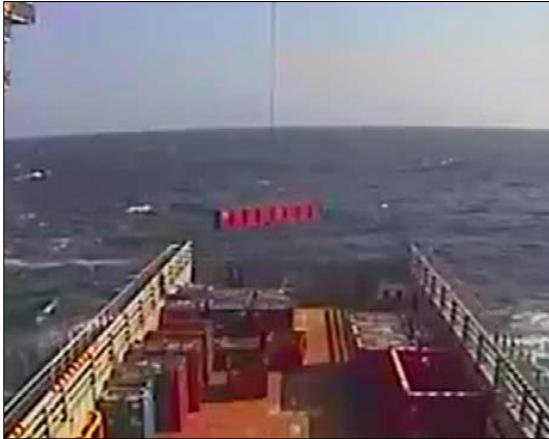
Basket being lowered to deck

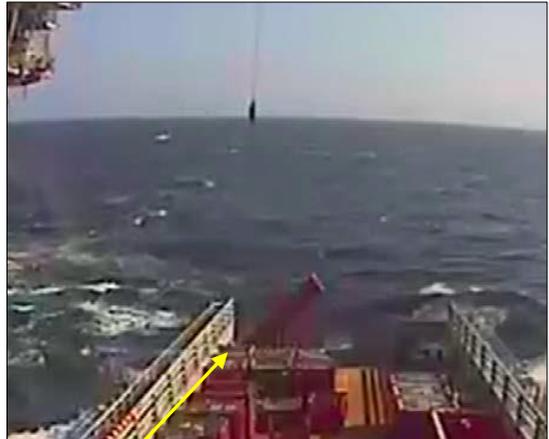
- The design of the protective rail did not prevent the basket from entering the protected area.
- Whilst the crane driver repositioned the basket after lowering it to deck, the vessel dropped due a wave causing the basket to leave the deck, swing to starboard causing it to snag under the protective rail.

Basket snagged on protective rail

- Basket was safely landed and returned on shore.
- Vessel carried out a "Time Out for Safety" following the incident to identify any further potential snagging points.
- The vessel involved was restricted to loading full height cargo containers in the way of the hose bay areas mid ships and at the stern.
- Offshore and onshore pre-shipping checks to include potential snagging points so these can be protected or highlighted and discussed with vessel prior to loading.
- **All vessels should be aware of possible snagging hazards, particularly access doors, hose bay areas or other openings and where possible keep baskets, half heights or other cargo which is not full height away from these areas.**
- **It is recommended that vessels carry out a "Time Out for Safety" to review their deck for snagging hazards and any subsequent controls that need to be put in place.**

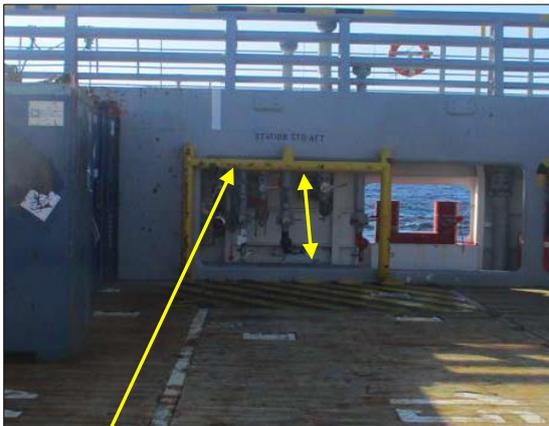
Basket swung under protective rail

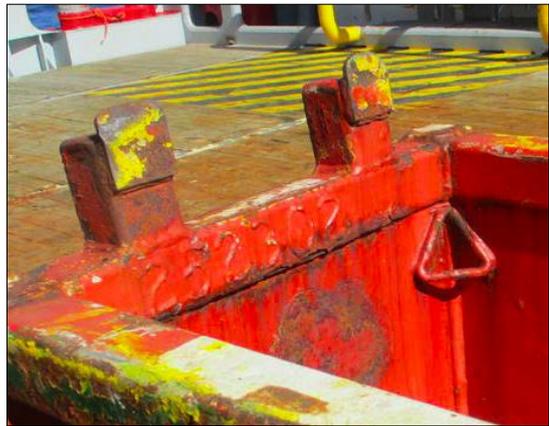
Basket stacking pins snagged on inside of protective rail

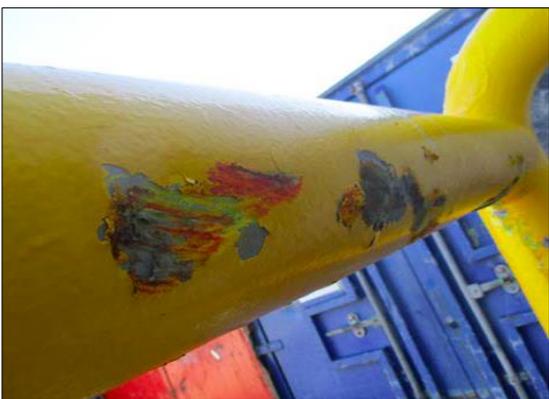
Damage to vessel structure

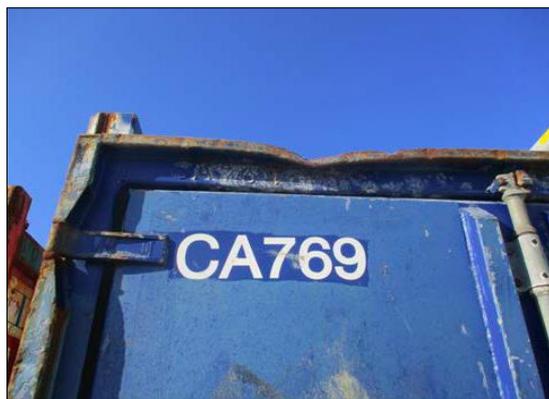
Damage to adjacent baskets
