# Safety Alert

**Number: 20-01**

**Subject: Vessel Contact with Wind Turbine**

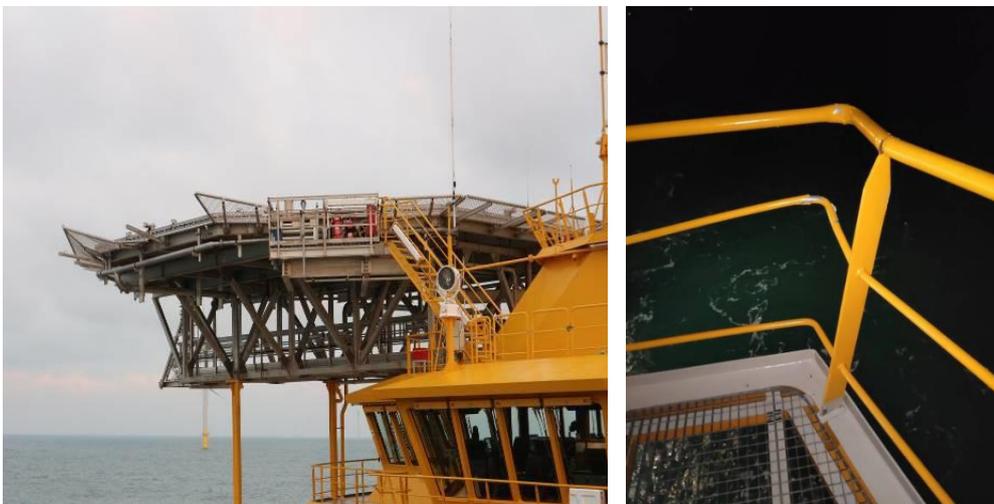
The vessel hit the wind turbine with the helideck perimeter netting and the bridge wing on port side of the vessel. The incident did not result in any personal injuries, and only minor damage to turbine, and vessel. No technical issues were identified during the investigation of this incident.

1. OOW failed to comply with procedures and industry guidelines
2. OOW did not confirm that full auto DP was activated after double tap of the button on joystick
3. OOW was alone on bridge
4. OOW decided to deal with some administrative task while alone on bridge
5. Vessel placed in a drift on position

Damage to vessels helideck perimeter netting and bridge wing

- A review of Bridge operations procedures with emphasis on bridge routines.
- A review of Bridge operations training Module 1 and 2
