Safety Alert

Number: 20-05

Subject: Water Based Mud Spill on Deck

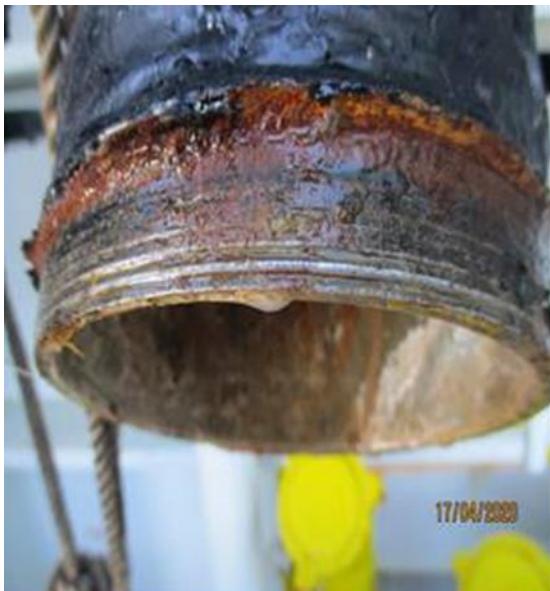
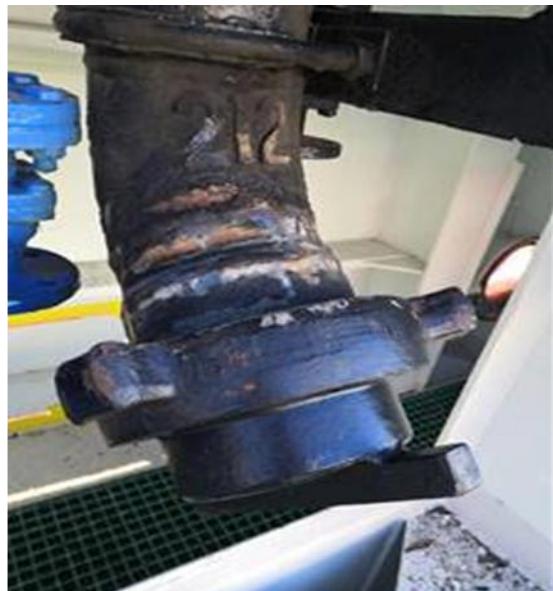
Photographs / Supporting Information

The manifold is normally fitted with a hammer union connection. In order to facilitate the TODO connection on the end of the hose, the crew usually use a hammer union to TODO adapter. On initial inspection of the vessel's manifold, the thread between the manifold and the hammer union was found to be corroded. After further inspection of the manifold threads it was determined that the threads in place were incompatible. The original manifold threads onboard the vessel were non-compliant to the standard National Pipe Thread (NPT) connection and therefore did not correctly engage. As a result, these threads did not provide an adequate seal which increased the opportunity for corrosion to occur. This led the connection, over a period of time to become weakened and resulted in the hose parting from the manifold.

- Vessels with manifold thread connections found not to be NPT compliant to be inspected for corrosion and, if required, repaired by fully welding the connection to effectively provide the same strength as a fully welded slip-on fitting. Alternatively, the original manufactured thread should be cut off and the correct NPT thread nipple be welded in place.
- Regularly monitor and inspect the condition of the threads on manifolds by implementing into the vessels' Planned Maintenance System
- Pre-use checks to be conducted as part of the Wet bulk transfer checklist to incorporate visual inspections of the manifold connection threads.
