Safety Alert

Number: 20-08

Subject: Cargo Snagging

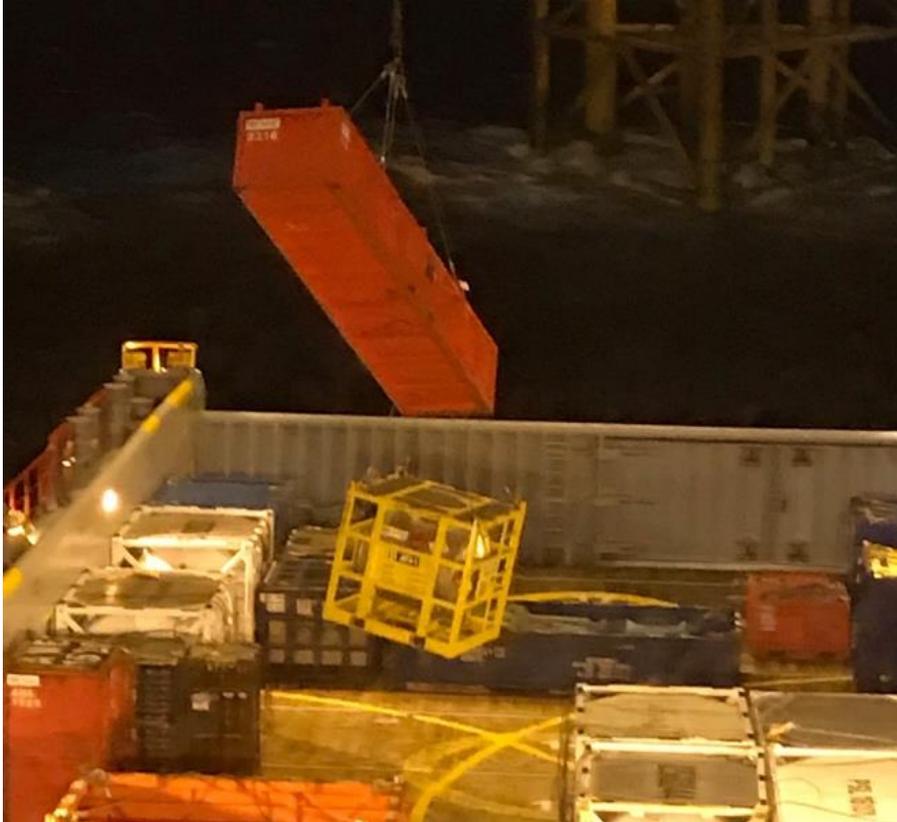
A vessel was engaged in deck cargo operations at an offshore location. A number of lifts had been successfully discharged and backloaded which led to limited space on deck. The crane operator advised the next lift would be the 25ft basket on the starboard side which was duly connected to the crane hook. The vessel deck crew moved to a safe place and confirmed the crane op was clear to hoist. As the crane operator began to lift the basket off the deck, the vessel bridge team noticed a corner of the basket had become snagged on the bridle of a nearby heli tank and called 'Stop Stop Stop' over the VHF. The call was not acknowledged, and the crane operator continued to hoist. As the 25ft basket was raised approximately 3m above the deck, the snagged lift was suspended approximately 0.5m and the 'Stop' call was given again by the bridge team. The crane operator continued to hoist causing the basket to rotate over the adjacent cargo and a third 'Stop' call was issued by the bridge team. The crane operator acknowledged the third stop call and began to take avoiding action. The crane operator was able to successfully land the snagged helitank in a clear area of the deck. The snagged lift was naturally freed, the vessel deck crew remained in a safe location and the basket successfully offloaded without further incident.

- The vessel deck crew did not 'tuck in' the heli-tank bridle on completion of backload
- The crane operator missed two opportunities to stop the job when the call was given
- The vessel master failed to report the incident in accordance with the company and charterers reporting procedure

- The vessel crew held a 'Time Out for Safety' to discuss the lessons learned focussing on industry best practice and incident reporting procedures.
- The platform operator has re-enforced the communication needs between vessel and platform crew, particularly in relation to 'stop the job'.
- The platform operator recognises a potential improvement in deck space management and planning. Vessel crew are encouraged to pro-actively give feedback in this area where possible.
- All crew are reminded to always be aware of potential snagging hazards and proactively take avoiding action where possible.
- Where possible, containerised cargo bridles should be stowed or tucked into the framework or basket to prevent snagging.
