# Safety Alert

**Number: 21-03**

**Subject: Finger Injury During Rescue Boat Launch Drill**

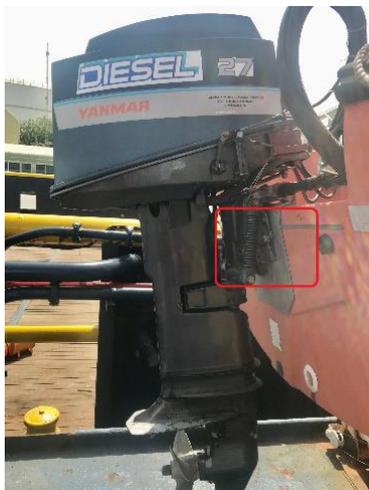
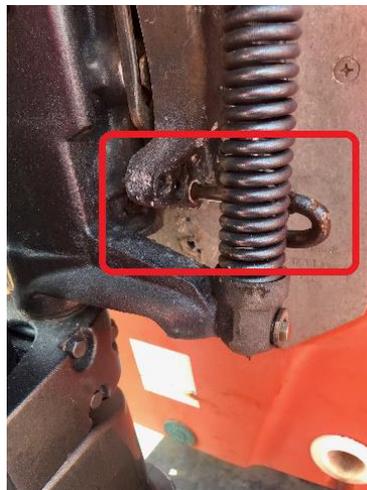
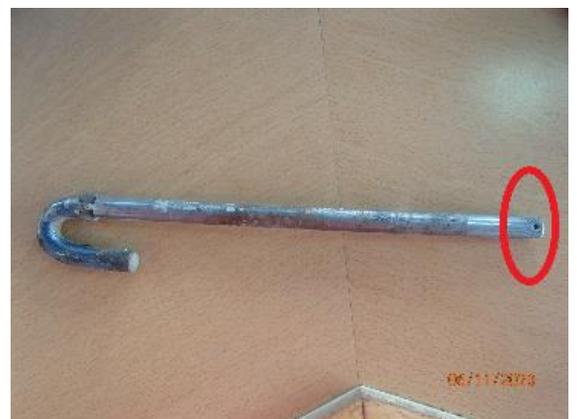
## Photographs / Supporting Information

- Failure to check the rescue boat prior to its operation

- Outboard engine was left engaged which caused it to continue to tilt up and down.
- Lack of understanding the ongoing situation by the rescue boat crew.
- Lack of maintenance of the rescue boat.
- Outboard engine locking pin out of position.
- Missing split pin from the locking pin.
- Inadequate working gloves used although it could have only helped to reduce the seriousness of the injury – not confirmed but assumed.

The analyzed root cause indicates that even with inadequate awareness, if the process for checking the equipment prior its use had been conducted, it should have avoided the unsafe condition to operate the rescue boat.
