# Safety Alert

**Number: 21-04**

**Subject: Escalation of Poor Maintenance**

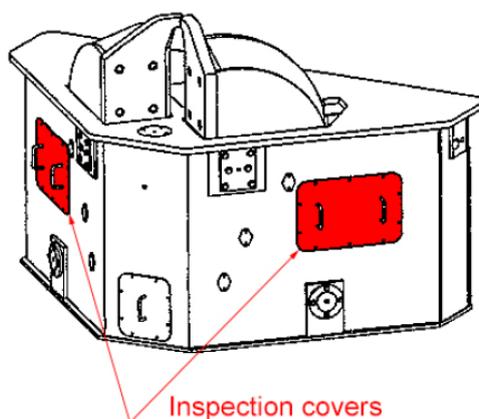
## Photographs / Supporting Information

“Shark Jaws” are critical equipment on an AHT, they are built in a housing frame which is secured at the stern of the vessel, their purpose is to secure Chain or Wires during Anchor Handling Operations. “Shark Jaws” normally sit flush with the deck in a housing frame and are controlled from the Bridge. The manufacturers of the “Shark Jaws” recommend maintenance to be carried out once every week, which states that the inspection covers are to be removed and all silt, sand, mud and obstructions removed. Upon completion of the maintenance, the inspection covers are to be installed with silicone sealant/gasket. There was no evidence of this being completed on the Shark Jaw housing or other types of inspection covers, which compromised watertightness of the lower compartments. This with a combination of other unfavourable circumstances enabled the water quantity to increase to a level which lead to the AHT foundering and subsequently sinking.

The investigation team recommended that all Shark Jaw housing systems are strictly maintained to the manufacturers guidance as a minimum standard, in addition to existing maintenance instructions, the items to be address by this procedure should include:

- Preventive actions to mitigate the risk of water ingress through the inspection openings during maintenance tasks on the anchor handling systems (e.g. sea state limitations, installation of anchor handling system deck cover plates);

- Instructions for the appropriate sealing method when installing the inspection covers to ensure the watertightness of the anchor handling system housing (e.g. application of silicone sealant, installation of gasket);

- Instructions for testing the watertightness of the anchor handling system after completion of the works and installation of the inspection covers (e.g. flooding of anchor handling system housing frame with closed drainage by use of fire hose).

- Maintenance actions to prevent a degradation of the inspection covers and securing devices, which could compromise the watertightness of the anchor handling system.
