# Safety Alert

**Number: 21-07**

**Subject: Tank Corrosion**

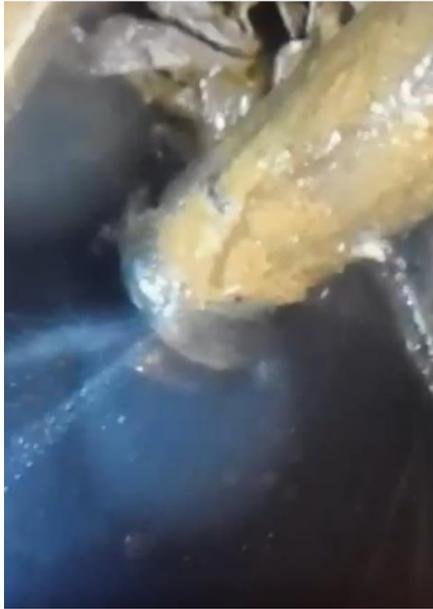
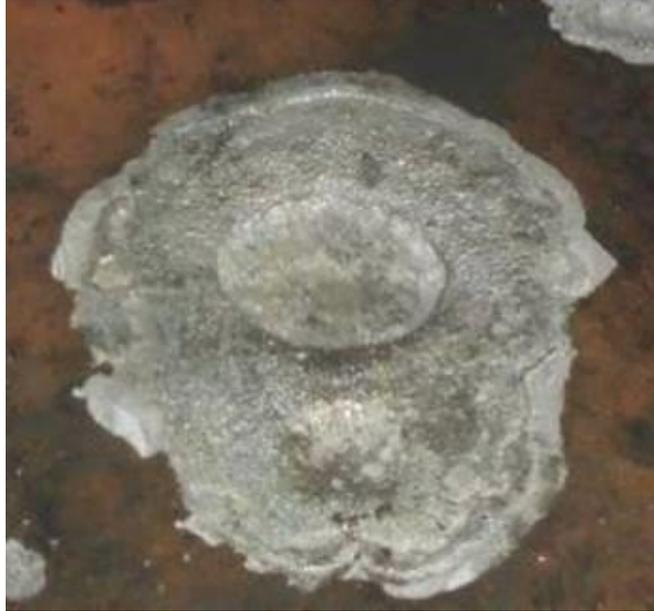
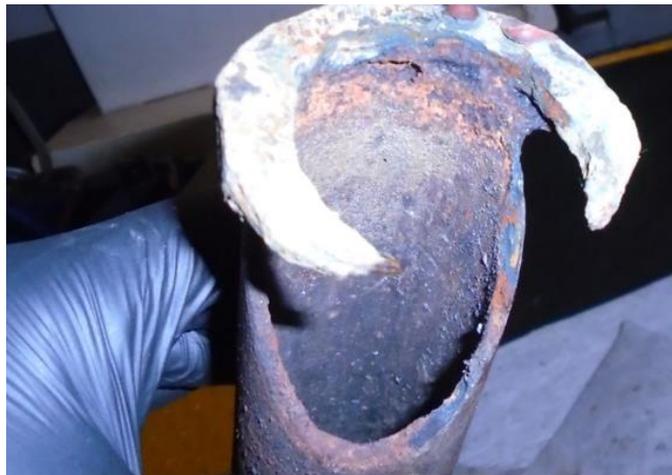
Upon investigation, the Chief Engineer discovered a pinhole leak in the structure beneath the sounding pipe, allowing salt water to enter the space from outside the tank. The Master informed the Duty Technical Manager, and the vessel was sent to a layby berth for repairs.

An initial investigation was carried out by ship staff which concluded the striking plate at the bottom of the sounding pipe was missing. This allowed the brass weight to repeatedly strike the steelwork, damaging the paint coating and exposing the steelwork to corrosion.

A further investigation was carried out by the onshore management team which included a review of the evidence submitted. The tank space was inspected six months previously and the photographs filed in TM Master alongside the work report. The previous photographs did not give any indication that the level of corrosion experienced today could have occurred naturally within the last six months. After cleaning the tank, additional photographs revealed exposed bright and shiny steelwork – which could only be caused by an acid attack.

- The tank had been duly inspected and maintained in accordance with company procedure.
- The brass weight of the sounding tape had damaged the paint coating on the striking plate and steelwork below.
- A corrosive chemical had been incorrectly disposed of and introduced to the tank, accelerating the corrosion process.
- The acid may have become trapped under bubbles of damaged paint, allowing concentrated corrosion over the short time.
- The combination of exposed steelwork and caustic solution destroyed the striking plate and steelwork below.

An effective repair was carried out onboard in collaboration with third party welders and divers.

Vessels must ensure that after using caustic chemicals, the contents/container are disposed of to an authorized hazardous or special waste collection point in accordance with any local regulation.
