# Safety Alert

**Number: 21-08**  
**Subject: Potential Dropped Object**

**Published: 27/04/2021**

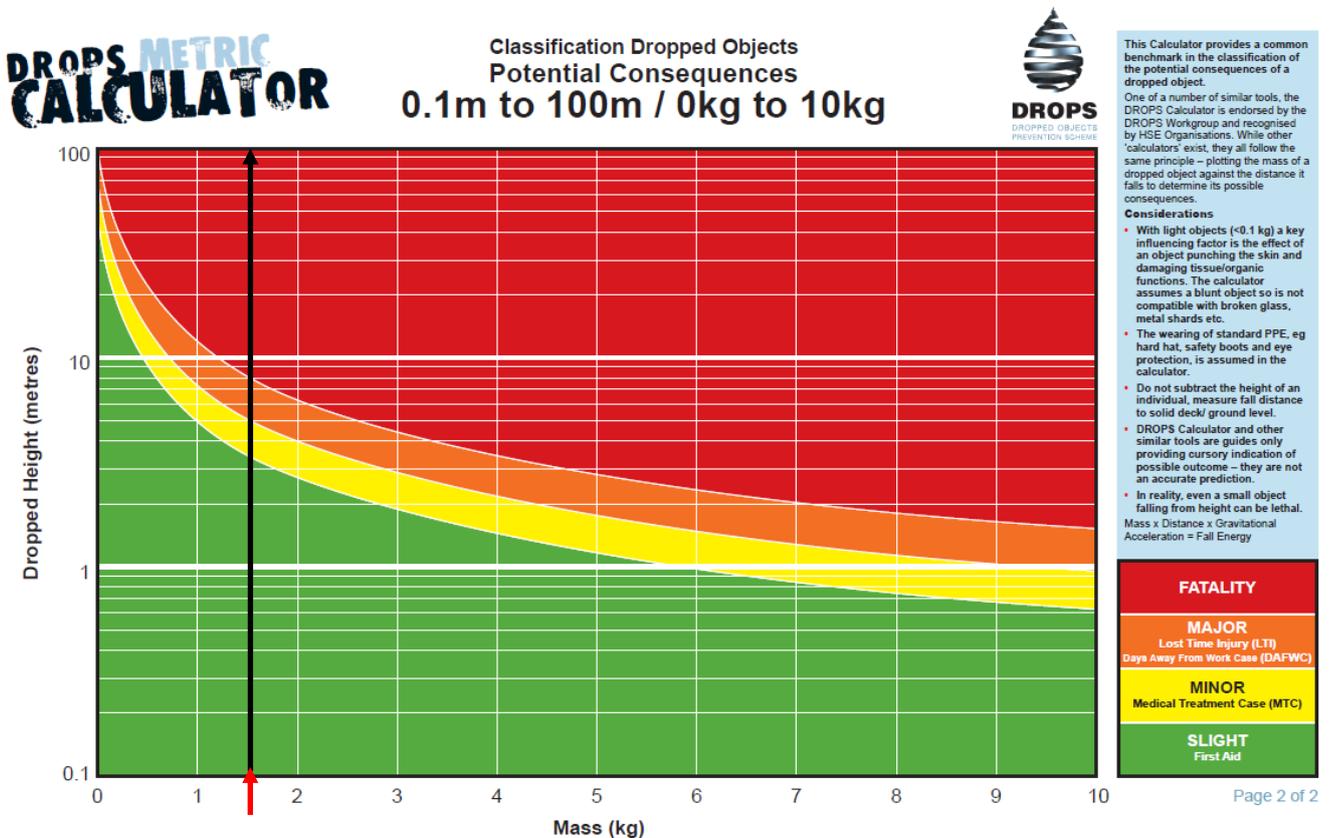
Potential Consequences at various heights during the lift shown below on the DROPS Calculator:

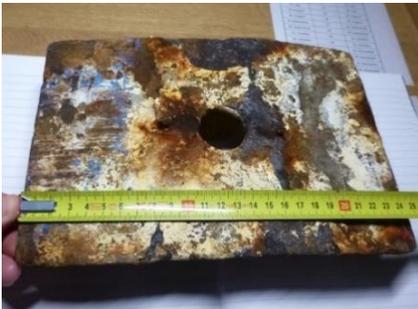
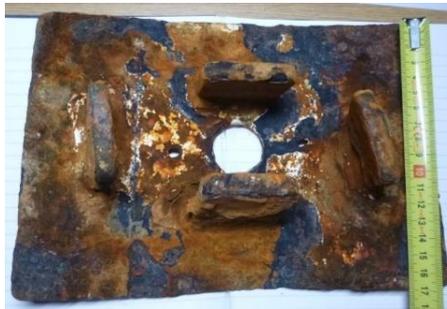
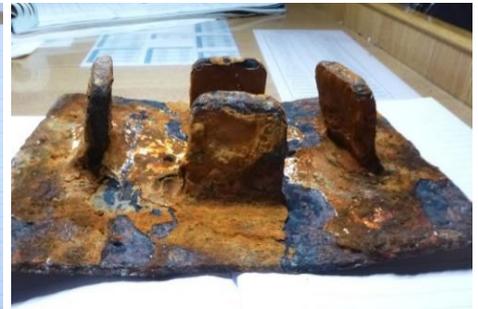
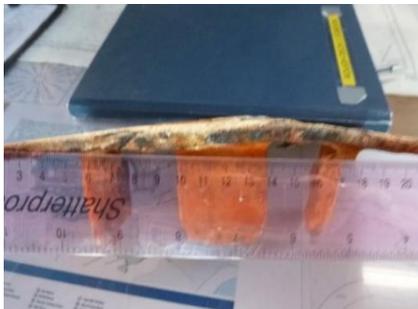
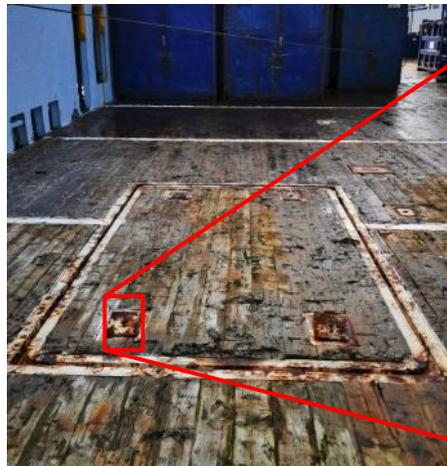
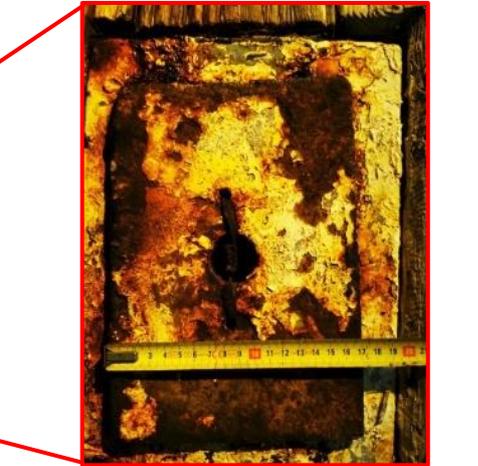
## Photographs / Supporting Information

After discharge to an installation, a metal plate (see attached photos) size 250 x 170 x 55mm weight **1.6kg** was found inside a forklift pocket hole by the platforms deck foreman on a 10' container when landed on the platform from the vessel.

As can be seen from the photographs, this PDO had the potential to be a life-threatening event. The sheer size and weight of the plate should cause concern for all vessels working in the offshore sector. It cannot be stressed enough, that deck crews and bridge officers must continue to remain vigilant to this sort of PDO. It is not good enough to claim that the vessel has no control over the effect of sea/waves have on deck fittings which have a potential to be dislodged from their position and “float” into spaces within cargo.

One of the possible reasons that this particular plate may have been washed from its position within the main deck could have been that it was quite badly “bent” as can be see in pictures below. This could have enabled water breaking onto the vessel’s main deck, to work beneath the plate to lift it.

It is recommended that vessels check their pin post/lifting point plates, to ensure:

- they are not buckled
- that they fit correctly
- there is an ability to secure them with seizing wire and that it is done. If the plates do not have holes, to enable fixing with seizing wire, then they should be modified.

If there is no securing point beneath the plates, then small wedges could be used to assist in making sure the plates fit snugly.
