# Safety Alert

**Number: 21-09**

**Subject: Engine Damage After Routine Maintenance**

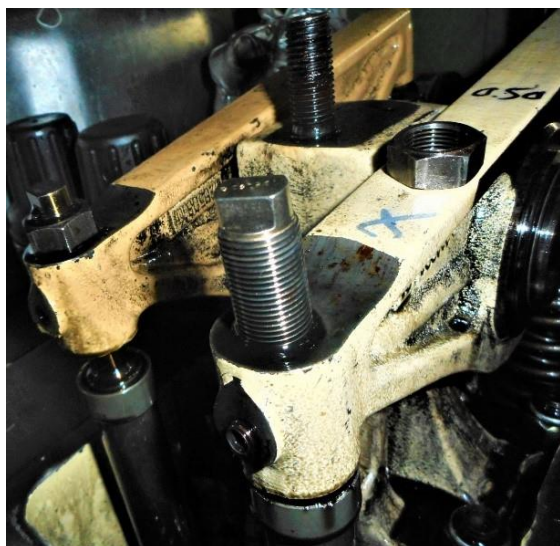
The evidence available indicated that the locking nut of the adjusting screw from the exhaust rocker arm (that regulates the clearance of the exhaust valve) had become loose. The most likely cause of this is that when reassembling, the locking nut had not been tightened as per the manufacturer's requirements.

Picture showing rocker arm adjusting screw with locking nut removed / dismantled

- After maintenance always carefully (double) check that all parts are properly (re-)assembled
- Always check torque using a torque wrench as per manufacturers manual

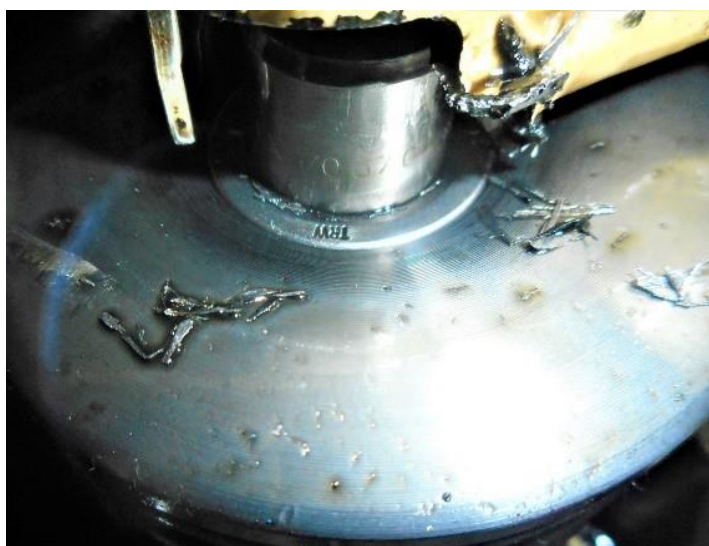
Investigation showed that 86 running hours before the incident, valve adjustments had been carried out. When removing the cylinder cover small metal particles and partial destruction of the exhaust valve tappet tip was found.

Picture showing partial destruction of the exhaust valve tappet tip, showing also the valve roto cap.
