Safety Alert

Number: 21-15

Subject: Eye Injury Whilst Opening Paint Tin Lid

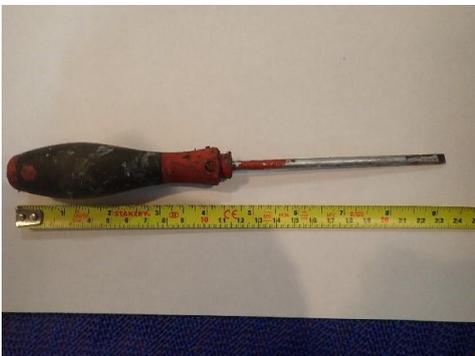
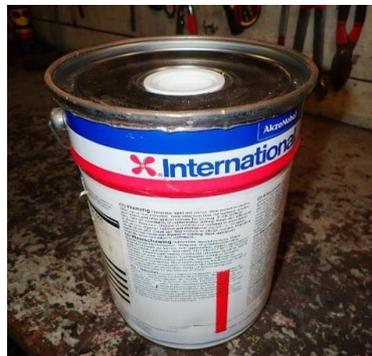
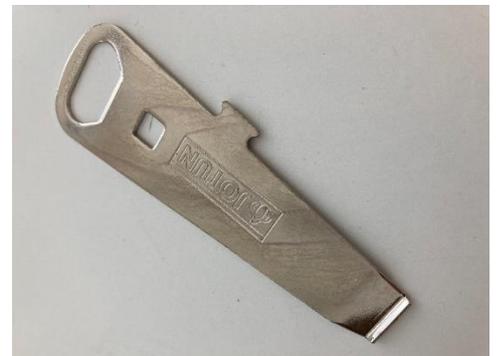
Photographs / Supporting Information

During offshore bulk cargo operations onboard a PSV in the North Sea, the IP attempted to open a 5L paint tin with a flat head screwdriver in order to commence a painting work scope. The incident took place in a well-lit workshop, the IP was not fatigued, nor inexperienced, was focussed on the job and wearing proper PPE including fitted safety glasses. When attempting to pry open the lid, the screwdriver slipped from the point of contact and sprung in an upwards motion travelling underneath the safety glasses to penetrate the IP's right eye.

Following investigation, it was determined that there was no defined tool or recommendations within the company for opening this type of paint tin lid. It was also discovered that the Risk Assessment in place did not capture the task of removing the paint tin lid as a hazard.

By design, the paint tin lid was rounded and tight fitting, which was also deemed a contributing factor as the screwdriver required force to separate the paint tin lid from the tin itself. Given that the screwdriver used was of the long-handled type, it was also considered difficult to control.

- Vessel Master performed "Safety Stand Down / Time out for Safety" – to discuss the incident and client notification and reporting requirements.
- To ensure that no further injuries were caused during the process of the investigation and until corrective actions were agreed, the vessel was instructed that no painting work scopes were to commence.
- A circular letter was distributed to the owner's fleet detailing the incident, root causes and corrective actions taken.
- A safer alternative in the form of a specific paint tin opening tool (as shown below) has been agreed to be purchased for the entire fleet with the use of screwdrivers prohibited for the task.
- The crew held safety meetings on both shifts to refamiliarize themselves with the Marine Operation Manual with special importance given to notification and reporting of incidents.
