Safety Alert

Number: 21-16

Subject: Defective Securing Arrangement

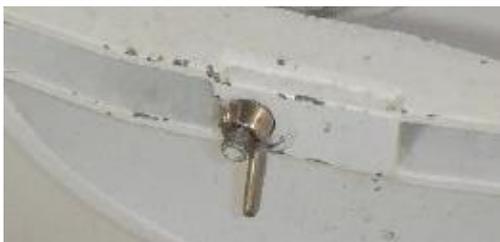
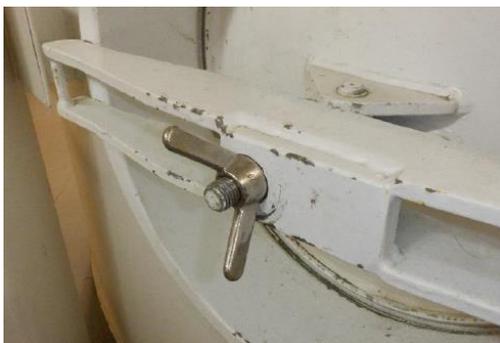
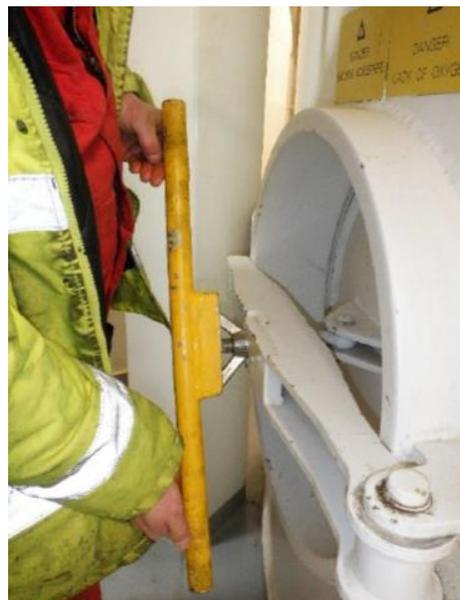
Photographs / Supporting Information

Further investigation revealed that part of the securing arrangement was damaged. The defective wing nut prevented use of the approved securing method which was required to ensure a good seal on the pressurised tank.

- The deck crew could not use the approved securing device because the wing nut was defective. – It is unclear when the defect occurred.
- The risk assessment and operational checklist identified the need for an appropriate securing device but failed to confirm if the device was free from defect.
- The inspection regime in the planned maintenance system did not include this specific check.

- The generic risk assessment on the vessel was updated to include a check that the securing device is inspected and confirmed without defect.
- The vessels IMS Checklist was revised to include the same.
- The planned maintenance inspection regime is to be updated in due course.
- The defective wing nut was replaced, and operations continued without further incident.
