Safety Alert

Number: 21-17

Subject: Snagging Point

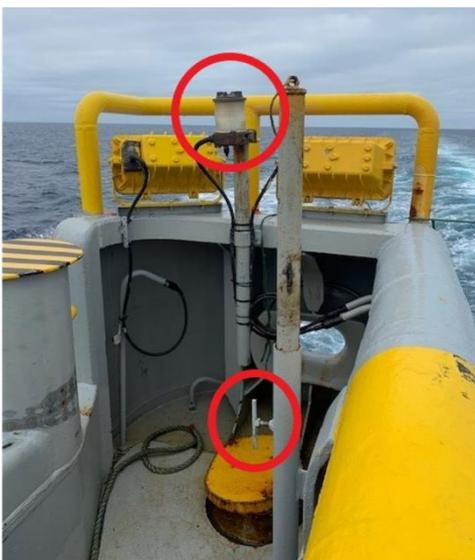
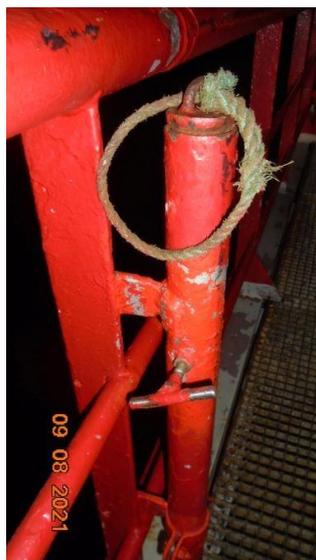
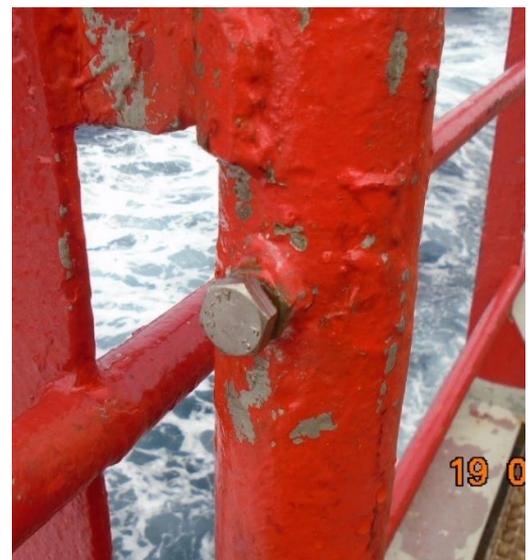
At the second event, the same dry bulk hose arrangement was connected to the stbd midships connection and hose pin on top of the crash rail. During retrieval, the hanging off strop was seen to snag at the securing clamp on the hanging off pin.

The vessel type is fitted with retractable vertical hose pins at various locations around the main deck crash rail. When extended, the hose pin is held in place with a securing clamp. The hose pins are retracted or lowered to a stowed position when not in use to avoid damage from overhead lifting operations. The design has been implemented onboard since the vessel was built and there have been no other reported incidents of the same nature at any time. It is unclear why a repeat snagging event occurred at this location, the hose pins are in regular use and had been used several times each day with other bulk hoses without reported incident.

As a proactive measure, the screw clamps have been removed and replaced with a flush hexagonal screw (example below). This action has been implemented on all sister vessels and those with a similar arrangement. All vessel Safety Officers were instructed to pay particular attention to similar snagging hazards during routine area inspections and pre-work risk assessments.
