Safety Alert

Number: 21-18

Subject: LTI – Fall from Height

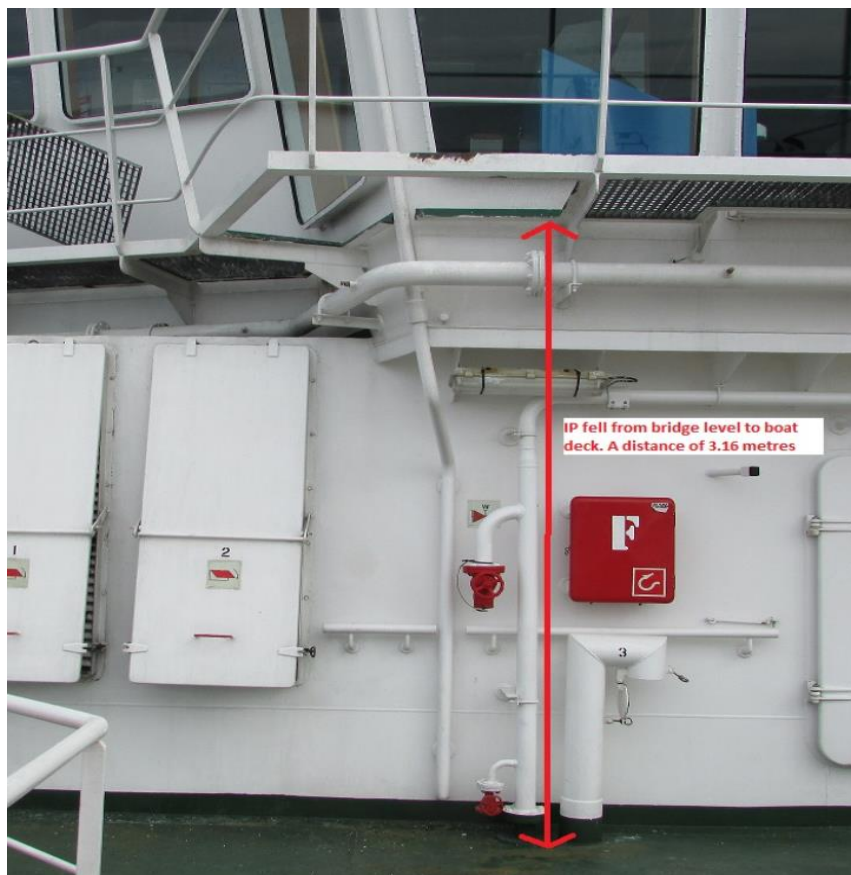
When moving backwards IP took a confident step backwards, which led him to fall through the opening left by the lifted section of grating down to the boat deck, approximately 3.2m.

2. There were no barriers or signage in the area of the incident. A fall hazard was introduced by removing Bridge gantry gratings.
3. IP presented lack of situational awareness and risk perception. When he decided to continue with maintenance on the Bridge level, he did not assess the area for any potential hazards, deciding to turn around and move backwards, not looking behind to see if there were any obstacles.

1. Masters and Chief Officers/Chief Engineers (if they do not lead toolbox talks) – to attend random toolbox talks carried out by the crew.
2. Those for non-routine tasks, when Toolbox Talk Meeting Record cards are used and those for routine tasks when crew discuss between each other the task and review risk assessment, all foreseeable hazards and available control measures.
3. To ensure that the company COW and PTW Systems are correctly and fully implemented.
