Safety Alert

Number: 22-02

Subject: Contact Between Vessel in Standby & Offshore Installation

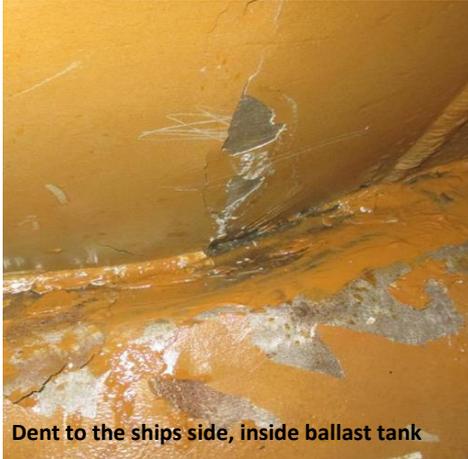
The vessel suffered dents to the hull, which did not compromise the hull integrity or safety of the vessel. The installation was undamaged by the contact.

- Ensure that all emergency switches do not have multiple functions
- Update of the existing navigational audit checklist
- Clarification of the lookout's duties in bridge procedure
- Emergency scenario-training sessions to be implemented
