Safety Alert

Number: 22-04

Subject: Man Overboard Incident

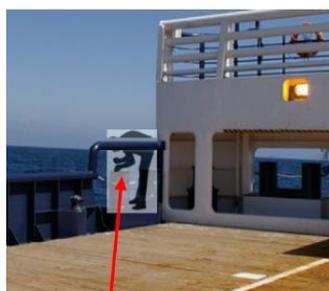
Position X

This crewmember decided that he would throw the heaving line to the shoreside from a position leaning out between the stern bitts (Position X in the diagram). The heaving line should have been thrown from the top of the crash barrier walkway (Position A in the diagram), at the backspring bitts (Position B in the diagram) or leave the throwing to a watchmate, who is more comfortable with throwing from any position on the main deck. (Position C in the diagram). Both should work on the same rope until completely fast and then move on to the next rope. Unfortunately, the crew member concerned overbalanced and fell out between the bitts, quick reactions from the linesman and the AB's fellow watchmate, ensured that the casualty was safely retrieved from the water. The MOB was wearing safety Wellington boots, which slipped, which did not help in maintaining his balance, he was also not wearing a life jacket/work vest. This had the potential to be very serious, fortunately he only suffered a bruise to his face.

4. Crew involved in mooring or gangway operations must not lean out between the bitts, or over the gangway opening.
5. Appropriate footwear should be evaluated and in use, providing both adequate traction and ankle support.
