Safety Alert

Number: 22-07

Subject: Manual Handling Injury During Bulk Hose Operations

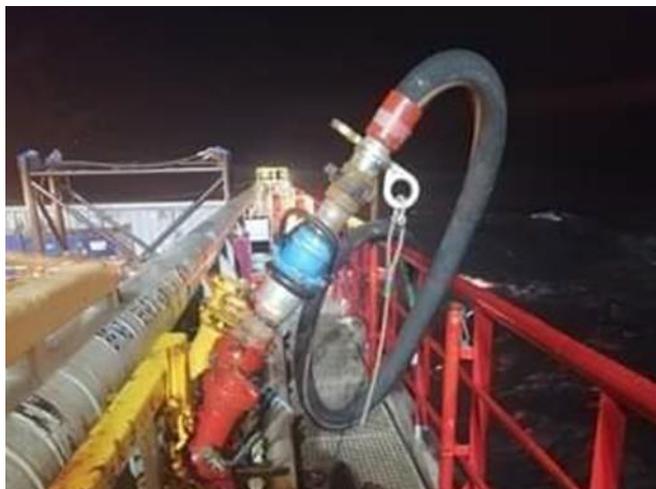
A member's vessel was preparing for bulk cargo operations at an offshore installation. The installation crane operator lowered a bulk hose with dry break connection via the hooky hook to the vessel where the crew were standing by to connect. Once received, the crew attempted to connect the dry break connection to the midships manifold on top of the safe haven, but the hose was heavy to manoeuvre due to residual liquid inside. The crew further struggled to connect due to the angle of the vessel manifold and an awkward series of rigid connectors and adapters on the hose end. The crewmember was forced to put the hose over his shoulder and raise onto the balls of his feet to line up the connecting parts, resulting in a muscle sprain injury to his right calf muscle. The crewmember required first aid attention and a period of restricted work duties.

The crewmember was forced into an awkward manual handling position causing additional strain and overexertion due to the following contributing factors:

- the angle of the vessel manifold in relation to the connections, deck and surrounding pipework
- the length of the hose end including a series of rigid connectors and adapters
- the weight of the hose due to residual liquid inside the hose length

Experience indicates the points of connection are a common weak link and most likely to experience fatigue which could result in a leak. An increased number of connections and adapters, increases the risk of manual handling injury to crew and environmental pollution. Best practice dictates the number of connections on the hose should be kept to a minimum and efforts made to drain back the liquid contents of the hose on completion of operations and prior to transfer.

- The manifold arrangement was reviewed with proposal for modification and improvement across the sister vessels.
- The installation operator was requested to review the hose connection arrangement with opportunity for improvement in mind.
- The installation operator was requested to review internal procedures for draining back hoses.
- The lessons learned have been shared with industry safety bodies with proposed recommendations to be included in the review of relevant chapter of the Guidelines for Offshore Marine Operations (GOMO).
