Safety Alert

Number: 22-13

Subject: Vessel Contact During Manoeuvring

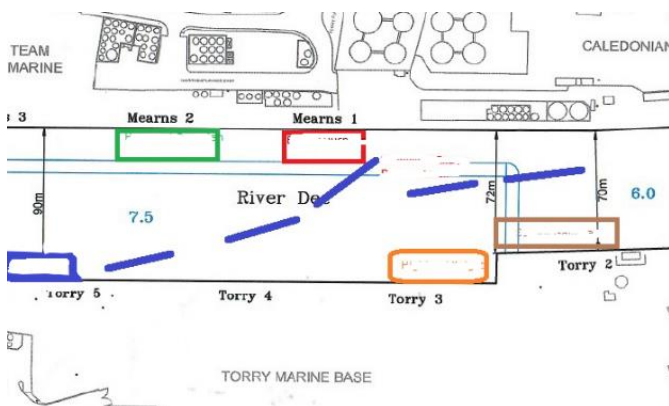
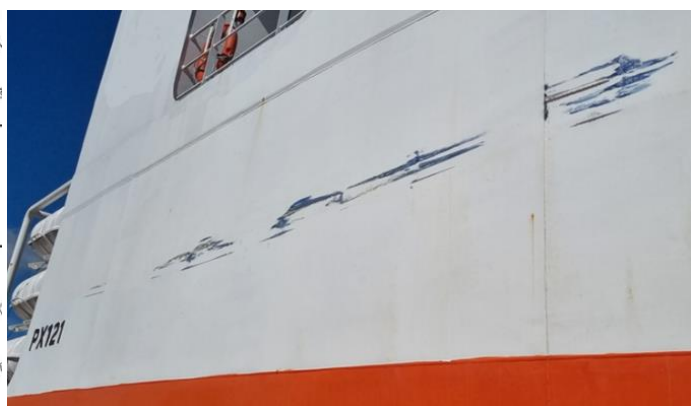
Photographs / Supporting Information

Due to an underestimation of the current coming down the river (approx. 1.0 knot or over) the manoeuvring vessel made contact with the vessel on Mearns Quay with their starboard quarter to her starboard bow.

No structural damage was incurred, but there was some damage to the paint coating as can be seen in the picture below.

- Lack of planning ahead
- The vessel was unfamiliar with operations in this port
- The ebb of the river was at its strongest and in addition had it been raining heavily 2 weeks prior to the incident causing the current in the river to be stronger than normal
- The vessel should have asked the port Vessel Traffic Services for information about the current in the river

- Plan manoeuvring ahead of departure/arrival. If elements such as strong current exceeding 2 kts, or constant wind is above 25 knots a toolbox talk must be carried out in addition with departure/arrival checklist. This has been added into the departure/arrival checklist as item.
- Use of an active AB for lookout on deck for reporting distance and movement of vessel towards all barriers
- Use of safe speed has to be considered when manoeuvring in areas affected by strong forces of wind and/or current
- Use of port Vessel Traffic Services for advice when entering the river if vessel crew is not familiar with the area
