# Safety Alert

**Number: 23-06**

**Subject: Injuries Sustained from a 2m Fall Between Decks**

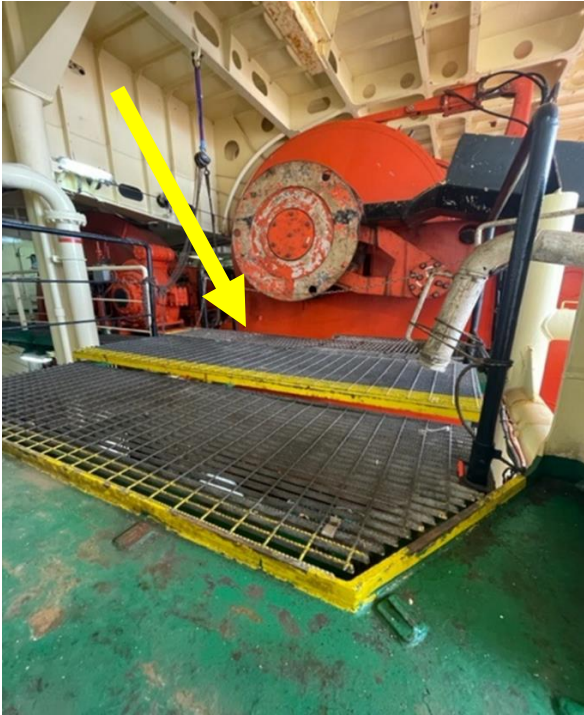
Picture 1 – 'A' Deck

Upon assisting the IP inside the accommodation, the Bosun went to A-deck and found the safety chain was not in place. Safety chain could not be confirmed to be in place as it was found in the down position with a link missing. A carabiner was still in place at one end and a welded link in place on the other. Missing link on welded end could not be located.

As the IP was off shift he went on deck with no PPE and fell between the winch gypsy and the deck grating. It could not be determined if the safety chain at the edge of the deck grating was actually in place prior to the Incident.

Picture 1 – 'A' deck showing the area around the gypsy and grating walkway including different levels highlighted by yellow paint. The yellow arrow denotes the space in which the IP fell between winch gypsy and grating.

1. Improved barriers to be installed around port and starboard gypsies
2. Shipboard/Contractor Familiarisations Inductions to be updated to include identification of restricted and working areas
3. Vessel to replace all chain barriers with gates or solid railings. All restricted/working areas to be identified and signage posted
4. Install barriers and signage to clearly identify working areas
5. Temporary chain barriers and signage have been put in place as a short term measure until solid hand rails can be fabricated and fitted

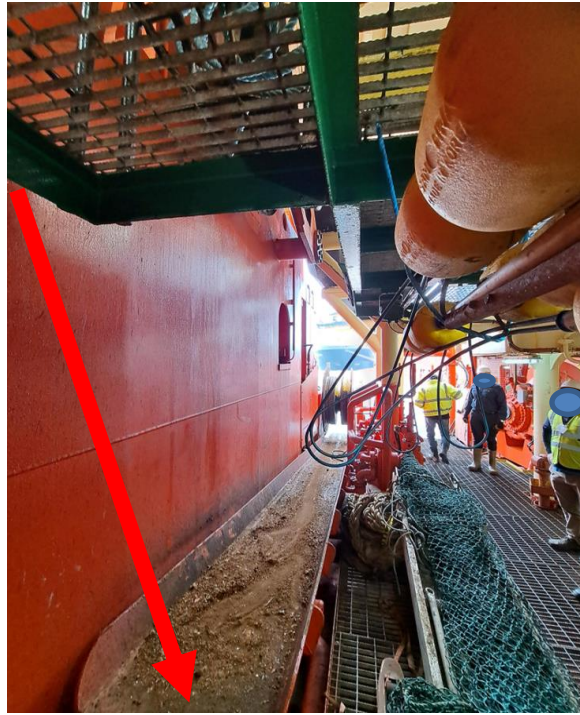
Picture 2 - Main Deck

Picture 2 – Main deck showing chute where IP landed from the grating above (height of approximately 2m). Red arrow depicts the drop zone and area where IP landed.
