MARINE
Safety Forum

Failed Mooring Line Incident on Anchor Handling Vessel

David Jamieson C.ErgHF

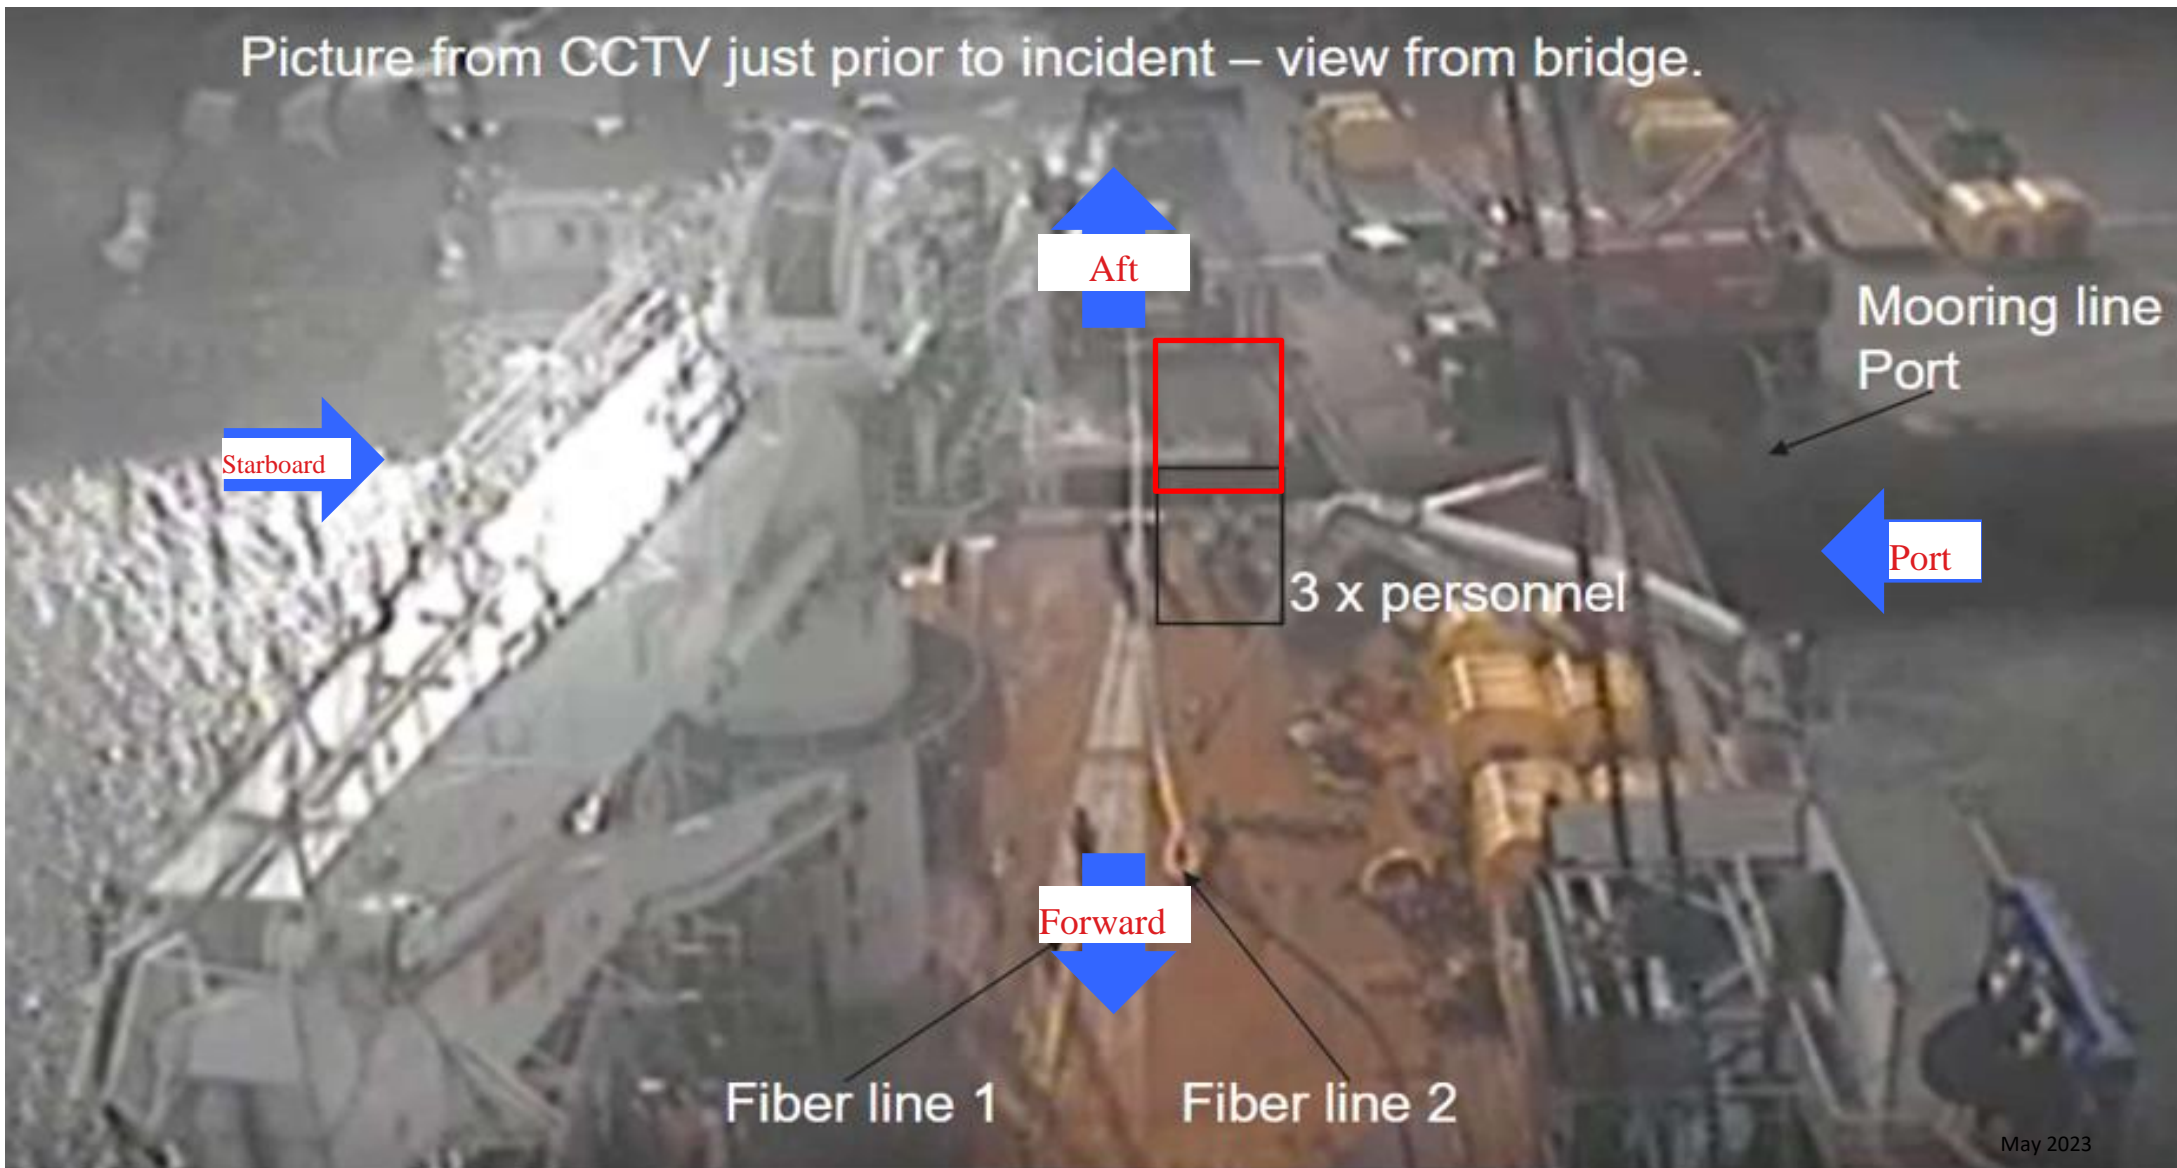
Picture from CCTV just prior to incident – view from bridge.

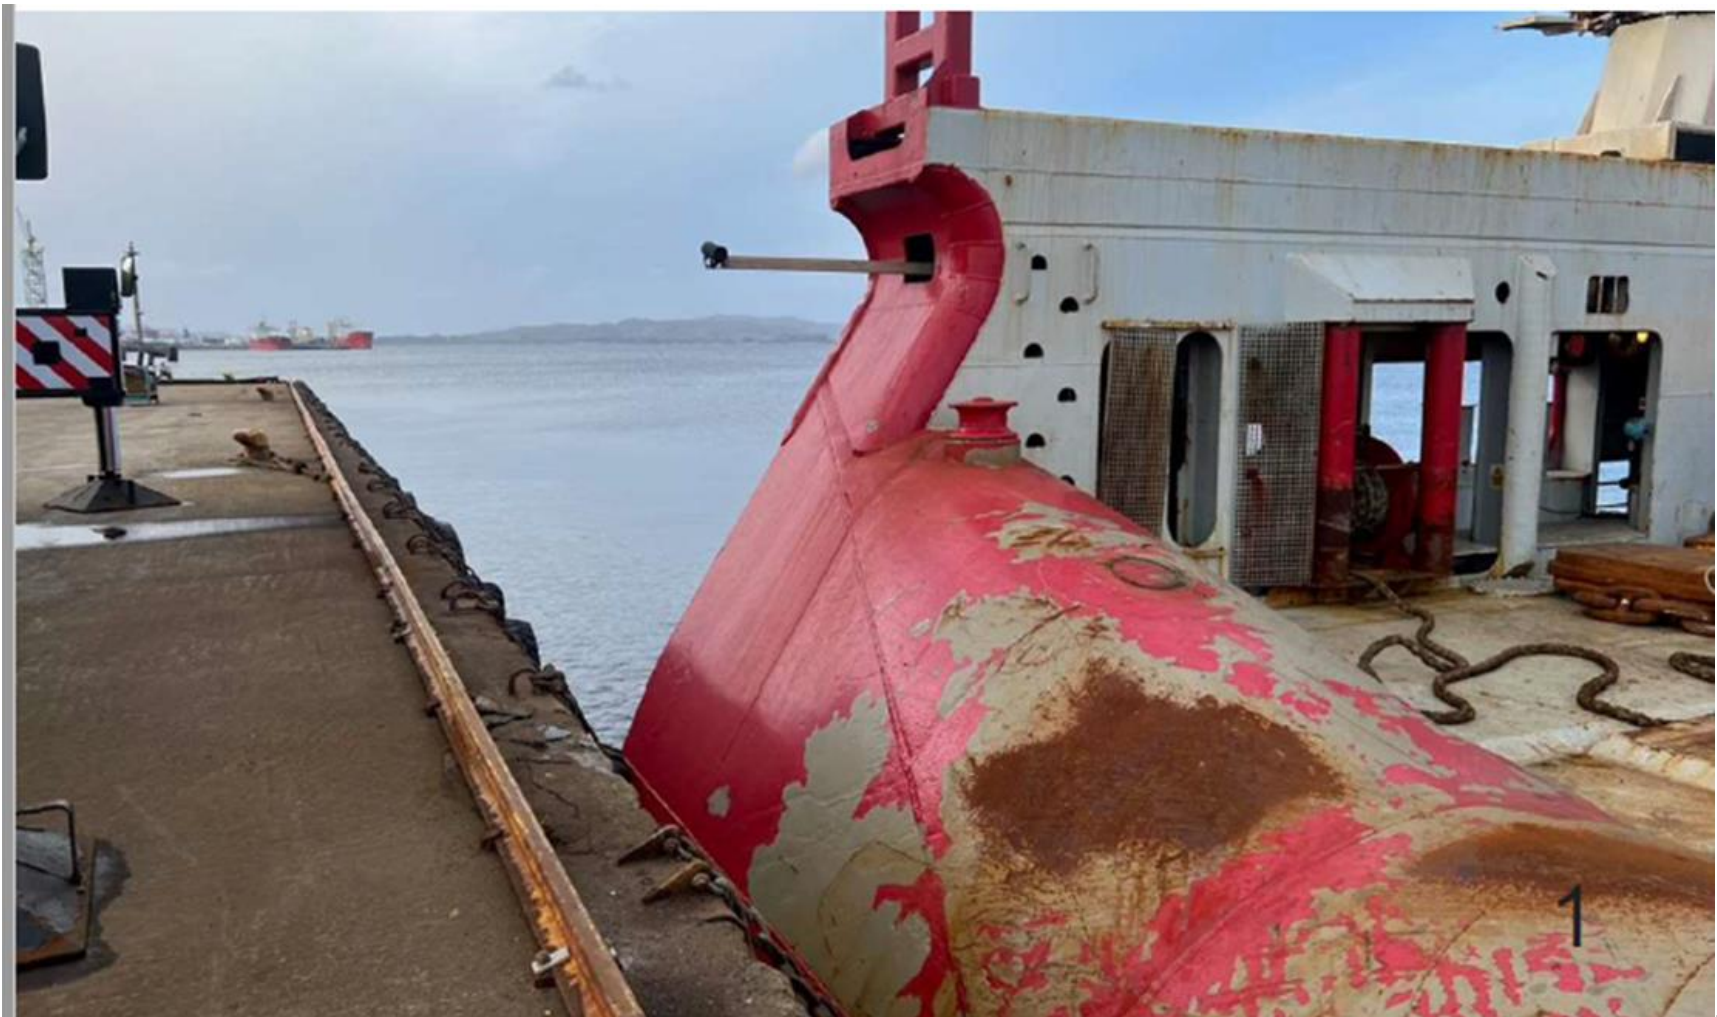
View of aft deck and quayside immediately after the incident

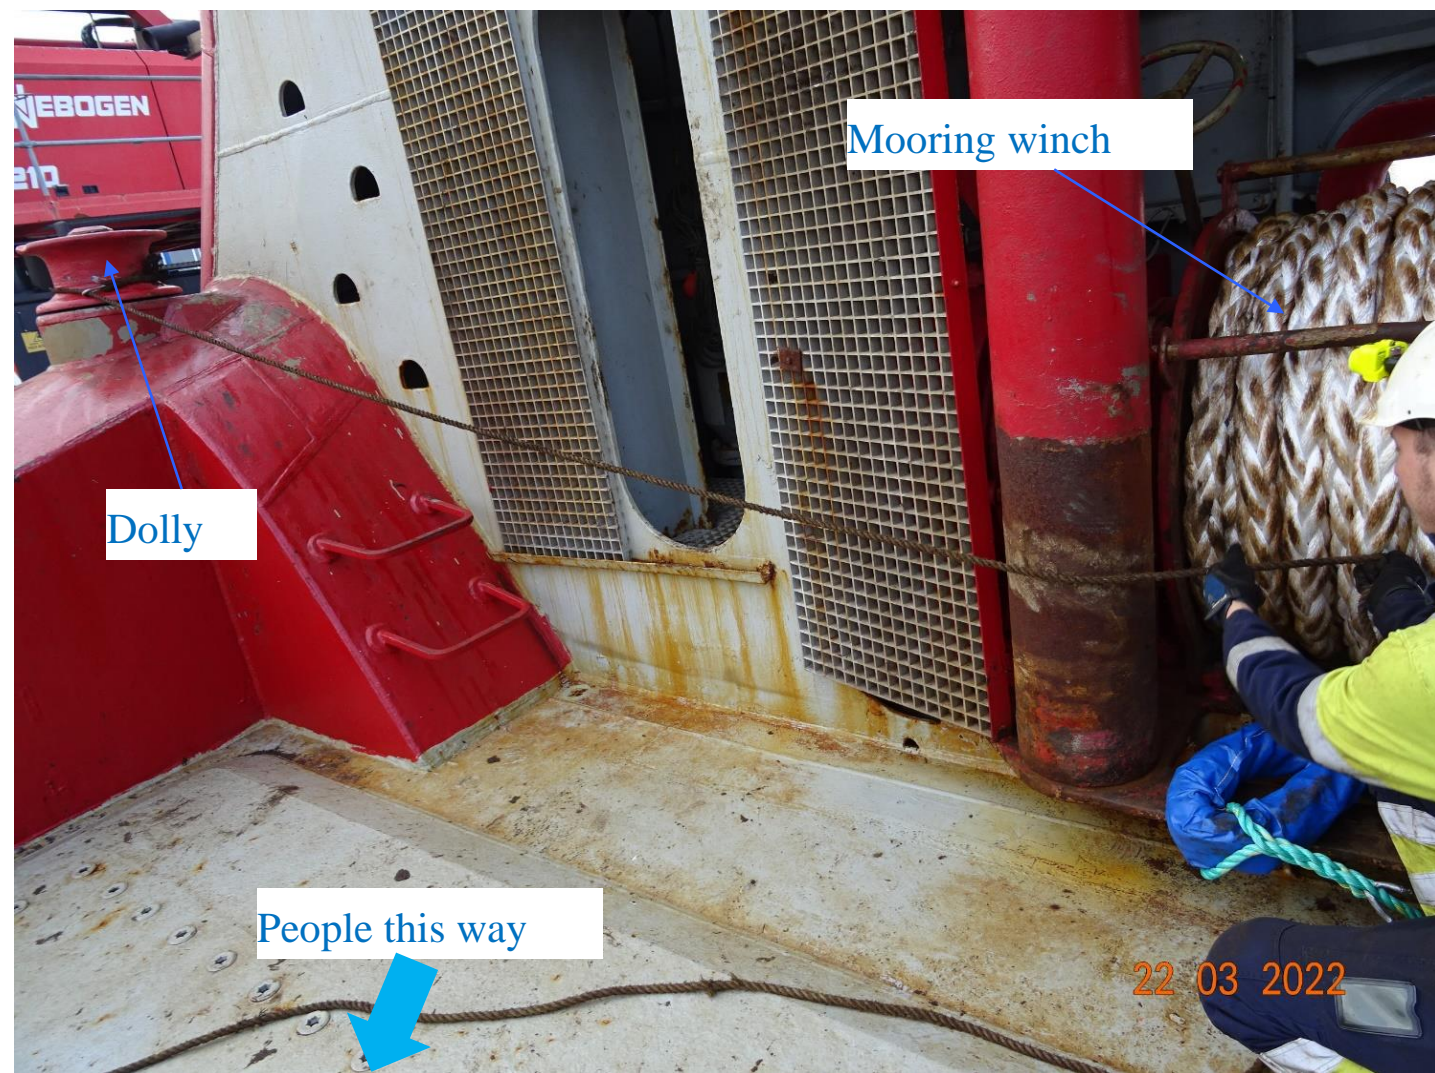
Replacement mooring line on the winch showing lead from winch around dolly on stern

- Natural degradation e.g. from environmental factors
- Mooring arrangement (rope bend around the dolly on the stern and lead of the rope from the mooring winch)
- Friction on the rope from rail on the quayside

- Are mooring lines needed at all?
- Safest means of stern to quay mooring including characteristics of quay and vessel
- Where possible route the mooring line directly overboard

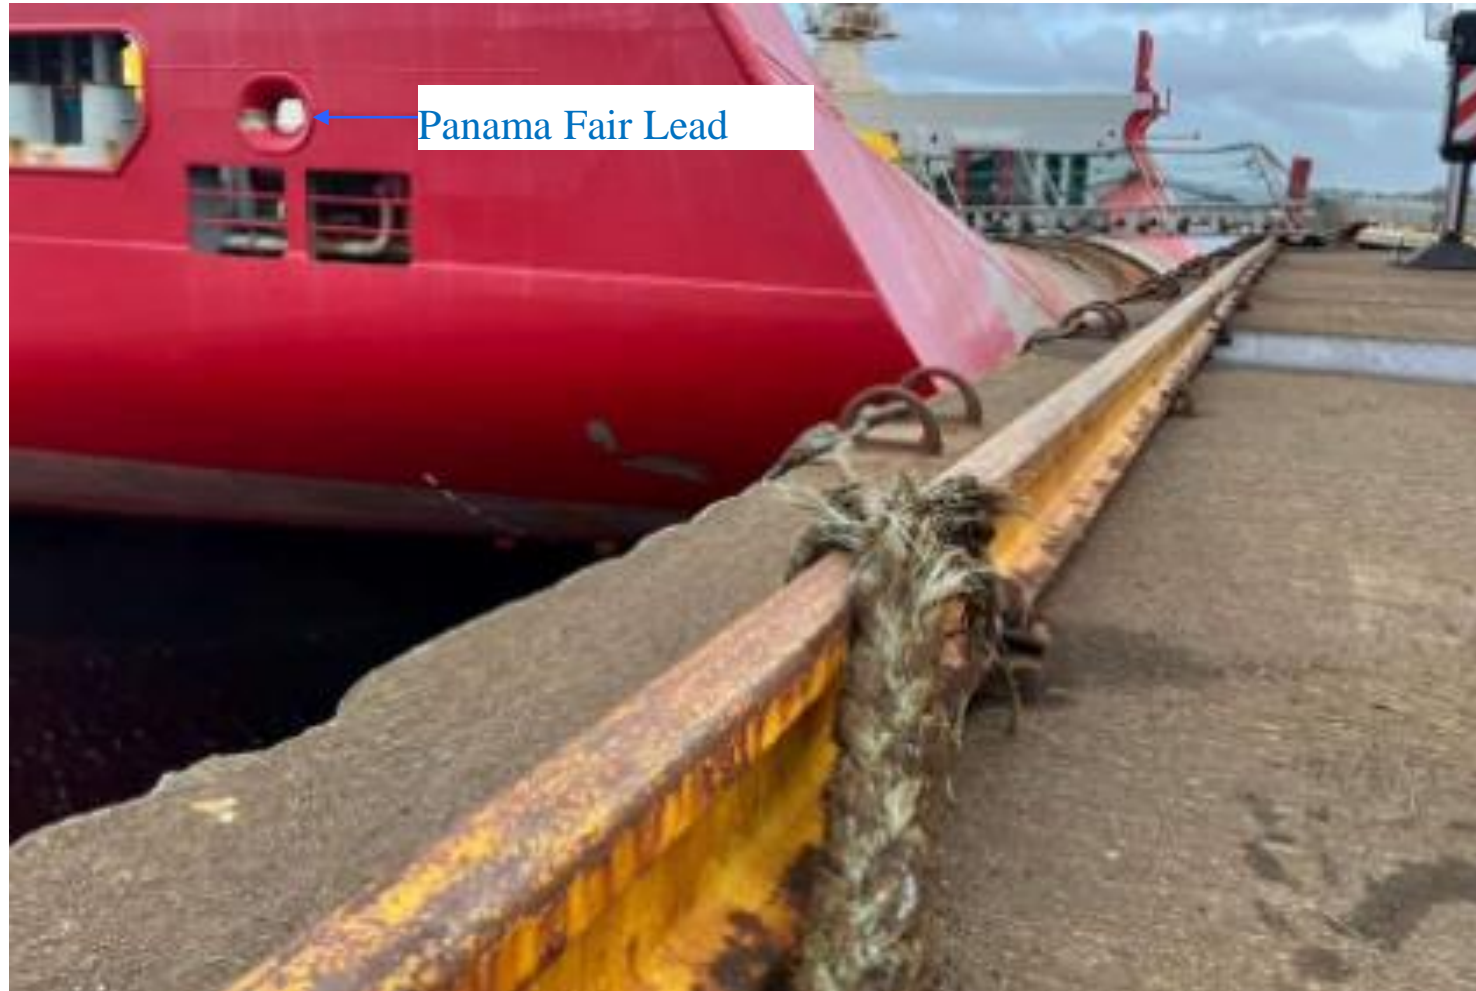
Stern of vessel from port side bollard on quay showing failed line.

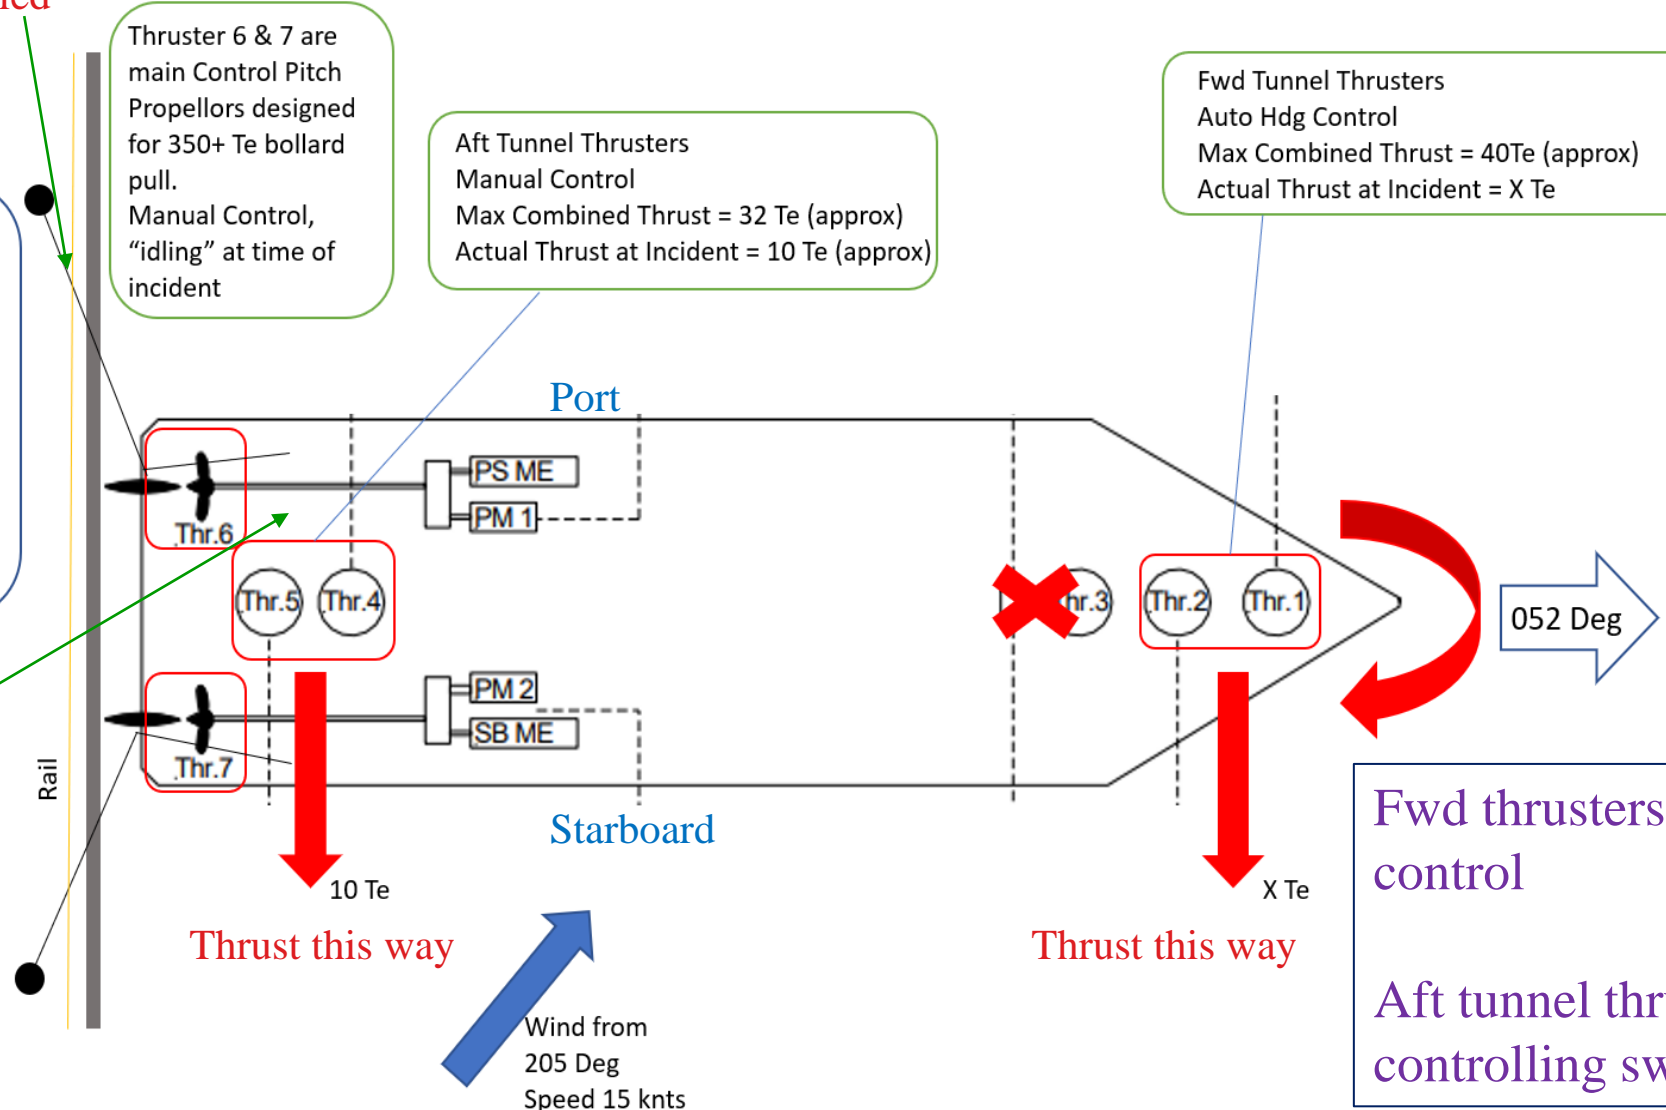
How the Vessel was Moored and Kept in Position During Operations

Mooring line that failed

Mooring line certified new with 52 Te MBL

- Residual strength of mooring line at time of incident was MBL minus factors such as:
- Wear & tear
 - Turn diameters / sheaves
 - Length of rope
 - Localised damaged
 - Cyclical loading
 - Shock loading

Thruster 6 & 7 are main Control Pitch Propellers designed for 350+ Te bollard pull. Manual Control, "idling" at time of incident

Aft Tunnel Thrusters Manual Control
Max Combined Thrust = 32 Te (approx)
Actual Thrust at Incident = 10 Te (approx)

Fwd Tunnel Thrusters Auto Hdg Control
Max Combined Thrust = 40Te (approx)
Actual Thrust at Incident = X Te

People standing here

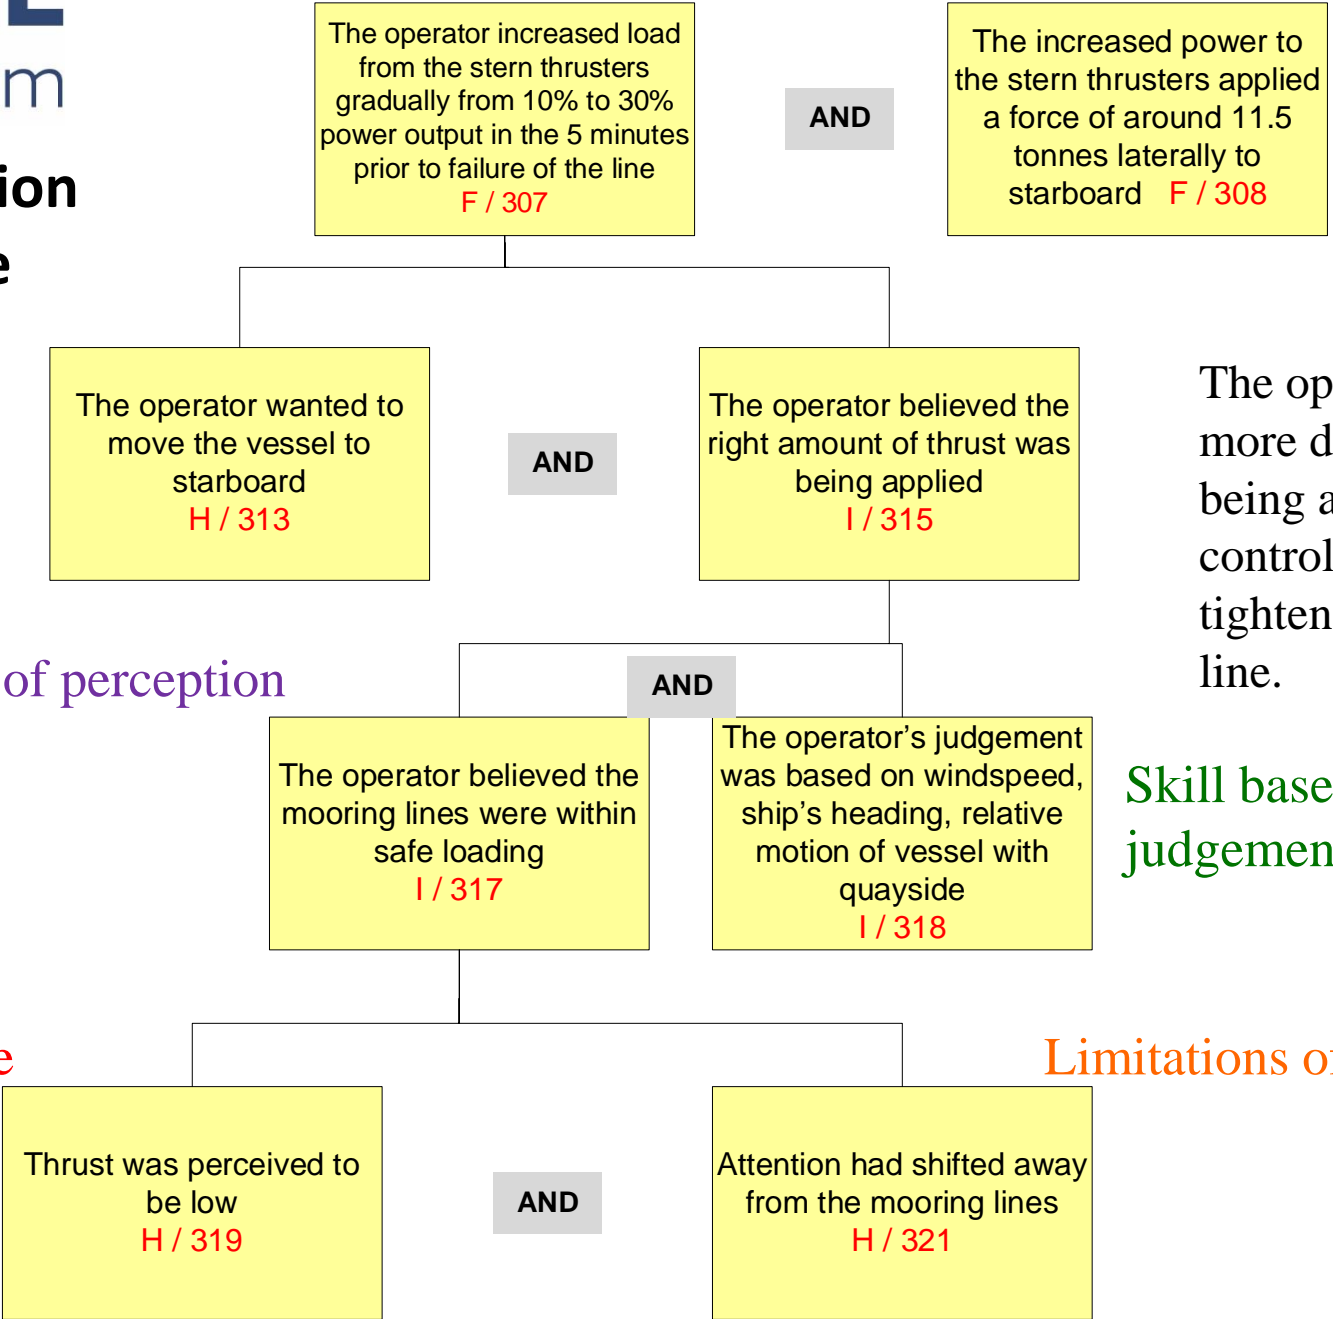
The increased power to the stern thrusters applied a force of around 11.5 tonnes laterally to starboard F / 308

The operators judgement is made more difficult due to 1) the thrust being applied by the auto heading control 2) the effect of the tightening of the port aft mooring line.

Supporting operators on the bridge - Is there a way to consolidate the thrust data for the operator, to a single point of control? Is there a way to improve the information for operators or how operators use the information to help them judge how much thrust is needed, e.g. the tension on the mooring lines?
