Safety Alert

Number: 23-07

Subject: Breakaway Coupling becomes a Dropped Object

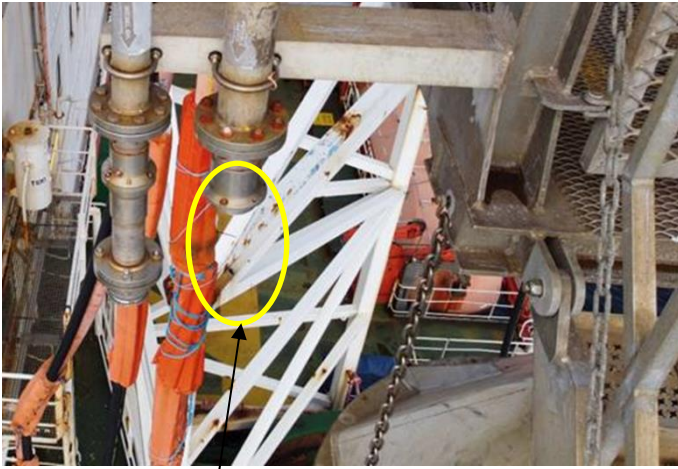
Original position of breakaway coupling

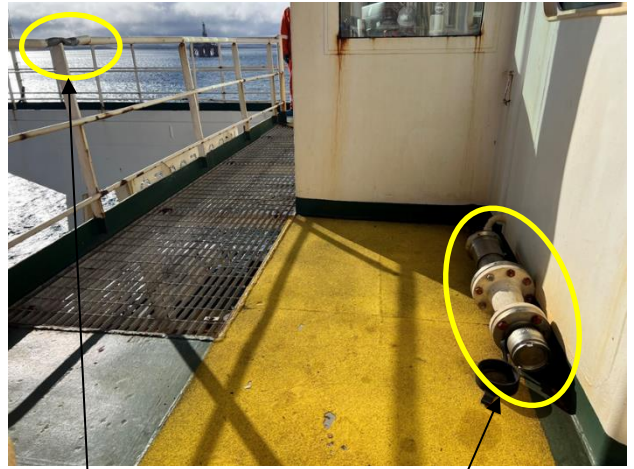
The damage to the handrail and coupling was minor however had the coupling not fallen to the adjacent walkway it could have continued to drop further and caused considerable damage to the anchor winch hydraulic pipework.

Damaged handrail

As found position of breakaway coupling

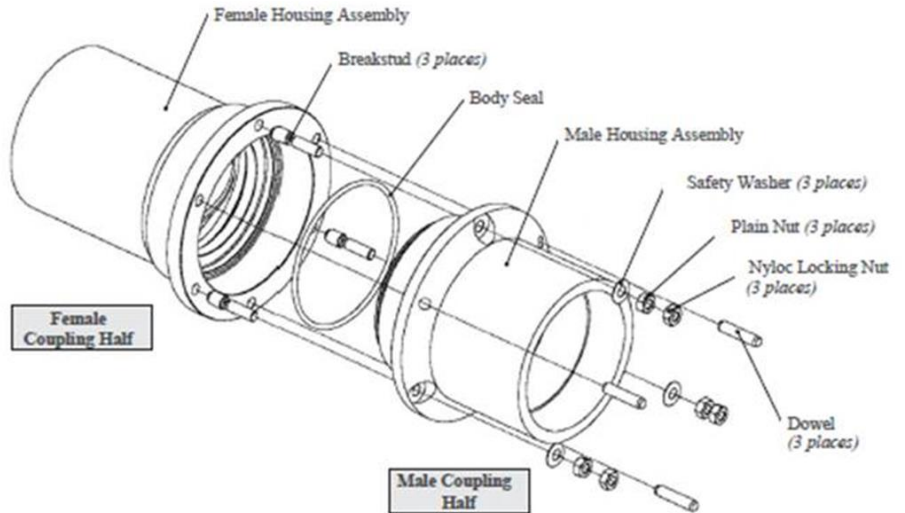
Exploded Assembly (Typical)
