# Safety Alert

**Number: 23-09**

**Published: 26/07/2023**

**Subject: Dropped Object in Drydock**

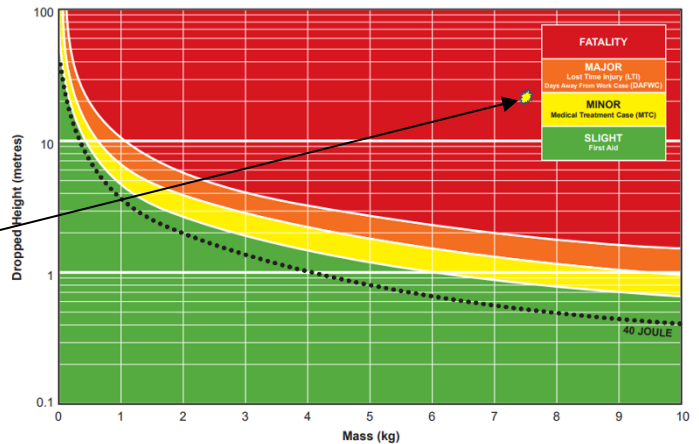
As the day's first job, the Chief Officer instructed the deck crew to collect all the lifebuoys. An AB attempted to retrieve the port side man overboard (MOB) lifebuoy. Holding onto the line which connects the lifebuoy to the smoke float, he released the pin. Failing to anticipate the weight of the buoy the line slipped from his grip and fell, contacting the corner of the dock quayside before falling to the dock bottom.

The combined weight of 7.6KG fell 22m to the dock bottom below with potential shown on the Drops calculator image to the right.

- The risk assessment and toolbox talk did not consider the potential for dropped objects.
- No precautions were put in place to prevent personnel from walking into the line of fire on the dock bottom.
- The AB involved was unfamiliar with the lifebuoy and smoke float arrangement, this lack of familiarity led to him not disconnecting the smoke float and not securing the lifebuoy against movement before releasing the pin.
- The required weight for MOB buoys is significantly more than the required weight of standard lifebuoys and may have been a factor not considered when anticipating the movement of the buoy.
- When discovering the job was not as simple as first anticipated the AB did not stop to ask questions or determine if there was a better way to complete the task.

- A meeting was held to discuss the risk assessment process onboard, appropriate allocation of tasks, level of detail in pre-task briefings and analysis of simultaneous operations.
- This task should have been assigned to someone familiar with the arrangement.
- The briefing given to the AB was not detailed enough for him to complete the task safely.
- On discovering the task was more complex than initially thought the AB should have taken a step back and raised his concerns with his immediate supervisor. A meeting was held with the crew to discuss the use of Step-back in relation to the incident and emphasise the crew's obligation to speak up, ask questions and stop the job.
