Safety Alert

Number: 23-10

Subject: Air Cylinder – High Pressure Discharge

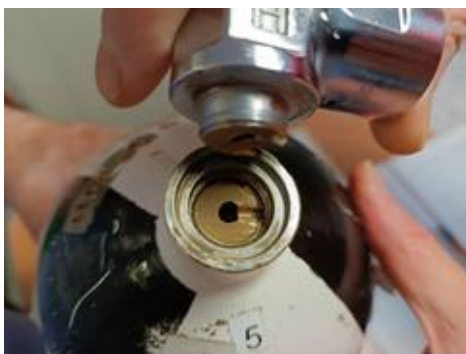
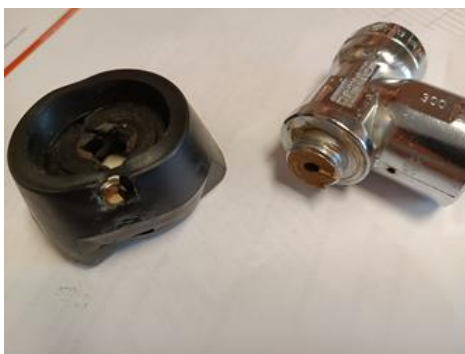
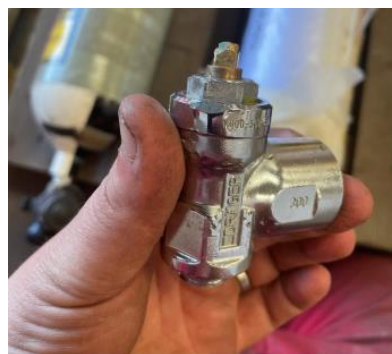
During preparations to land a leaking Breathing Apparatus bottle ashore, a crewmember was draining the remaining pressure from the bottle when the pillar valve broke off from the top. On inspection of the damaged valve, it was found that there was a fracture of the threaded end which had resulted in failure along a crack likely caused by metal fatigue.

"Upon inspection of the valve, I feel it is evident that this valve has seen a heavy impact, the nut retaining the handwheel has been pushed through the handwheel itself and you can see that what is left of the spindle has also seen a heavy impact along with the valve itself. In my opinion this cylinder has been dropped on the valve causing it to break. This is a very serious incident that ultimately could have caused a fatality".

- When moving pressurised cylinders around the vessel extreme care is to be exercised.
- When decanting cylinders for transportation, the cylinder is to be held securely with the valve being slightly cracked open with the contents being released in a slow and controlled manner.
- Always make sure that the valve end of the cylinder is pointing away from yourself and any colleagues.
- When conducting this operation full PPE is to be worn.
- Vessel owner is investigating the fitting of Excess Flow Valves when individual cylinders pass through the maintenance workshop.
- The importance of accurate reporting is to be stressed to crews.
