Safety Alert

Number: 23-14

Subject: LTI – Partial Thickness Burns from Cooling Water

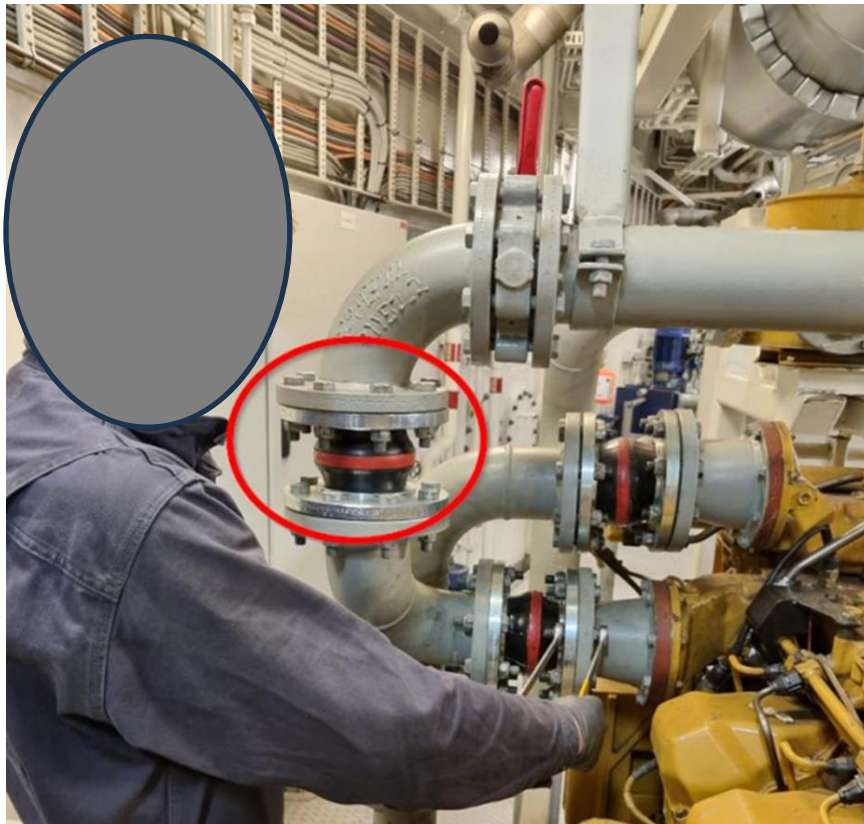
The incident occurred on a Platform Supply Vessel while in operation. In the early morning hours, the Engine Alarm System was activated due to low level in High Temperature (HT) cooling water system on diesel generator no.1. The 1st. Engineer examined the diesel generator no.1 and quickly identified a leak from one of the rubber compensators. He installed a new compensator and began filling the system with water. He went down to inspect the newly installed compensator to ensure it was not leaking. While standing in front of the compensator, another compensator in proximity burst and the 1st Engineer was exposed to a blast of steam and scalding water.

Figure 1: Position of the IP in relation to the ruptured compensator.

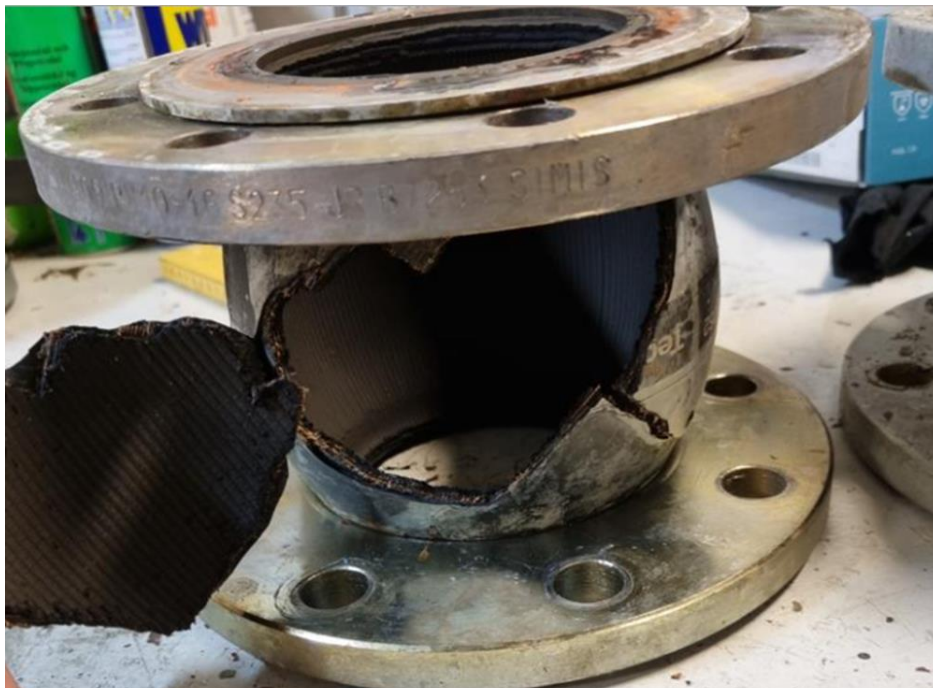
- The pressure in the cooling water system raised suddenly when the cold water was added to the hot system. This raised pressure exceeded the installed compensator's structural integrity.
- The installed compensator did not have the correct temperature rating for the system it was installed on.
- There was no maintenance or replacement history on the compensator since the vessel was built (10yrs ago)
- The compensator material likely degraded and weakened overtime due to the incompatible temperature rating.
- The cooling water system had a pressure relief valve; however, it was not sufficient or expected to deal with a sudden pressure increase.
- The manufactures procedure for filling the system while still hot was not followed. The system needed to be cooled before filling with water.

Figure 2: Ruptured Compensator.

- The primary corrective action was to ensure the compensators are rated for the media, pressure, and temperature of the system they are installed on.
- The compensators should also be checked to ensure they are not misaligned and are installed within manufacture specifications.
- The manufactures procedure for filling the High Temperature cooling water system with water, especially when the system is hot must be followed to avoid sudden increase in pressure.
- Appropriate inspection and maintenance plan to be implemented for this type of equipment.
