# Safety Alert

**Number:** 23-16

**Subject:** Messenger Line in Propeller

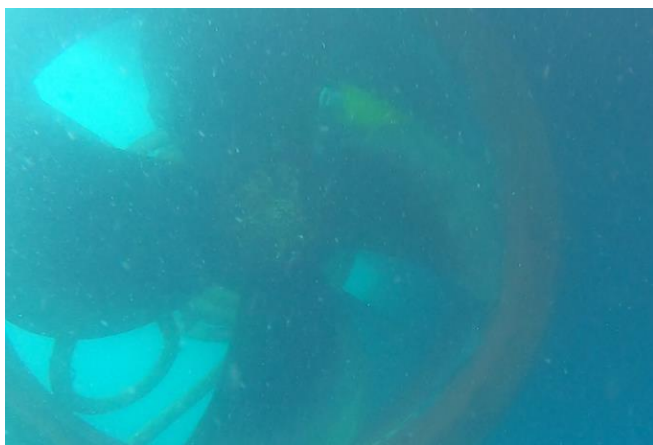
- The combination of the vessel moving aft, and the deck crew being unable to pull in the messenger line slack are the immediate causes for the line becoming entangled in the propeller.
- There were also additional personnel on the bridge who were being instructed by the DPO and Captain. This led to a loss of situational awareness and overview of where the vessel was in relation to the in-sea equipment.

Figure 1: Messenger line in propeller

- The marker buoy design needs to be improved to allow for a tangle free operation.
- The risks of losing situational awareness due to training of other personnel and how to avoid this during a complex operation must be addressed before the operation commences.
- Improve the specific communication requirements between the deck crew and the DPO so that relevant and necessary information about the operation is conveyed effectively.

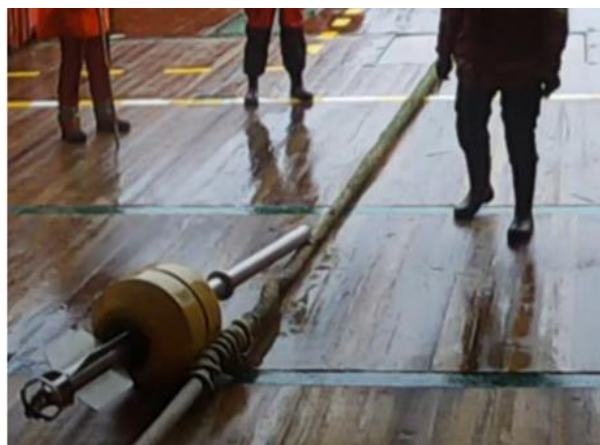
Figure 2: Marker Buoy
