Safety Alert

Number: 23-17

Subject: Dropped Metal Wedge

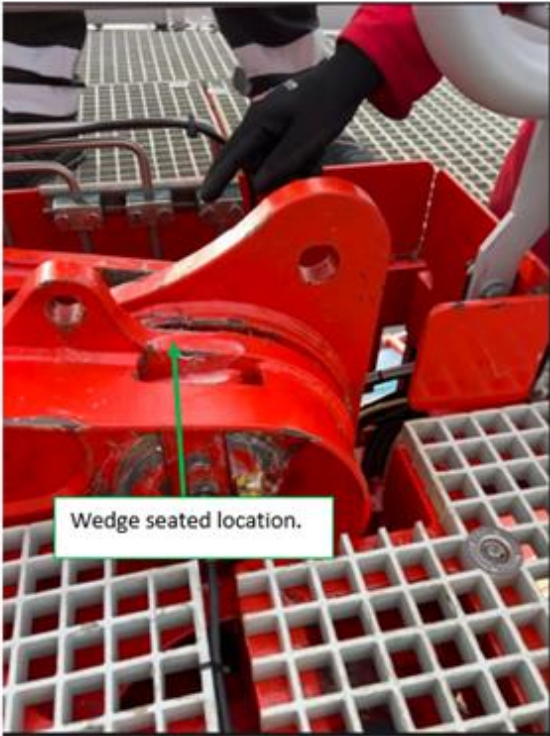
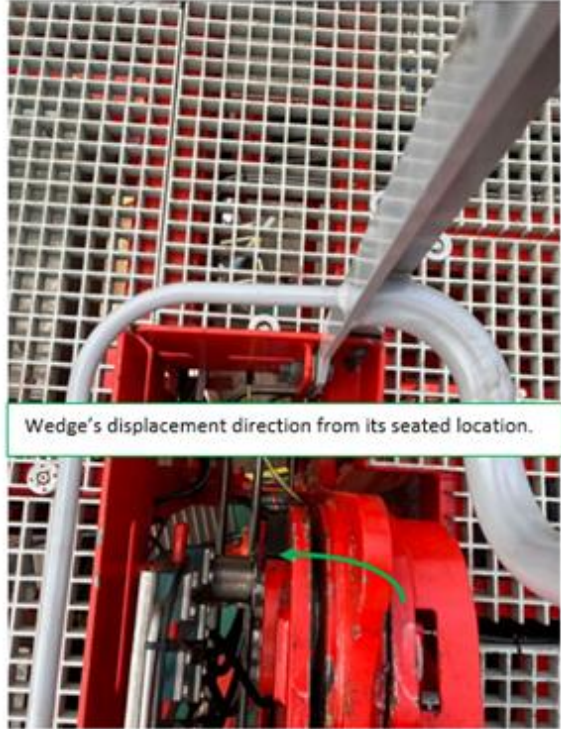
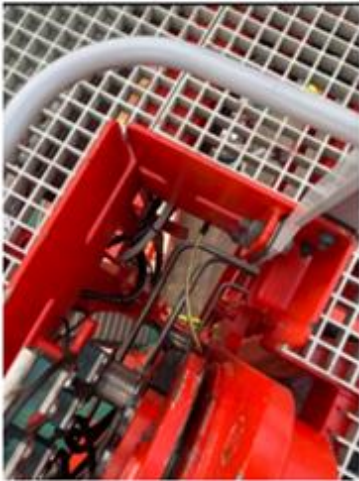
Note the narrow space and the obstructions present through which the wedge travelled.
