Safety Alert

Number: 20-18

Subject: Dropped Lightning Rod

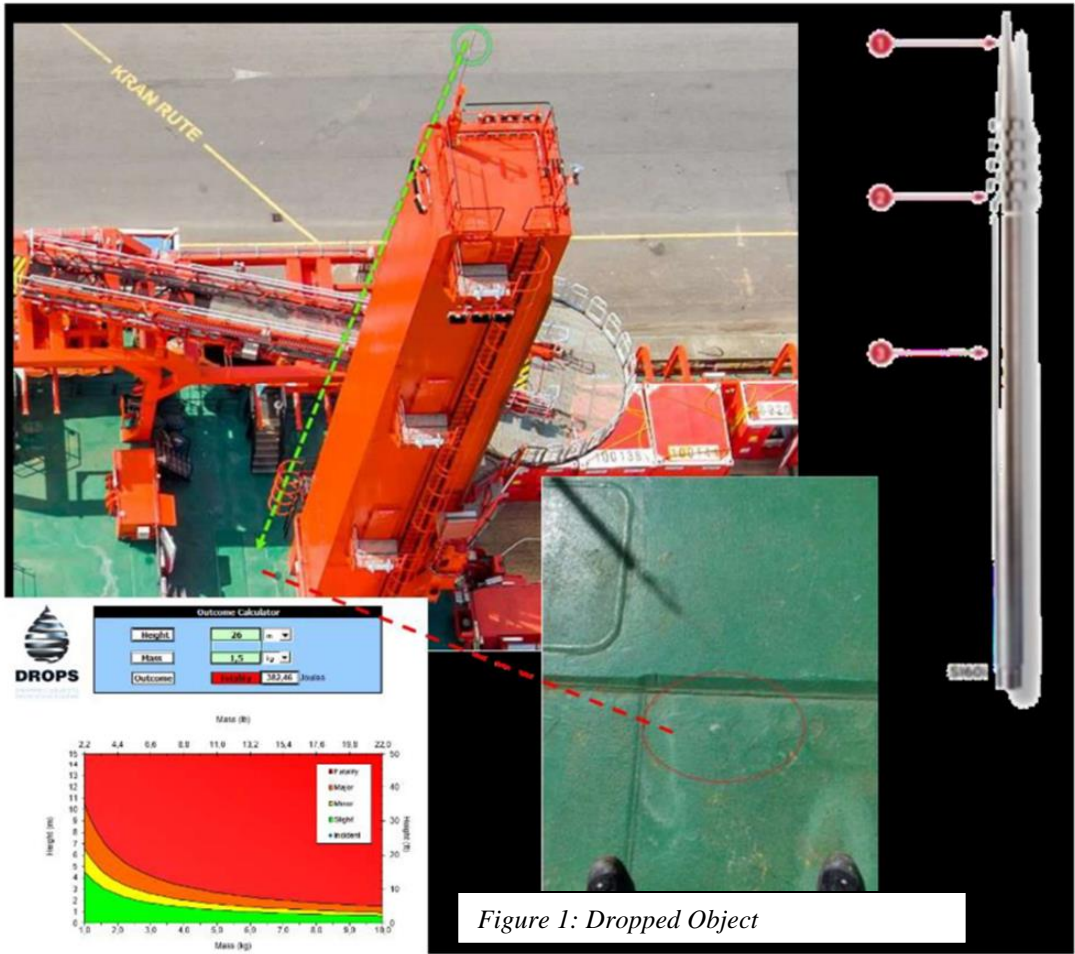
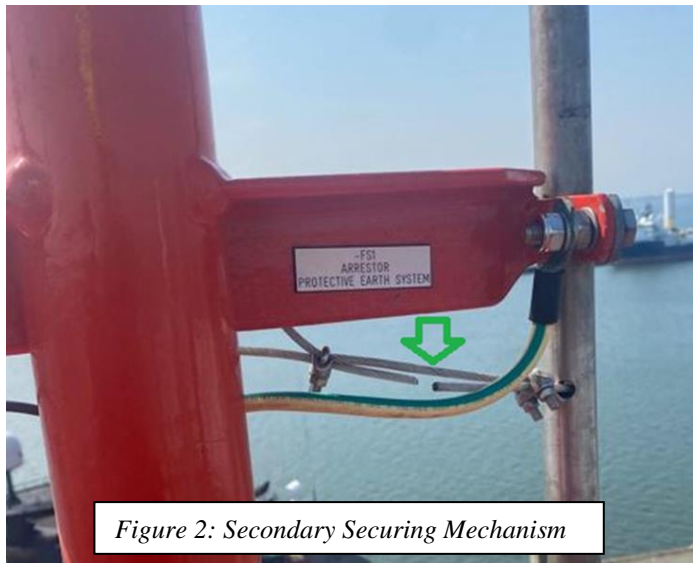
A lighting rod conductor mounted on top of a dynamic gangway tower for a Walk-to-Walk vessel was found lying on the deck below the tower. No personnel onboard the vessel observed or heard the object fall.

There was no obvious damage to the rod or fittings, it is assumed that the fittings loosened / unscrewed over time.

- Impact of rough or bad weather on the rod securing connections
- lack of inspection/maintenance on the securing of the rod
- Design deficiency in terms of a secondary securing mechanism for the rod

- Create a planned maintenance schedule to regularly check the lighting rod conductor fittings.
- This planned maintenance schedule must be applied to other installed equipment i.e., lights, cameras, wind sensors etc.
- Install a secondary securing mechanism to the lighting rod components and other equipment where necessary.
