# Safety Alert

**Number: 24-04**

**Subject: LTI – Compound Fracture of Right Foot**

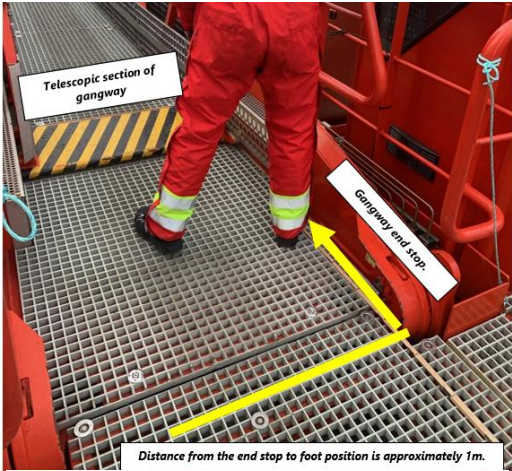
- A gap exists between the frame end and gangway floor grating. The IP was standing in the entrapment zone while making the connection and when the telescoping gangway section was retracted, in combination with the effect of the automatic motion compensation by the system, the gangway frame completed its maximum distance of travel over the IP's right foot.

Estimated position of IP based on video footage and safety shoe debris on the gangway.

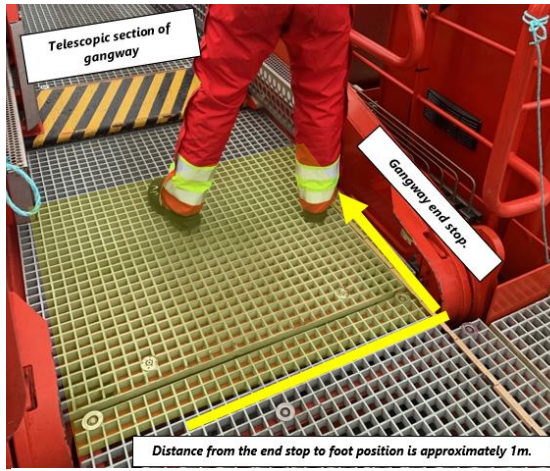
Right foot placement with a yellow marked Safety zone / No-Go area (reconstruction)

2. Update the gangway operator training program with specific focus on entrapment and shearing potential areas on the gangway. This should include no-go areas for operators and transferring technicians and form part of the gangway operator's assessment at the end of the course.

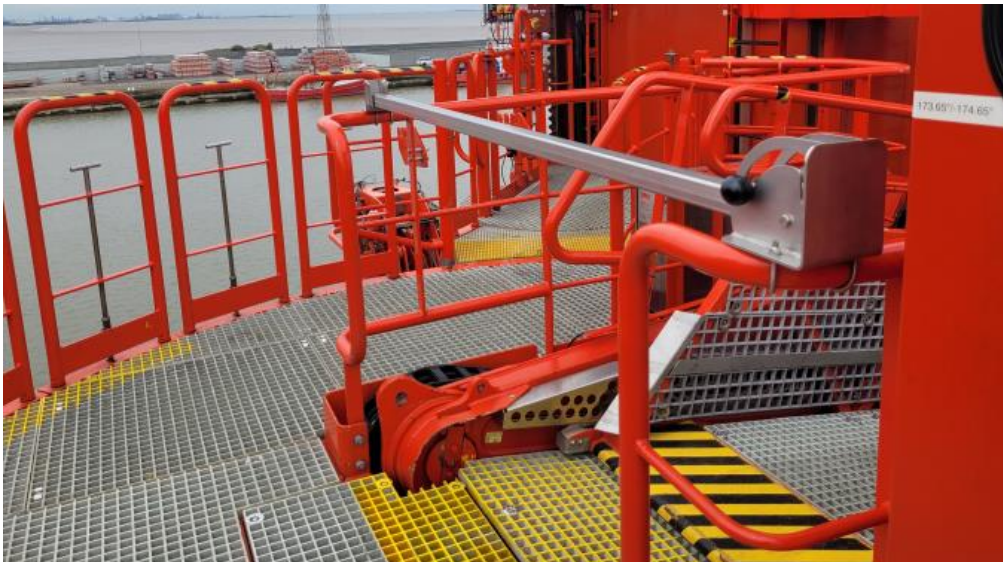
Gangway entrance, after installation of guard.

1. Install guarding along the exposed soft stop of the gangway to ensure a person cannot place their feet in the path of the retracting gangway frame and install a physical barrier at the base of the telescopic gangway section, and which will prevent the operator from encountering the gangway when it is fully retracted.

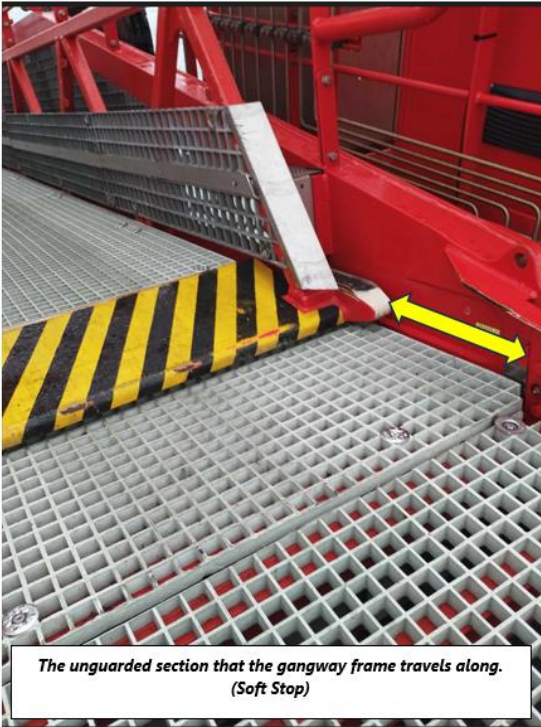
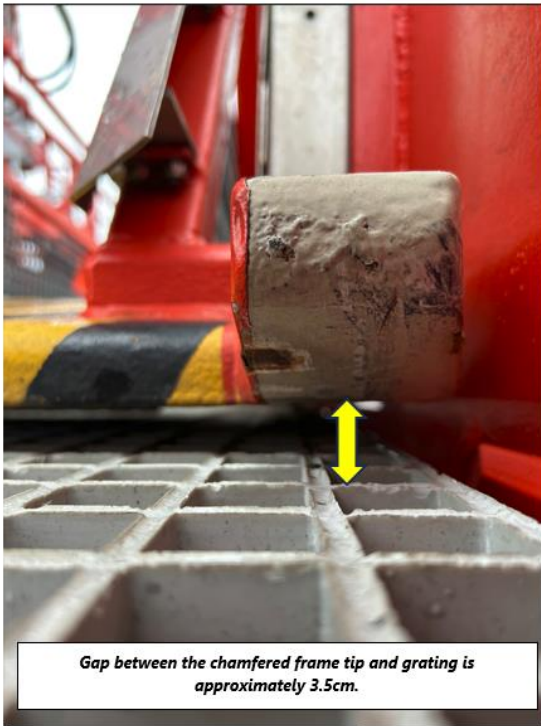
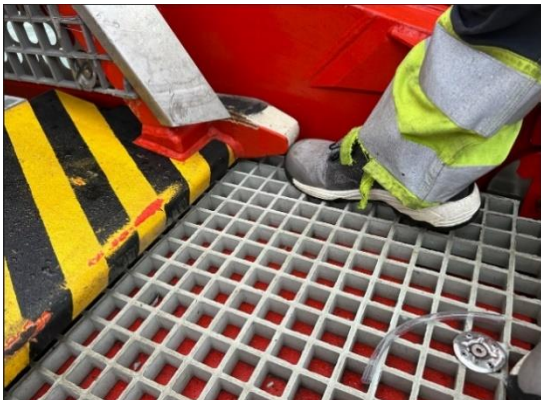
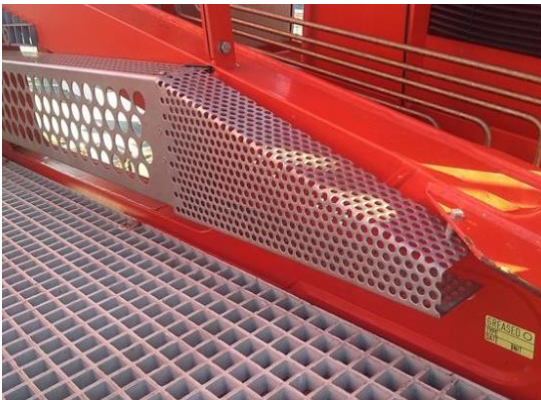
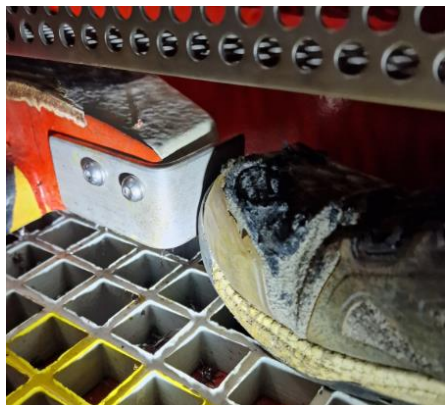
## Foot Entrapment Potential (Equipment Design)

- The ends of the telescoping gangway frame are engineered with a chamfer (approx. 45°) as part of the interrelated system design, where there is a gap between the gangway floor and the frame end.
- The final section of the travel path (soft stop) for the gangway frame was not guarded.
- The training delivered to the gangway operators included standing on the Telescope Access Bridge platform (TAB) or in the operator shelter (cabin) during gangway connection attempts, thus normalising the operators to this area.
