Safety Alert

Number: 24-05

Subject: Serious Hand Injury Whilst Donning Breathing Apparatus

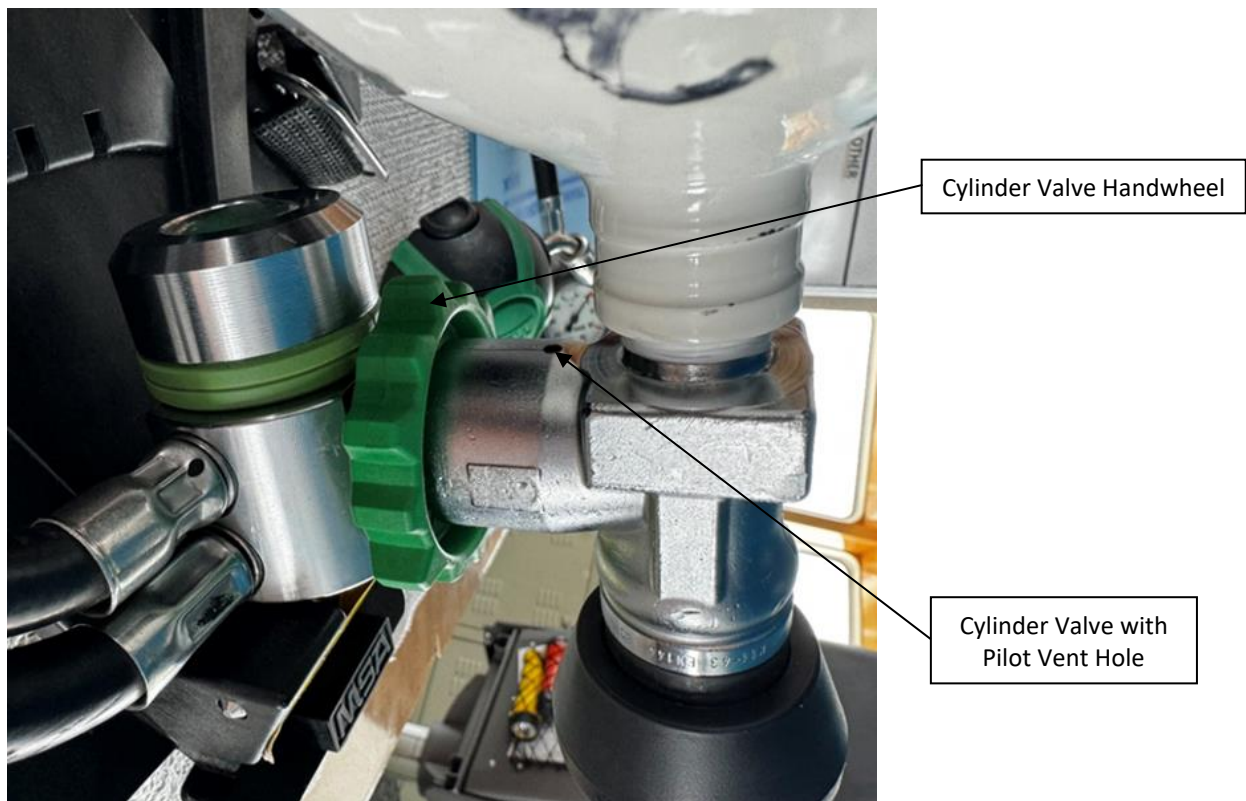
To try to recreate the leak, they loosened the Cylinder Valve Handwheel (between the BA Set and the BA Cylinder Valve) and immediately there was a high-pressure air release from the Pilot Vent Hole on the Cylinder Valve. The Pilot Vent Hole is a safety feature in 300 bar rated Cylinder Valves that has several purposes:

The Pilot Vent Hole is located on the Cylinder Valve so that any high-pressure release is in an upward direction and away from the BA Cylinder Valve Open/Close, where the person who is operating the Cylinder Valve hand would be. During the testing it was noted that when the Cylinder Valve Handwheel was tightened, "**hand-tight (no tools should be used)**" as per manufacturer's instructions, there was no escape of air from the Pilot Vent Hole. This only occurred when the Cylinder Hand Wheel was slackened slightly. The Cylinder Valve was then fully dismantled to check for any faults and no faults were identified.

It was confirmed that the escape of air was initially felt by the BA wearer on the "**back of his legs**" and only lasted around one second. The downward escape of air felt on the BA wearers legs, could only have been from the Cylinder Valve Handwheel connection not being secure. The injured crewmember could not recall the action, due to the timescale and shock, although he was the only one who could have stopped the leak, by tightening the Cylinder Valve Handwheel and in the process must have inadvertently placed his impregnated finger over the Pilot Vent Hole. When the Cylinder Valve Handwheel was tightened there was momentary release of pressure from the Pilot Vent Hole until the valve had full connection to the BA set and the BA Bottle pressures were equalised.

1. When replacing a BA bottle on a BA set always ensure that the Cylinder Valve Handwheel connection is tightened as per manufacturer's instructions. hand-tight (no tools should be used).

2. After changing the BA bottle, pressurize the system and listen for any leaks. Apply soapy water to the connection points and check for any bubbles indicating a leak. Tighten connections, if necessary, but close the main valve first.

6. When donning BA, manufacturer's instructions should be followed, and if any leaks are observed the main cylinder valve must be closed prior to tightening. Following the above checks when changing a BA bottle and conducting the planned maintenance should ensure that the integrity of BA connections is confirmed prior to using in Drill or Emergency.
