MARINE Safety Forum

All Members Meeting

Thursday 28th May 2026

Recent Safety Flashes

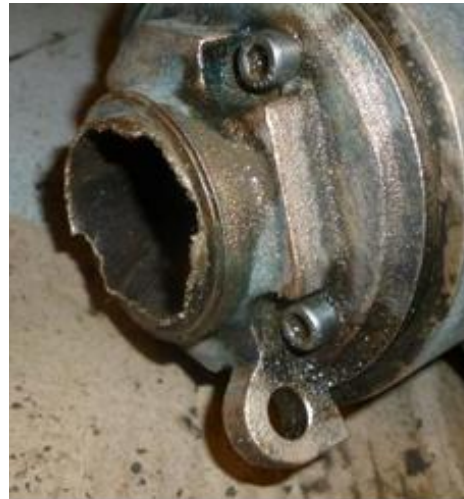
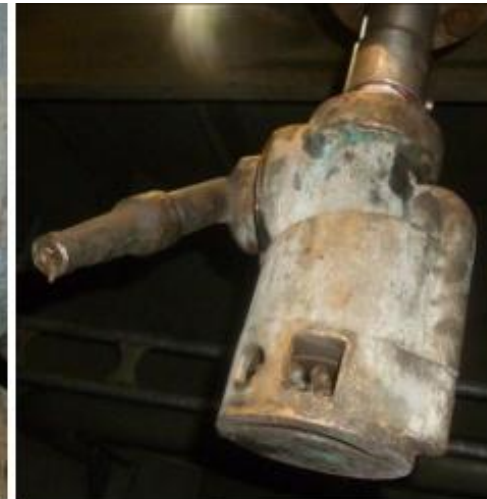
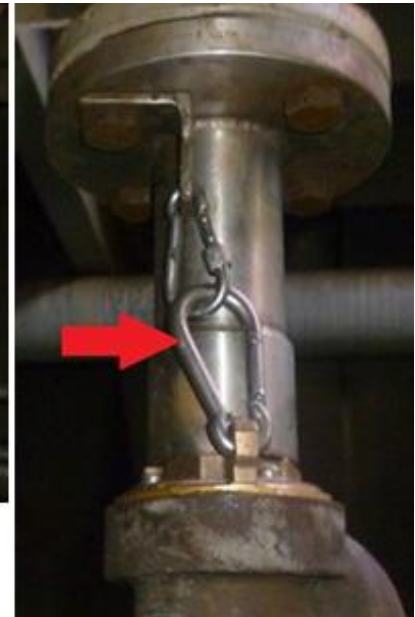
26-05 - Fixed Tank Washing Potential Dropped Object

Fixed 10kg tank washing machine found on the tank bottom by the tank cleaning team having fallen from its fixed position due to a broken connection to the supply pipe.

Causes were identified during the investigation:

- PMS periodic inspection and overhauling of those machines not carried out properly due to accessibility.
- Washing machines mounted with threads and are not secured or considered as Potential Dropped Objects.

The actions below were implemented on the members fleet of vessels:

1. Add Tank Wash machines to PDO Register.
2. Add secondary retention to each machine.
3. Review amend and/or correct PMS Routine

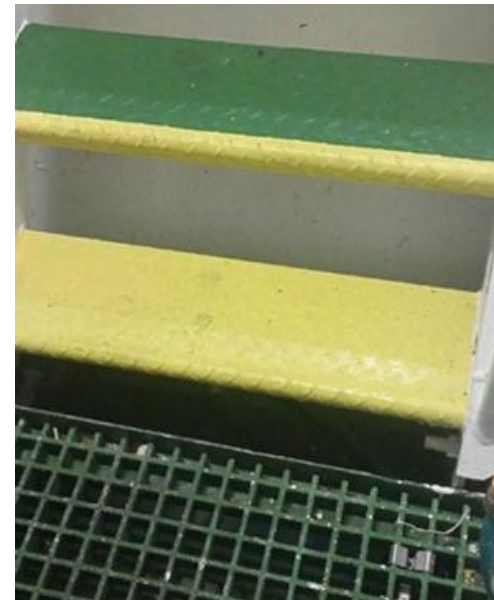
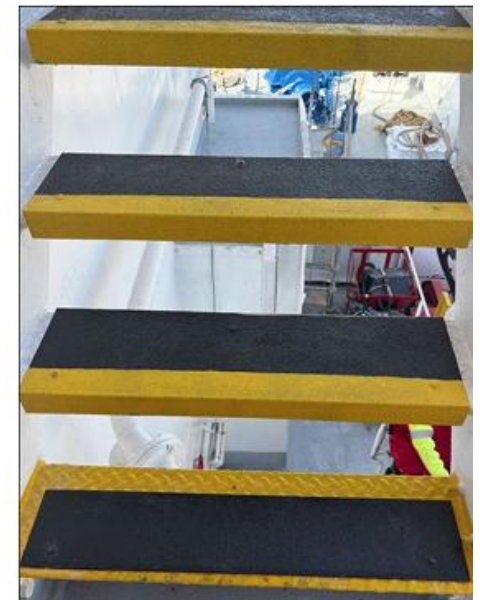
26-04 - Hazards of Vessels External Stairs

During daily activities onboard a member's vessel a member of the crew tripped on the vessel exterior stairs, lost balance and sustained a back injury.

Following the investigation two of the causes noted were:

- The 1st step has less of a rise than the others because of gratings which have been fitted at deck level
- The original anti-slip surface has become ineffective due to multiple layers of paint applied over the years

After this incident, the vessel owner implemented the following actions:

- If step heights / rise is inconsistent, this should be included in the vessel familiarisation process as a vessel specific hazard
- All vessel stairways to be inspected to assess the need for re-application of anti-slip treatment (e.g. sand in paint or anti-slip pads as shown below)

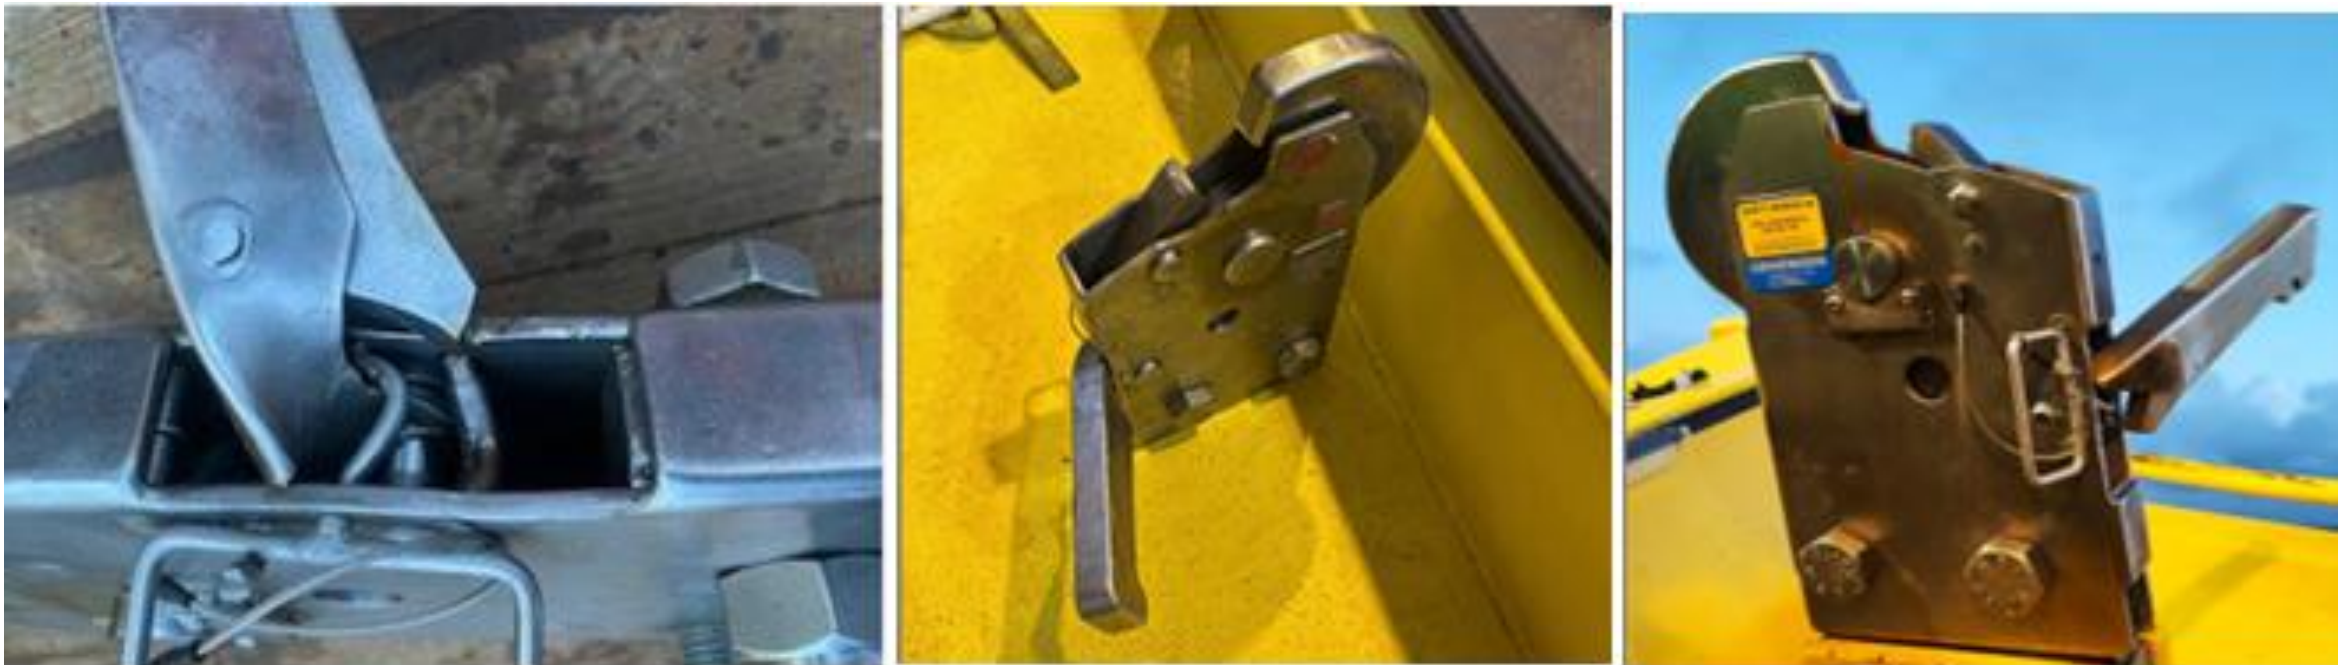
26-03 - FRC Lost at Sea (Continued)

Whilst a vessel was proceeding from port to an offshore location the Port side FRC washed overboard caused by a rogue wave impacting the port side FRC stowage compartment becoming swamped by a large wave from abeam during rough weather conditions. The boat was immediately seen by the bridge watch to be in the water floating in a capsized condition. Video footage shows that the wave reached up to and beneath the port side bridge wing. The boat could not be recovered at that time.

During the onboard investigation it was confirmed that the davit hook and wire were still intact/undamaged, but the fibre lashing straps had been torn apart, and several davit components were damaged.

The FRC was recovered and an equipment manufacturer report on the hook showed plastic deformation of the hook body, hook element, and release mechanism consistent with an abnormal high energy impact, resulting in structural deformation. No evidence has been identified to suggest malfunction, wear-related failure, or spontaneous release under normal operating conditions.

A large, unexpected wave hit the vessel from abeam. The wave forced the FRC upwards, impacting the davit with such a force that it severely damaged the hook release mechanism. The lashing straps for the FRC (2,5 t) were under-dimensioned and worn out (5 years old).

Norwegian Coastal radio and onshore ship management notified. A temporary FRC was provided at the first opportunity. Enhanced inspection of the FRC stowage and securing arrangements during weekly inspections, and when adverse weather is expected. Additional lashings may be applied in advance of forecast heavy weather. Periodic planned maintenance check of FRC lashing/ratchet straps (using 5t lashings), and planned maintenance routine to replace FRC lashings at 2-year intervals.
