# Safety Alert

**Number: 26-08**

**Published: 15/07/2026**

**Subject: Mooring Line in Tunnel Thruster**

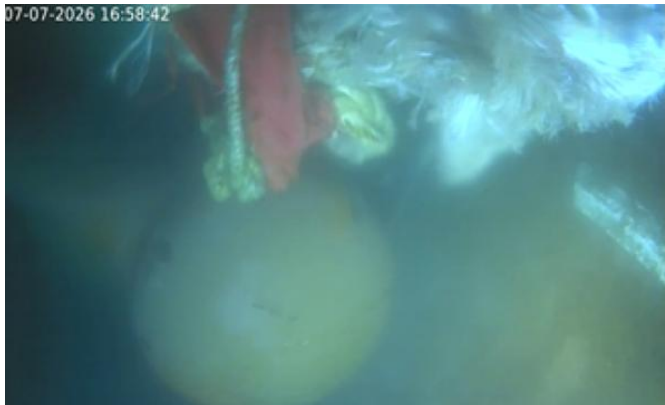
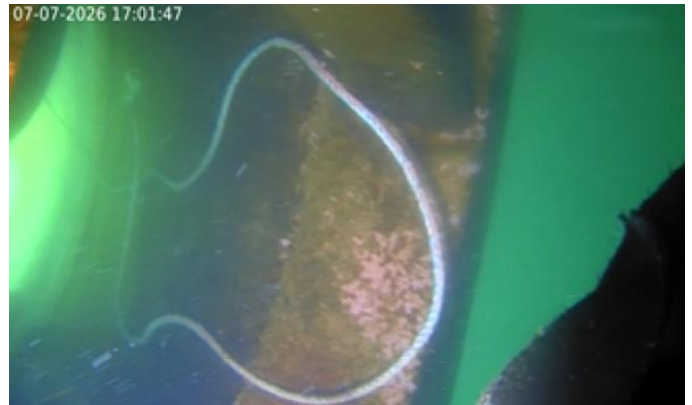
## Photographs / Supporting Information

The bridge was immediately informed, and bow thruster power was reduced. However, Thruster No. 1 tripped and shut down after ingesting the line. The vessel began to move off the berth but was safely brought back alongside using Thruster No. 2, and an additional bow line. Once safely moored, all thrusters were shut down, and it was confirmed that a rope had become lodged in Thruster No. 1.

A heaving line entered the water in the vicinity of an operating bow thruster and was drawn into the thruster by suction forces, resulting in the attached mooring line becoming fouled in the thruster.

Failure to ensure positive control of mooring and heaving lines while operating a bow thruster during mooring operations allowed a loose line to enter the thruster suction zone and become fouled.

- Diving contractors were mobilised and safely removed the rope from the thruster.
- The thruster and propeller were inspected by divers, with no damage identified.
- Functional testing of the thruster was completed with no alarms, abnormal noise, or vibration detected.

- Discontinue the use of daisy-chain mooring arrangements and pass mooring lines ashore individually wherever practicable.
- Always maintain positive control of all heaving lines and mooring lines during mooring and unmooring operations.
